**RE: Budget Estimate / Engineers Recommendation  
Structure 189**

**Re: Bridge #189 West Grey  
Inspection and Recommendation for Repair  
Our File WO 20-078**

## Photographs of Bridge #189 West Grey

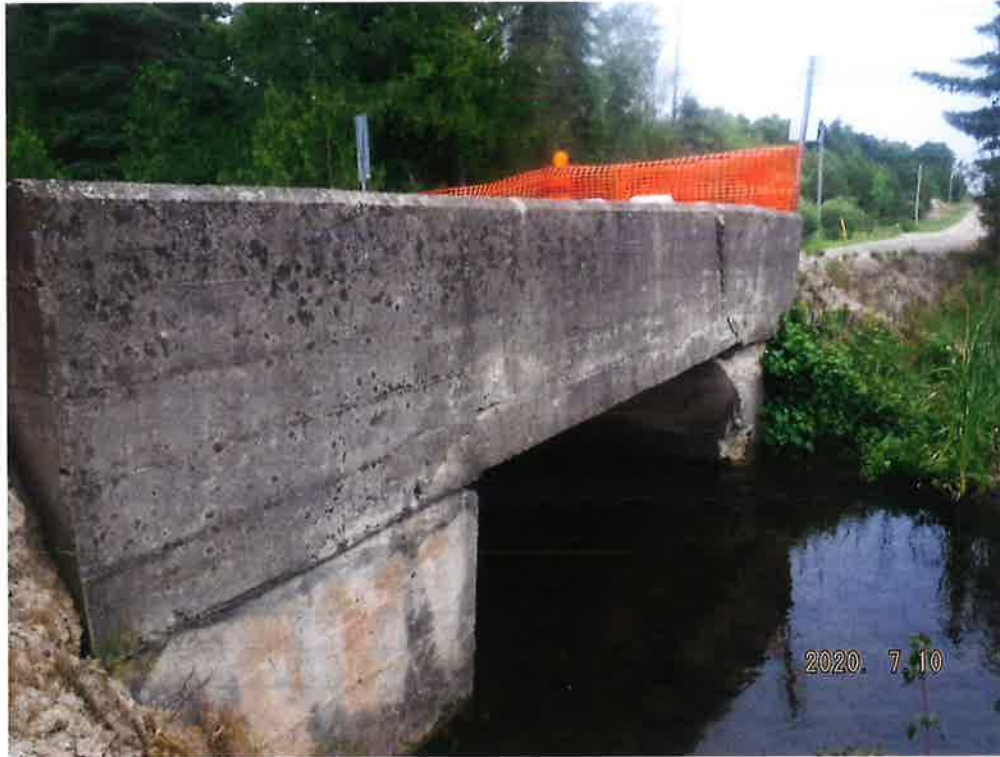
The abutments are believed to gain their stability from the ‘U’ shaped configuration of the abutment and wingwalls and their footings. Based on the visible cold joints in the wingwalls, the slab is believed to have been built on top of the abutments/wingwalls (see Photograph 1).

*Photograph 1 – West Elevations of Bridge #189.*

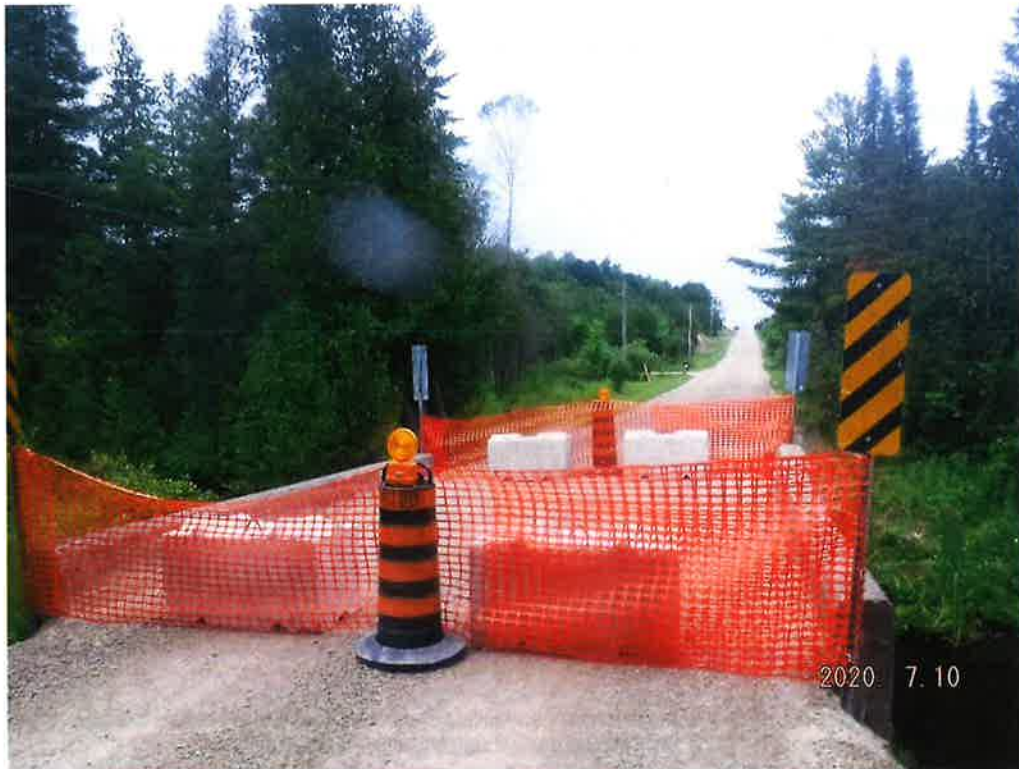
DDA arrived at the site at 3:00 pm and were on site until approximately 4:00 pm. Upon our arrival at the site the bridge was closed to traffic (see Photograph 2).

*Photograph 2 – Bridge 189 Closed – Looking North.*

We would recommend the bridge remain closed until the replacement can be implemented.

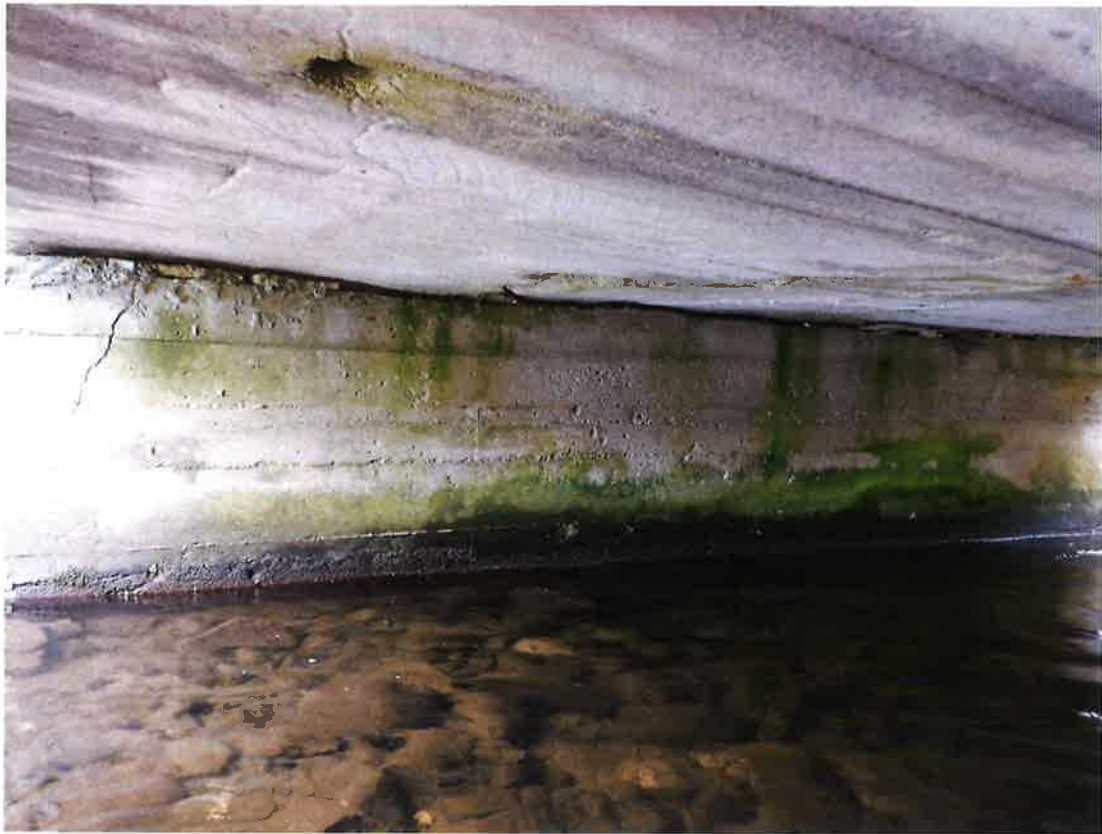
The structure appears to be a flat slab resting on concrete abutments. As noted above, the slab is not integral with the abutments (not a rigid frame) as shown in Photograph 3.

*Photograph 3 – South Abutment – Note the gap at the slab/abutment juncture.*

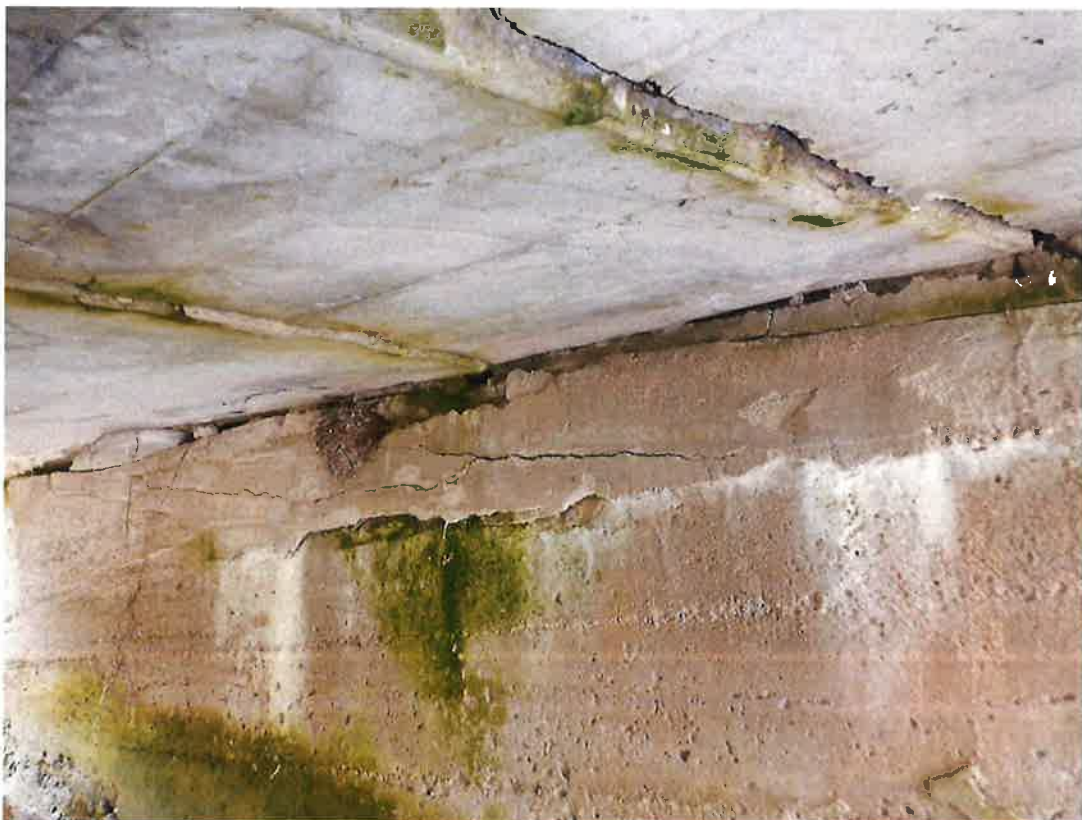
The concrete in the abutments has delaminated sections as can be seen in Photograph 4. In that Photograph, two (2) longitudinal cracks in the deck soffit are visible. These cracks are shown in Photograph 5. These cracks are very wide and appear to have opened in straight lines following suspected cold joints in the concrete. Some rust staining is visible in Photograph 5 however, the amount of rust staining is less than expected. We believe this may be as a result of there being few transverse reinforcing bars crossing the open cracks. Culverts of this vintage reserved steel reinforcement primarily for directions parallel to the span.

The cracks are 25 mm + wide with, in some places, 50 mm of vertical displacement exists between adjacent components. (See Photograph 4 and 5).

*Photograph 4 – Close-up of the north abutment. Note the cracking of the concrete in the abutment and the longitudinal cracks in the deck.*

Replacement for this structure is recommended by the undersigned. With no drawings and extensive deterioration, we believe that any attempt at rehabilitation would not be cost effective nor result in a durable culvert.

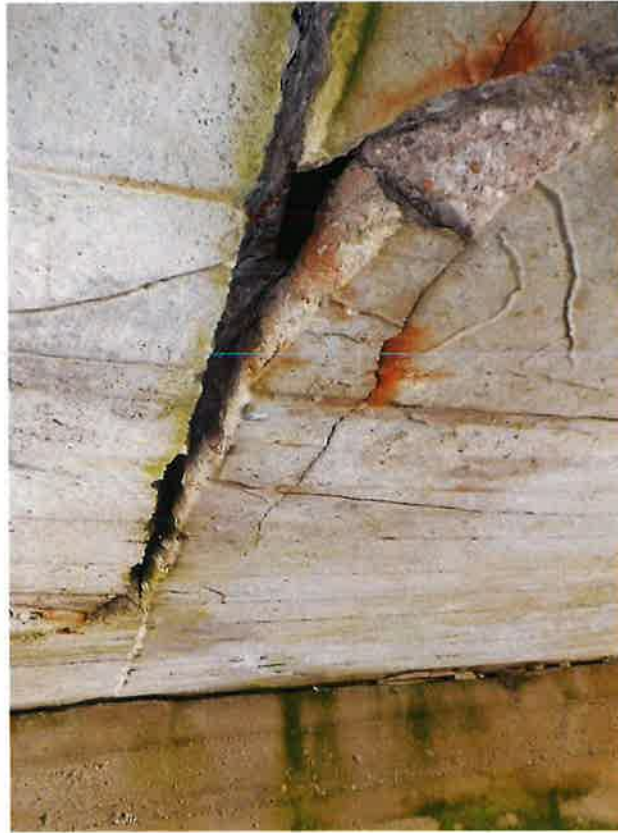
*Photograph 5 – Longitudinal cracks in deck slab soffit looking south.*

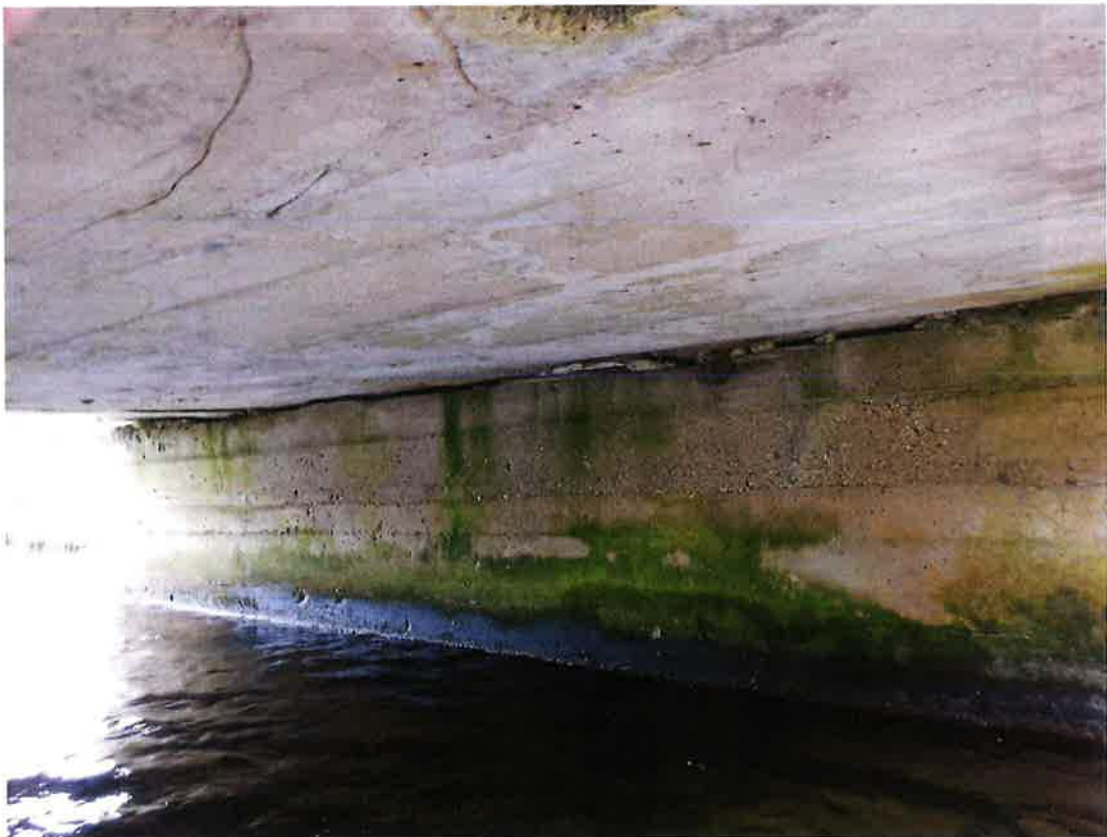
*Photograph 6 – South abutment wall. Note the birds nest at mid-frame of the Photograph.*

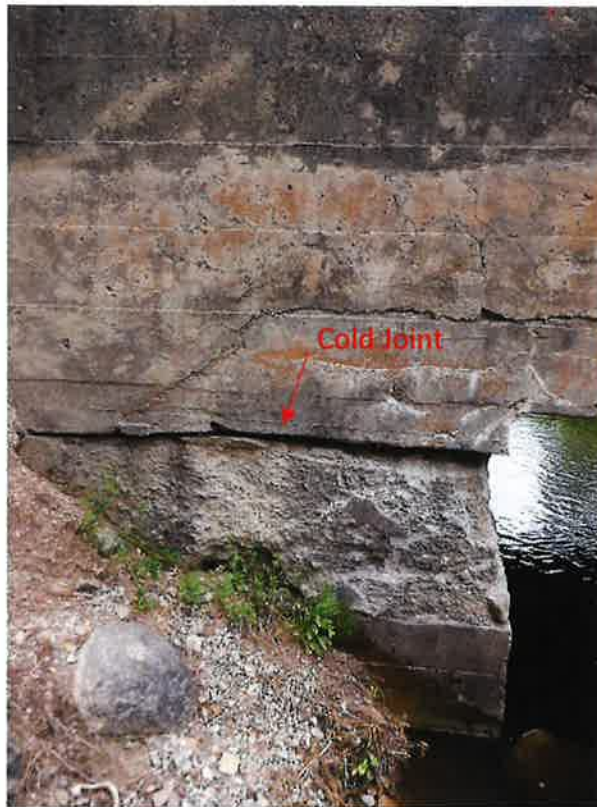
As we did not observe much exposed reinforcing steel, we anticipate any effort to repair the structure will be ineffective and would result in only “cosmetic” repairs. No increased durability is anticipated from such repairs.

*Photograph 7 – Deterioration on the northwest corner. Note the depth of the scaling with no visible reinforcement.*

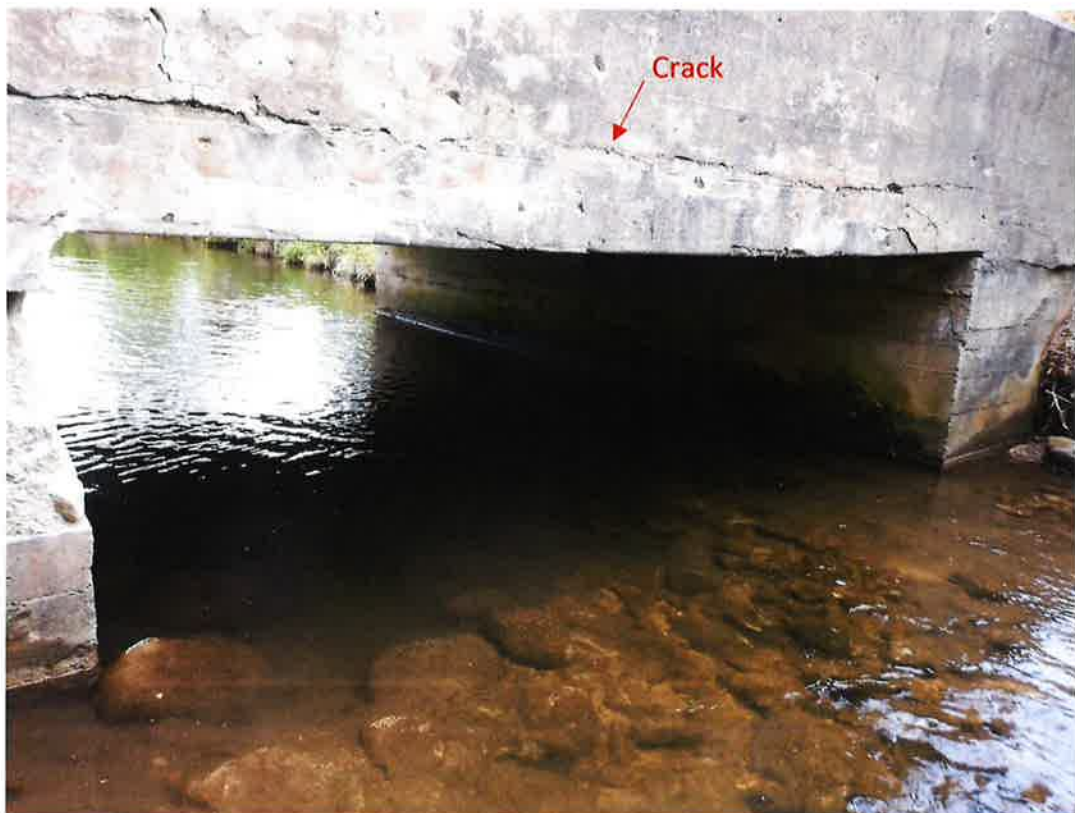
*Photograph 8 – West elevation. Note the deterioration and cracking of the structure slab.*

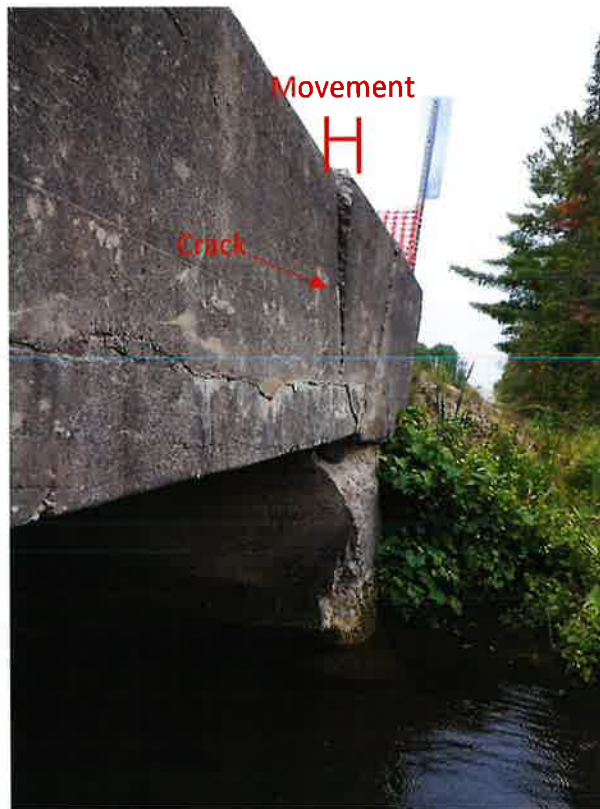
The east wall along the edge of the deck has extensive cracks. It appears this area has been struck by a vehicle resulting in the upper portion of the wall rotating outward (easterly). This is shown in Photograph 9 and Photograph 10.

*Photograph 9 – Broken wall at northeast corner.*

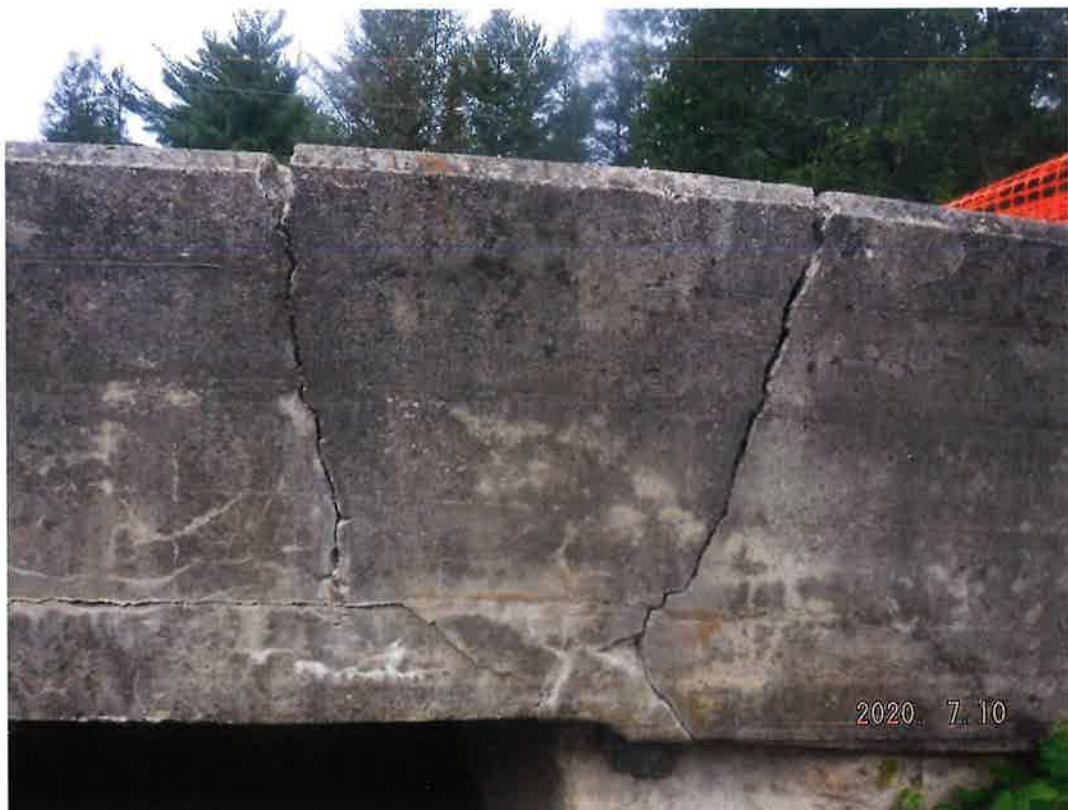
*Photograph 10 – East wall at north end of span.  
Note the v-shaped wedge on the wall that has partially dislodged from the wall.*
