RE: Budget Estimate / Engineers Recommendation - Structure 70

Attention: Mr. Chris Clark, M.A.Sc., P.Eng.**Re: Bridge #70 West Grey
Inspection and Recommendation for Repair
Our File WO 20-078**

Photographs of Bridge #70 West Grey Inspection Photographs 1 – 16

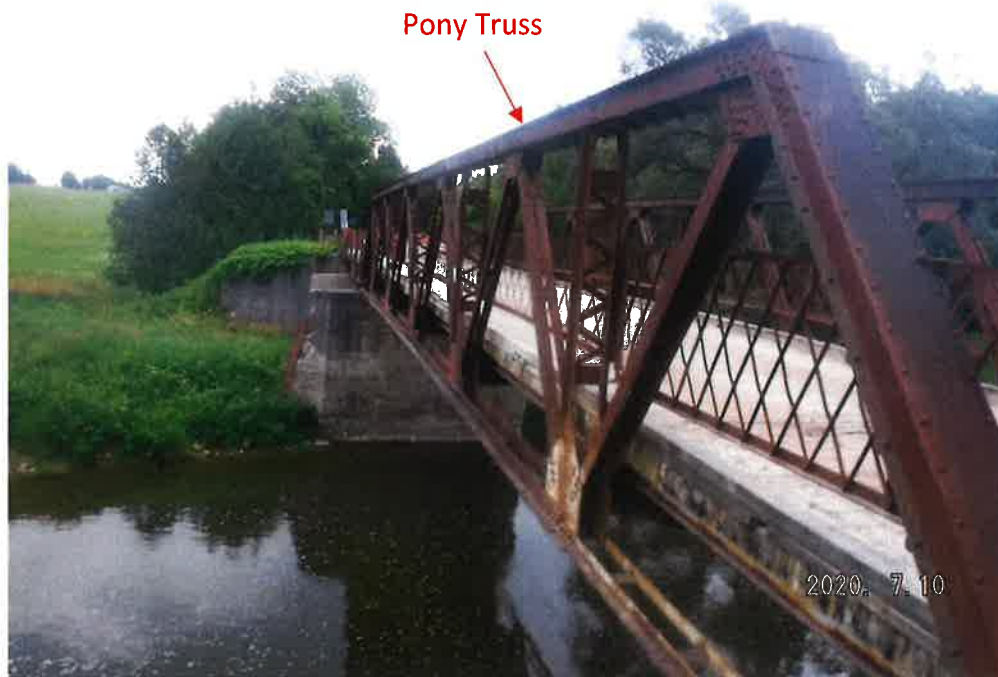
Photograph 1 – East elevation of Bridge #70

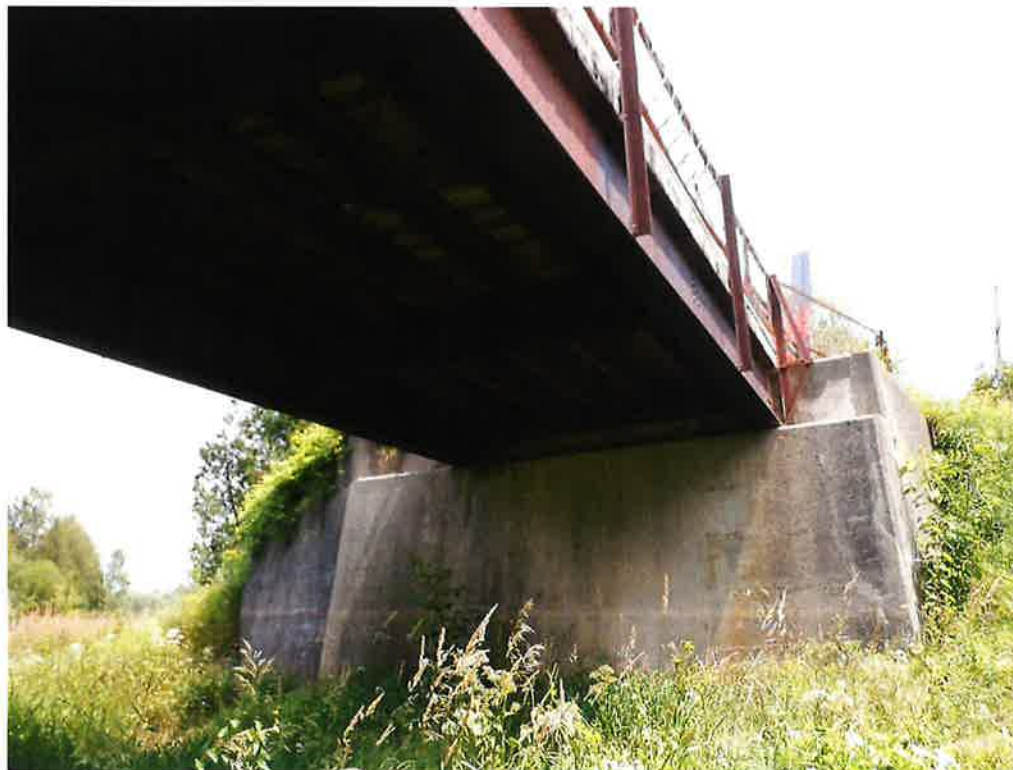
The bridge is a two span structure. The south span length is approximately 40 feet. The south span consists of two main girders (see Photograph 2) with end floor beams and two intermediate floor beams. There are five (5) longitudinal steel stringers that frame into the floor beams. The deck is a laminated timber deck constructed of 2" x 6" sawn timbers (see Photograph 3). The timbers are not believed to be preservative treated.

Photograph 2 – Two main girders of the south span

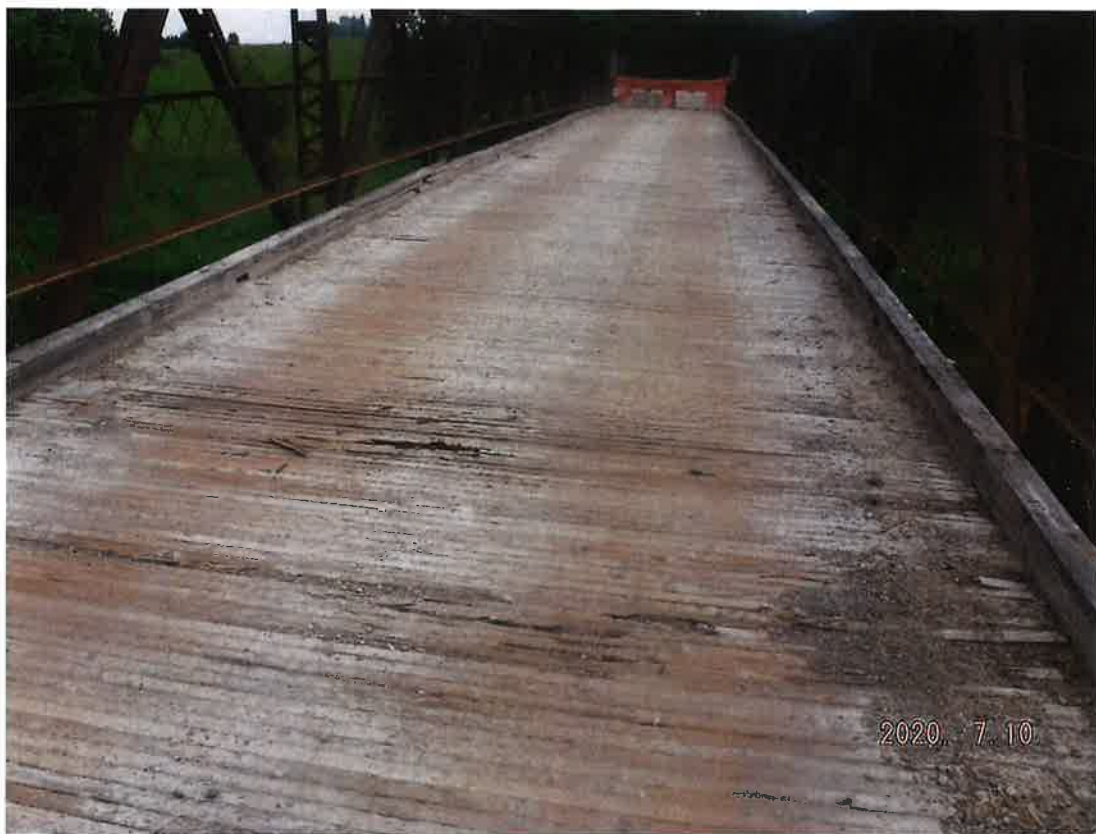
Photograph 3 – Deck made of 2"x6" sawn timbers (transverse laminated)

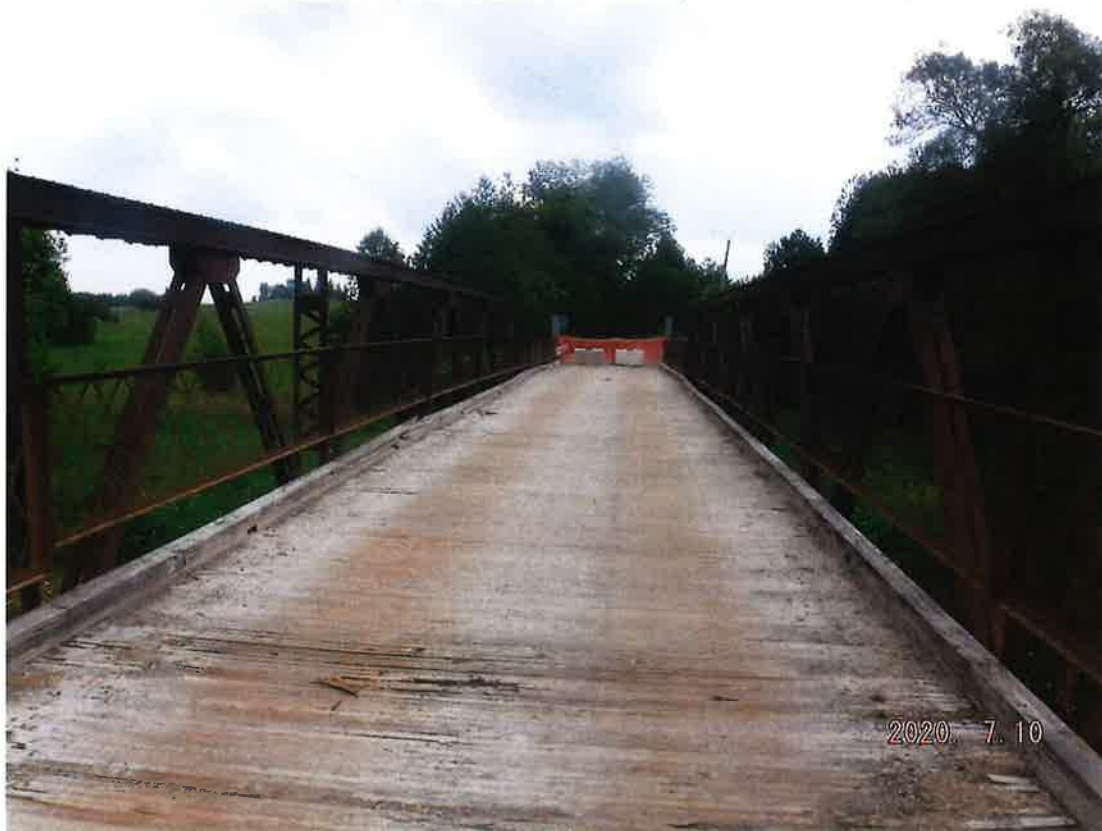
The north span is approximately 26.5 m long and consists of a pony truss span (see Photograph 4). The floor beams are spaced at approximately 0.7 m centres. There are seven (7) lines of stringers framing between the floor beams (see Photograph 5).

Photograph 4 – View of the north span looking north

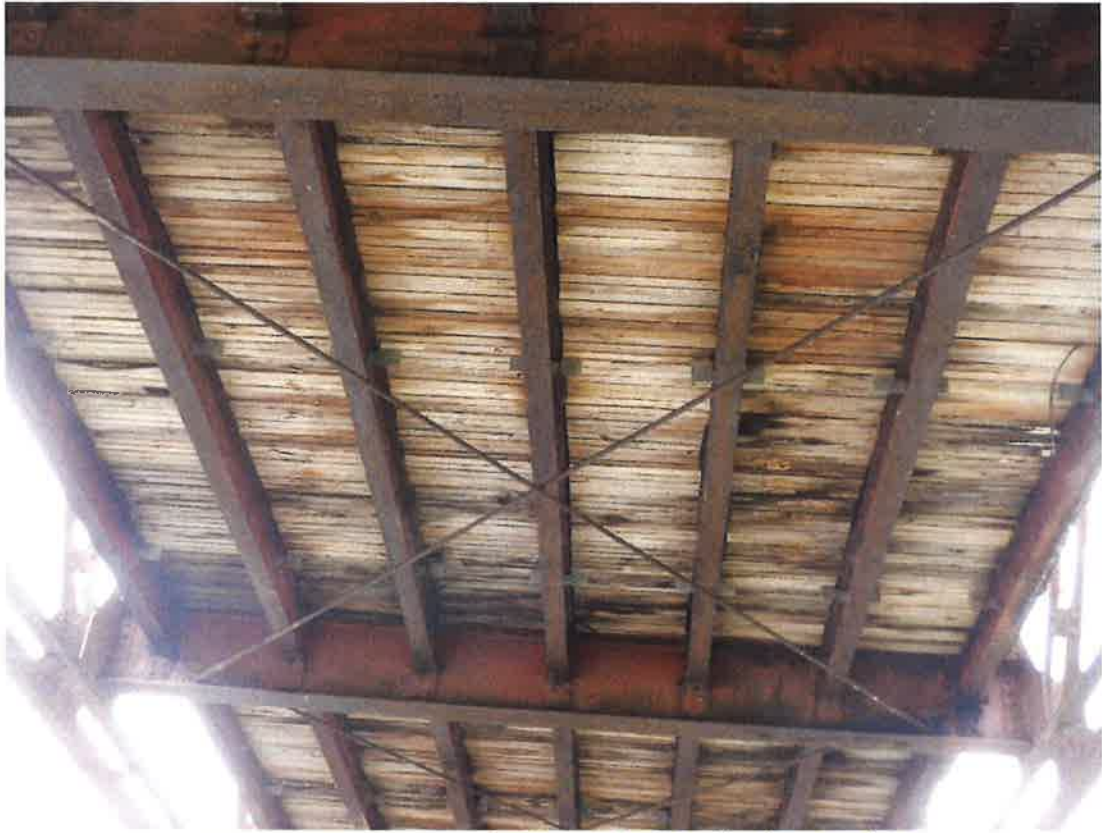
It is noted that the steel in the pony trusses is riveted, indicative of 1920 construction. So too is the connection of the floor beams to the trusses. We note that all of the stringers appear to be bolted to the floor beams suggesting the floor beams have been replaced at least once. The north span has a similar laminated timber deck, as does the south span.

Photograph 5 – Stringers running along deck soffit to floor beams and pier

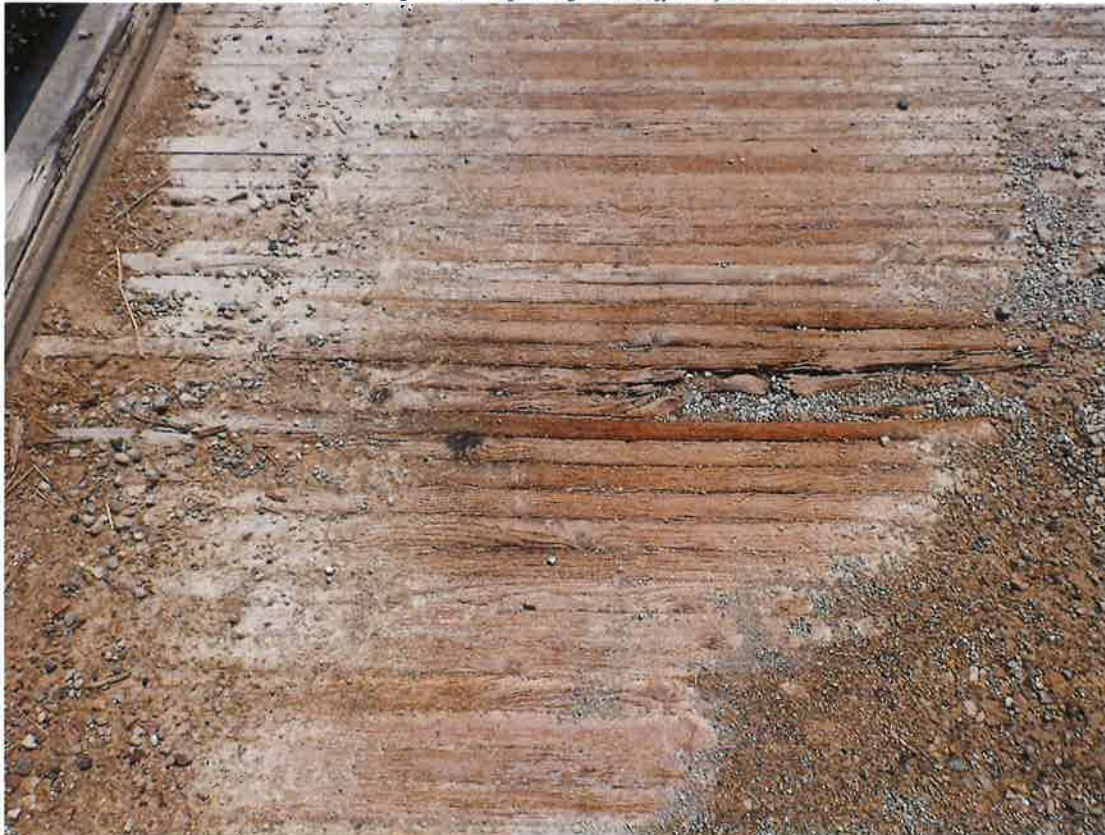
The laminated timber deck is in an advanced state of decay. The exposed deck surface has numerous worn boards (see Photograph 6) as well as boards where a portion of the laminate is missing/broken (see Photograph 7).

Photograph 6 – Worn and deteriorating wooden deck surface

DDA does not anticipate that any sections of the deck can be rehabilitated. Complete replacement of the existing deck with a new laminated timber (with preservative treated timber) is required to restore the existing five tonne posting limit.

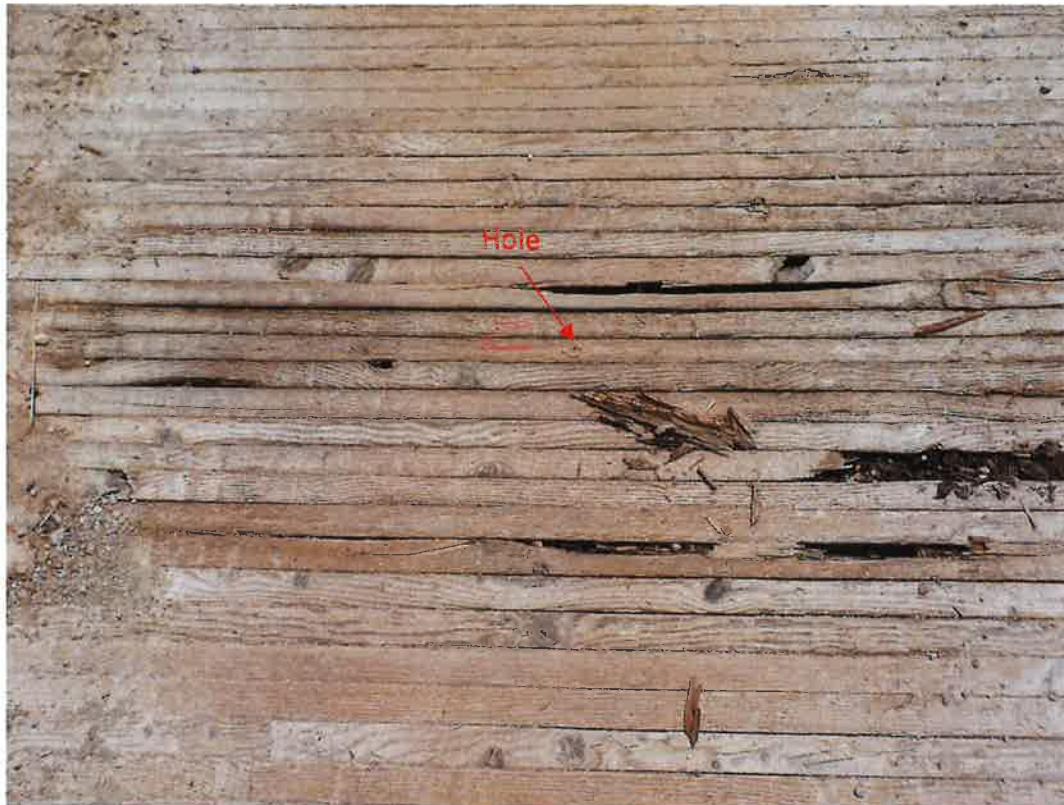
Photograph 7 – Deck surface with broken/deteriorating laminate

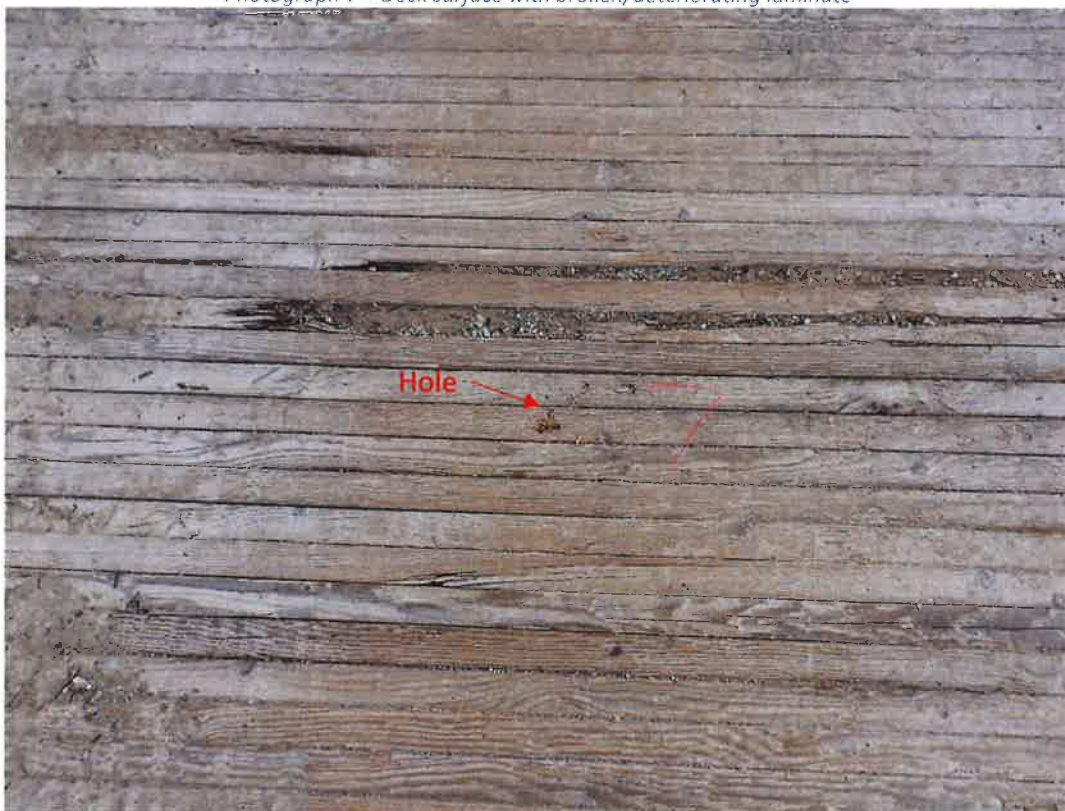
DDA staff hammer sounded portions of the deck. The timber over much of the deck area provided an indication of soft, decaying timber. DDA staff drilled ten (10), 6 mm diameter holes in the deck to confirm the sound was decay. Most of the holes met little resistance to drilling (see Photograph 8). In some, the wood recovered was wet and dark. There were some locations with sound wood at depth (50mm plus) which confirmed a noticeably different response to hammer sounding.

Photograph 8 – Drilling into wooden deck to confirm state of decay indicated by hammer sounding

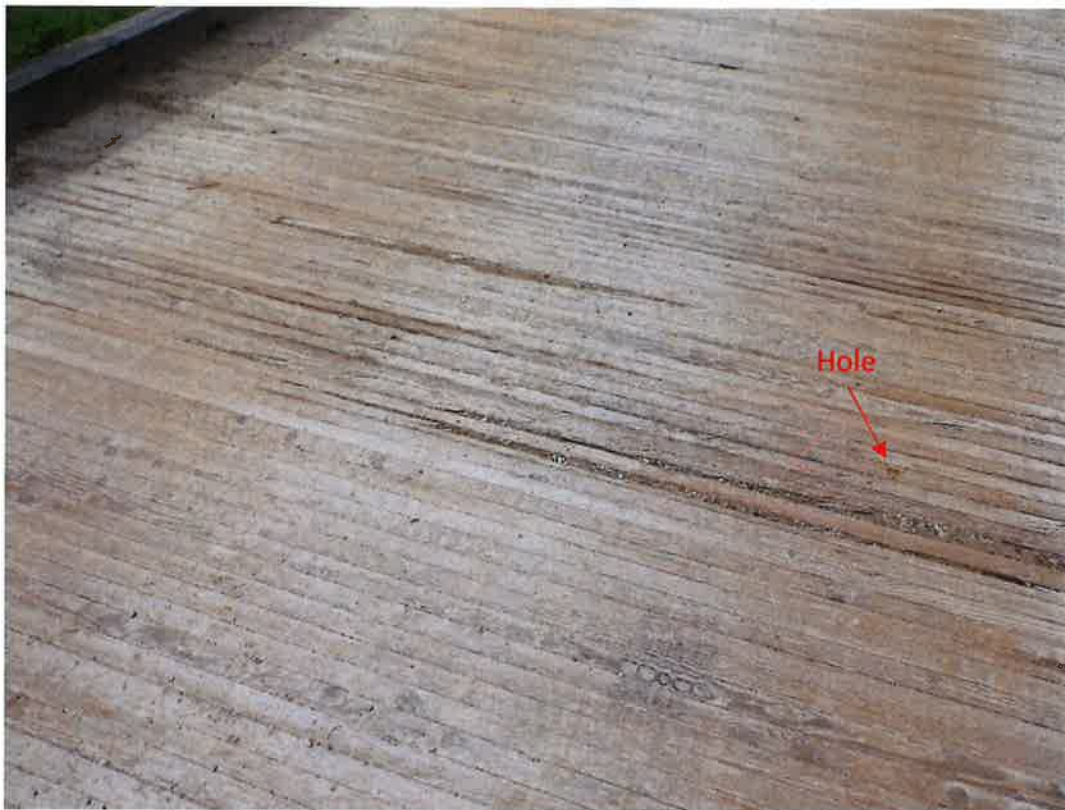
There are a number of locations where the laminated deck is decayed to such an extent that the deck deflects noticeably under an inspector's weight (see Photograph 9).

Based on our inspection of the timber laminated deck, the deck has a very high risk of local failure if allowed to be re-opened in its current condition. The extensive deterioration is approaching such condition where DDA would expect deck failure even from vehicles meeting the current five tonne posting.

Photograph 9 – Area which deform noticeably under the weight of an inspector

For vehicles that may exceed the posted five tonne limit, this risk of failure would increase. Depending on the load DDA believes that the small span (spacing) between adjacent stringers has allowed the 2x6 laminated deck to remain in service and functional as long as it has. **We would recommend that the bridge remains closed to traffic until such time as repairs to the deck can be made.**

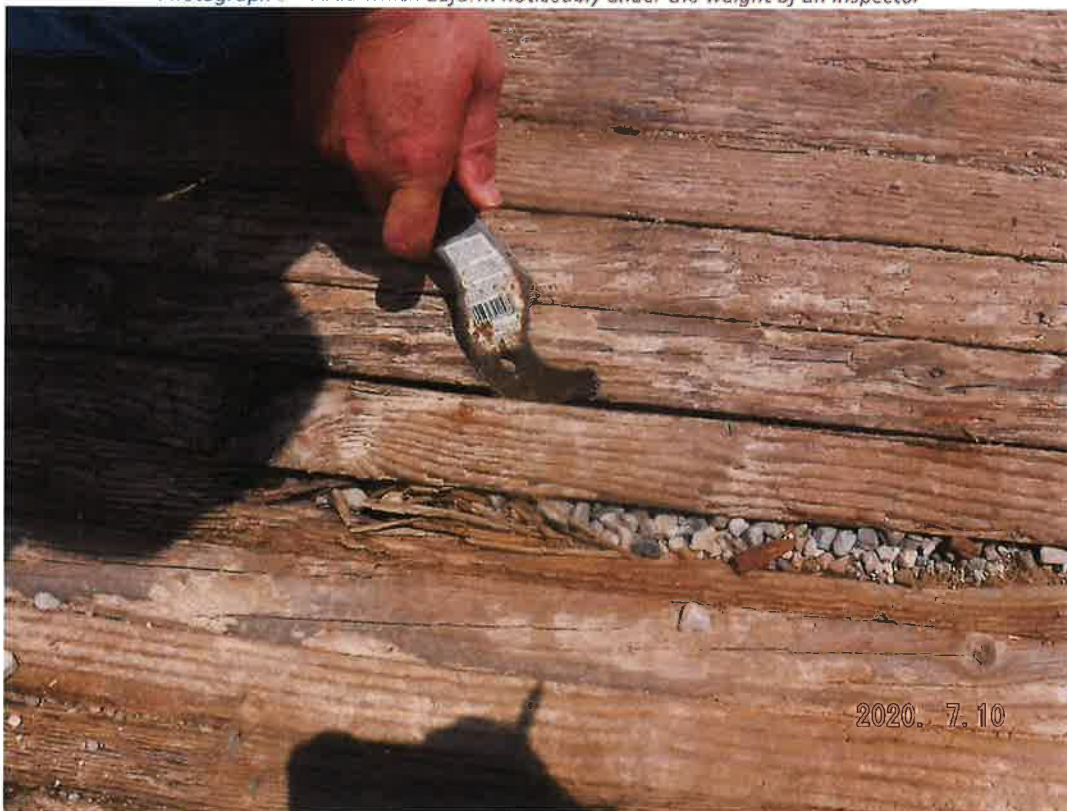
The laminates can be separated using a paint scraper (see Photograph 10). This demonstrates the advanced decay.

Photograph 10 – Laminate deck can be easily separated with a paint scraper

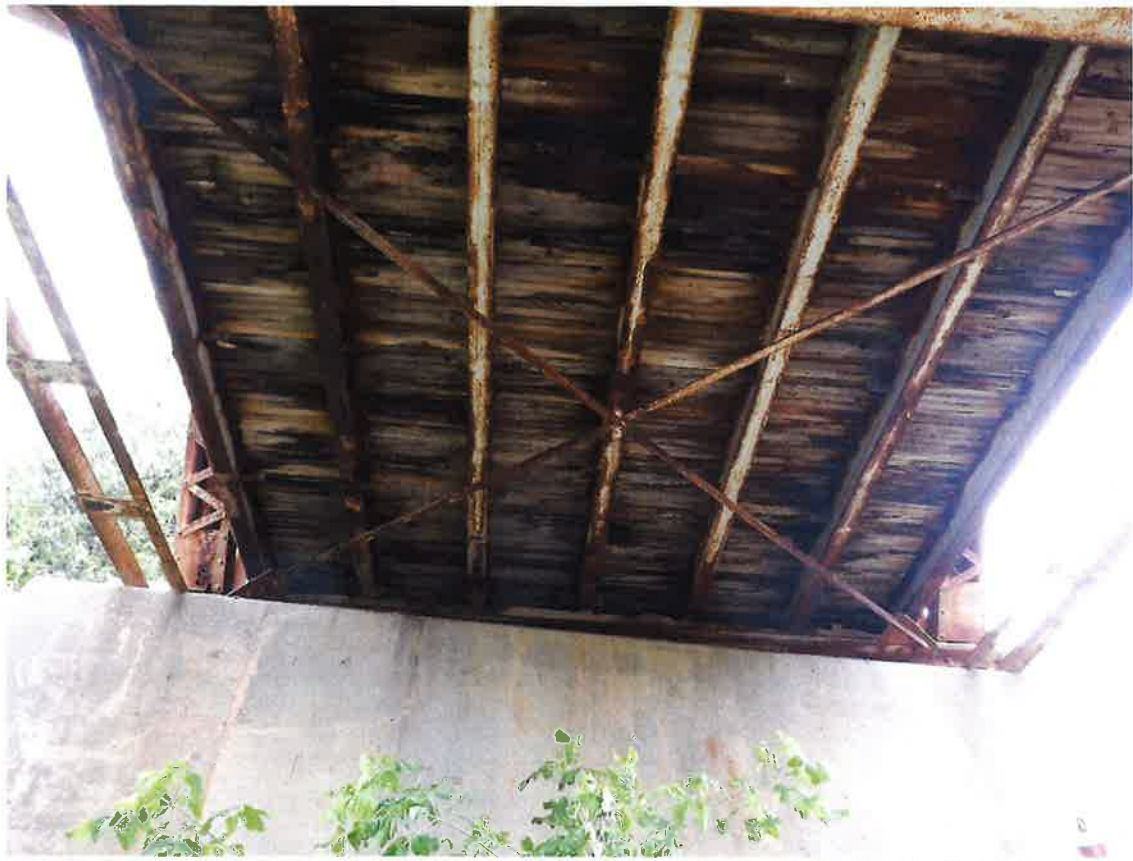
From beneath the deck the timber is noticeably wet and dark suggesting areas of through deck decay are present (see Photograph 11).

Photograph 11 – Areas of deck soffit with noticeably wet and dark areas indicating decay is present

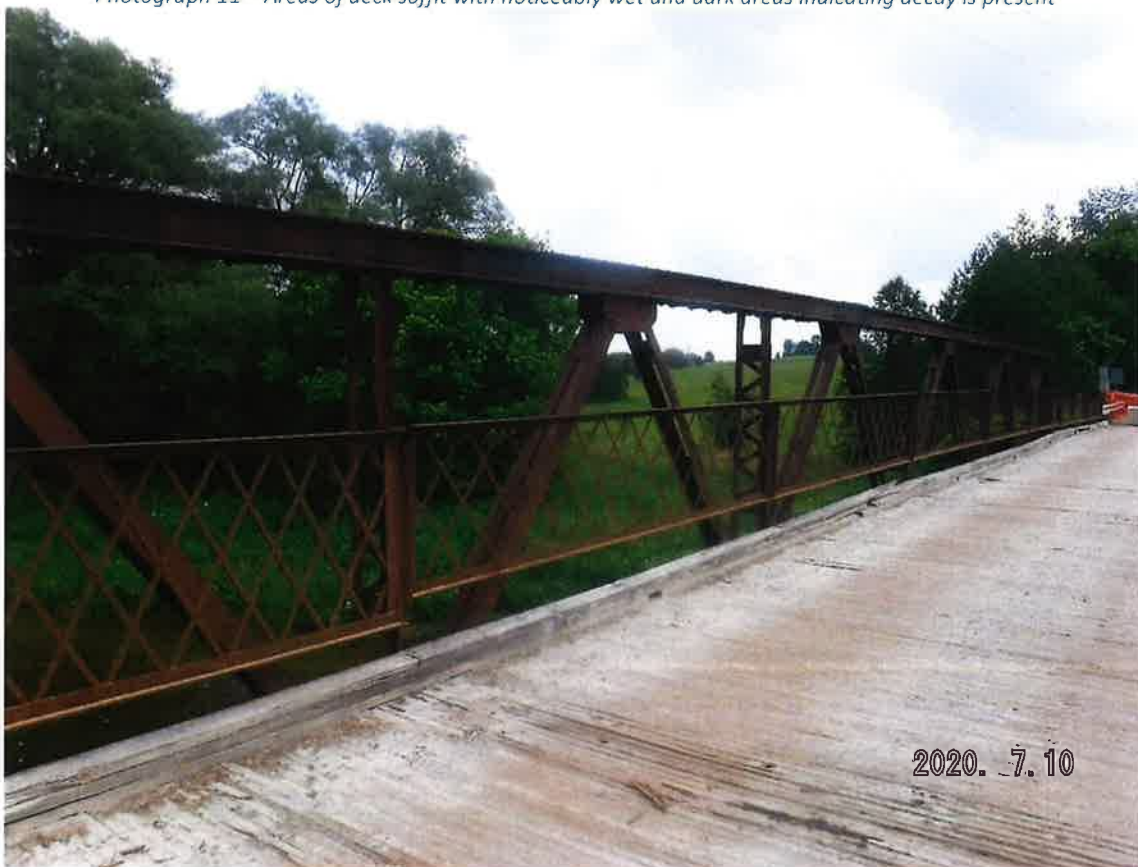
The **pony truss** is in fair condition (see Photograph 12). The coating/paint system is no longer providing protection to the truss. The steel has some heavy pitting in areas with some assumed section loss. No field measurements to estimate section loss were undertaken by DDA during this inspection.

Photograph 12 – East pony truss

DDA would recommend that the steel conditions be inspected at the time the timber deck is removed. The Contractor would be requested to provide for one day of time for the inspection for Engineers in his schedule. Alternatively, the inspection could be complete prior to detailed design. Cost for access is more extensive for such a procedure. This would allow an assessment of the condition of the steel in detail prior to tender. In addition, an evaluation could also be complete following the inspection to assess the load capacity and the possibility of increasing above 5 tonnes.

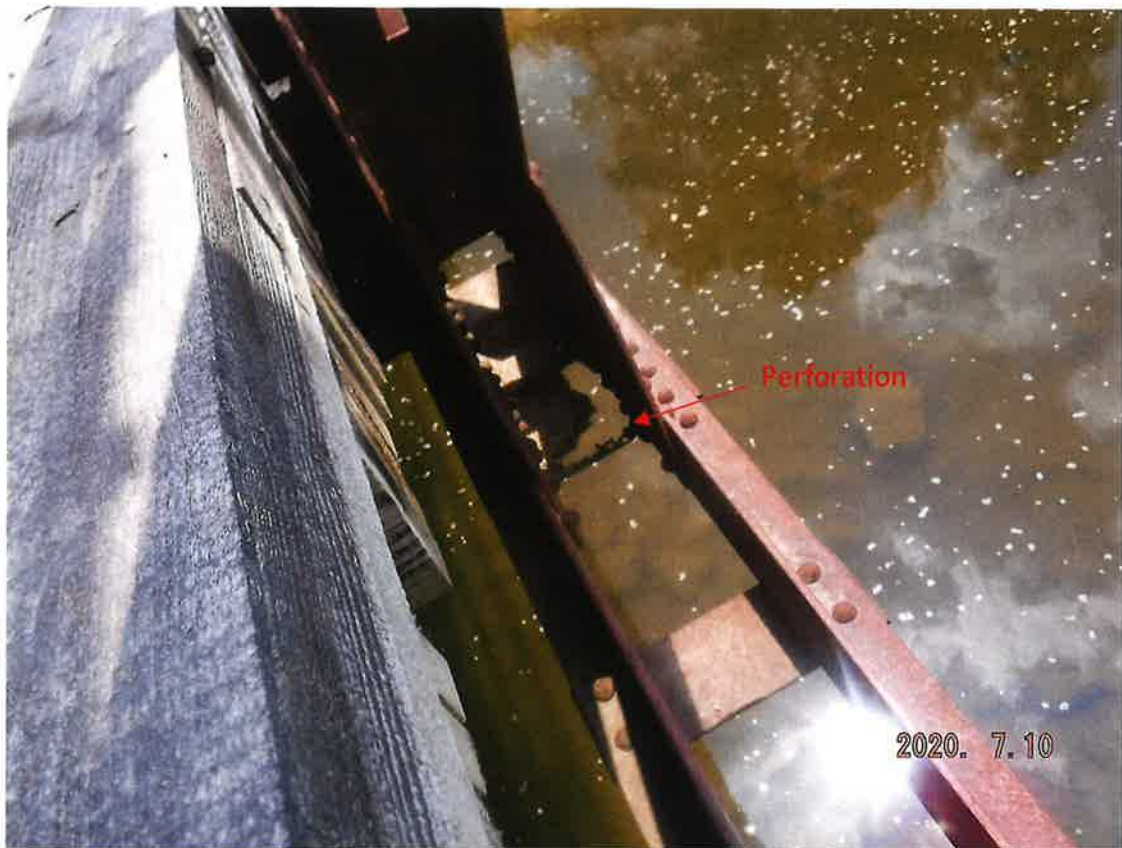
Some minor seam corrosion/rusting jacking was observed between built up member components in the truss. Batten plates connecting the bottom chord angles are perforated in several locations. Also, the batten plates at several of the floor beam to truss connections also have perforations (see Photograph 13). We also observed one (1) floor beam web perforation in the second floor beam from the north in the west end (see Photograph 14). The south span girders, floor beams and stringers exhibited no visually obvious defects. No perforations were observed.

Photograph 13 – Corroded/perforated connection plate on bottom chord

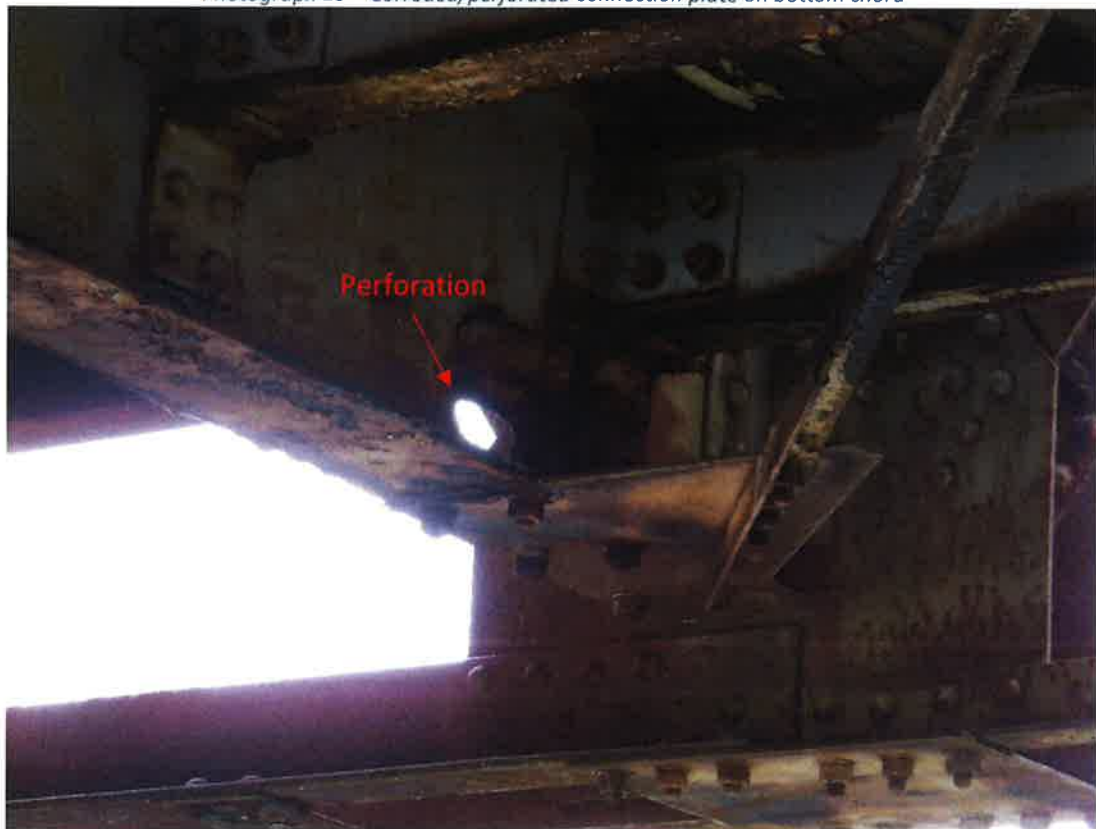
Photograph 14 – Perforation in floor beam web in NW corner

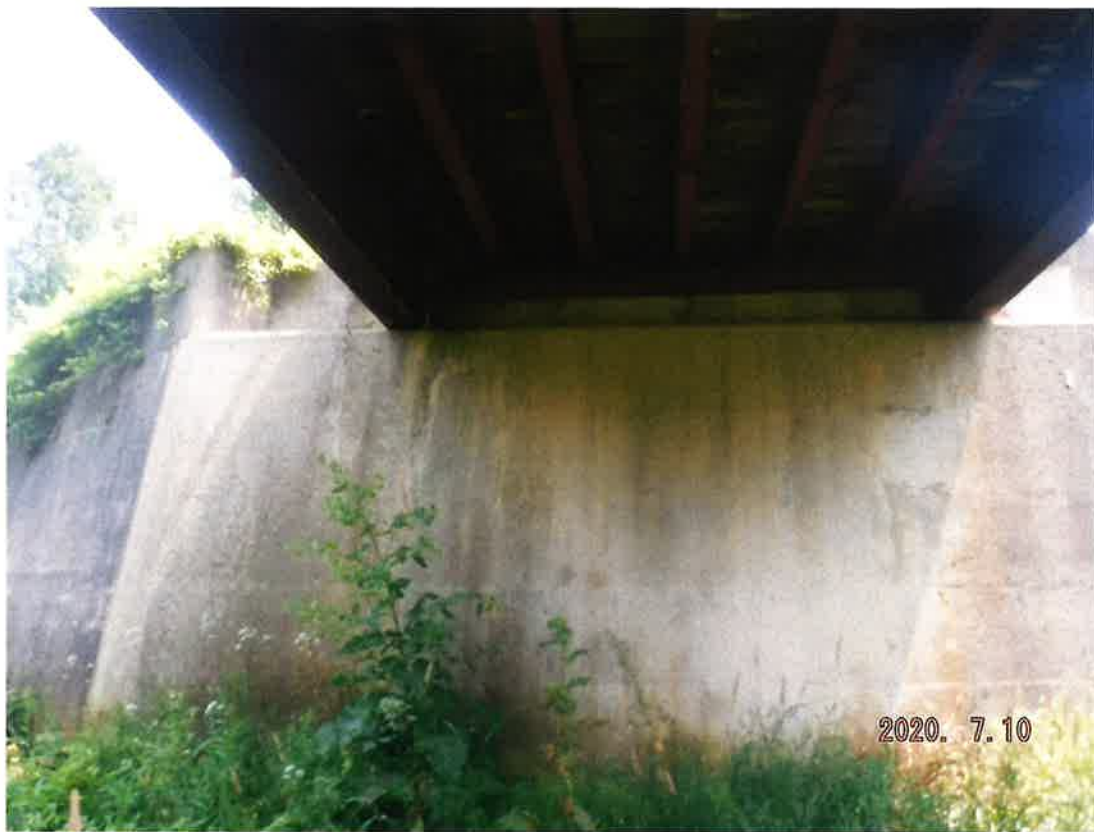
The two existing abutments appear to be in good condition. The abutments appear to be of more modern construction than the pier. We believe that the north and south abutments may have been rehabilitated since the date of original construction (see Photograph 15).

Photograph 15 – South abutment with some indication of rehabilitation

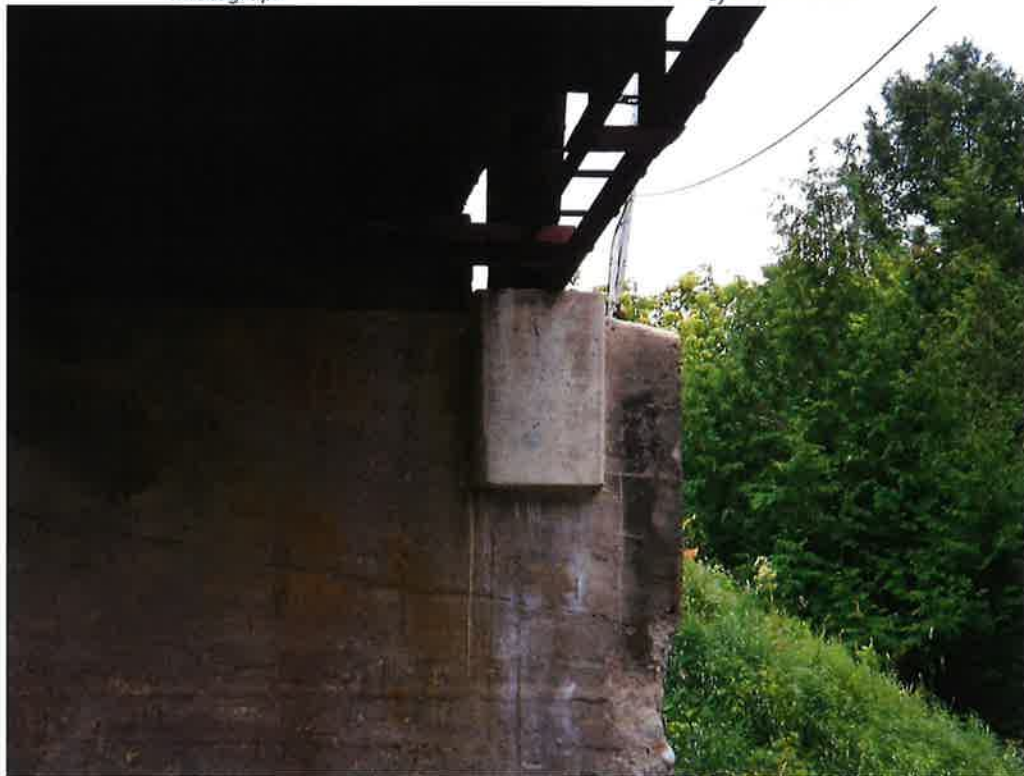
The pier does appear to be original construction with two more recent modifications to the pier on both the north and south faces under the east girder (for the south span) and beneath the west truss for the north span (see Photograph 16). The west end of the pier has one local area with scaling showing large diameter aggregate. Such aggregate was common for substructures built in the 1920s where aggregate was often sourced on site.

Photograph 16 – Corbel indicating some modifications to the pier (north face west of end pier)
