Doug Dixon & Associates Inc

Attention: Mr. Chris Clark, M.A.Sc., P.Eng.**Re: Bridge #17 West Grey
Inspection and Recommendation for Repair
Our File WO 20-075**

Photographs of Bridge #17 West Grey Inspection

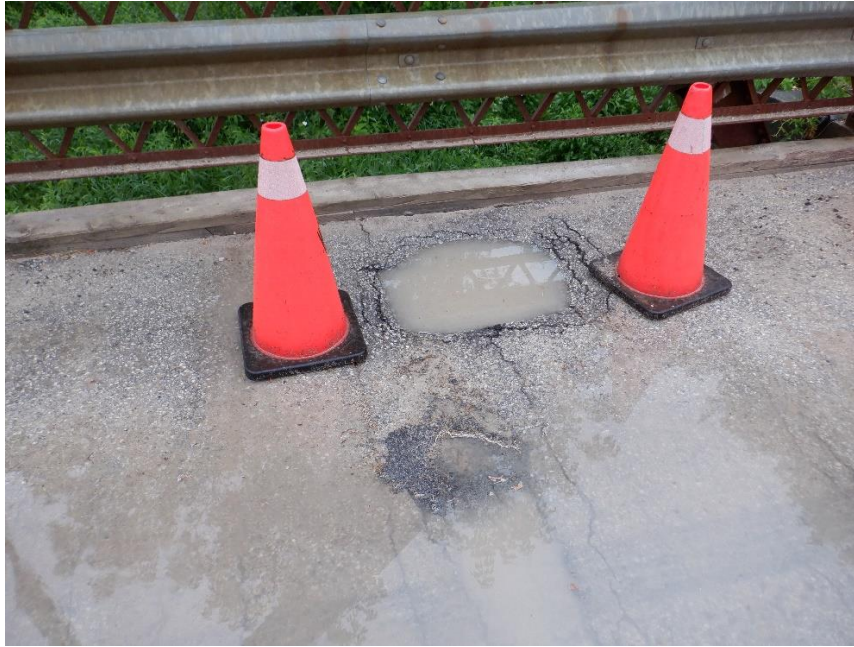
At the time of the site visit, there was a depression in the asphalt at the east end of the bridge near the north curb (see Photograph 1). Further investigation below the deck showed that the laminated timber boards had failed (see Photograph 2). The timber was wet and showed signs of decay/rot.

Photograph 1 – Punch Through – Northeast end of the bridge; note the adjacent deck failure location immediately south.

It is our conclusion from the observed condition that the existing bridge deck cannot be repaired to provide any expectation of service even for the short term. Replaced with a new nail laminated timber deck is feasible. The deck would consist of sawn 2" x 6" timbers. If possible, the timber would be dried and preservative treated, however, this may affect the timing of the work.

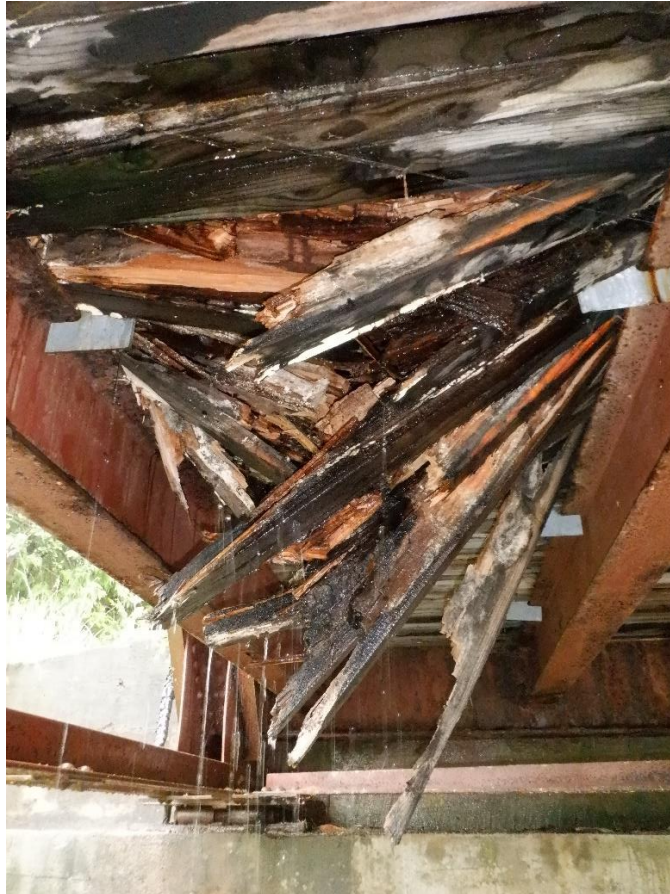
Photograph 2 - Location of Punch Through-timber in an advanced state of deterioration.

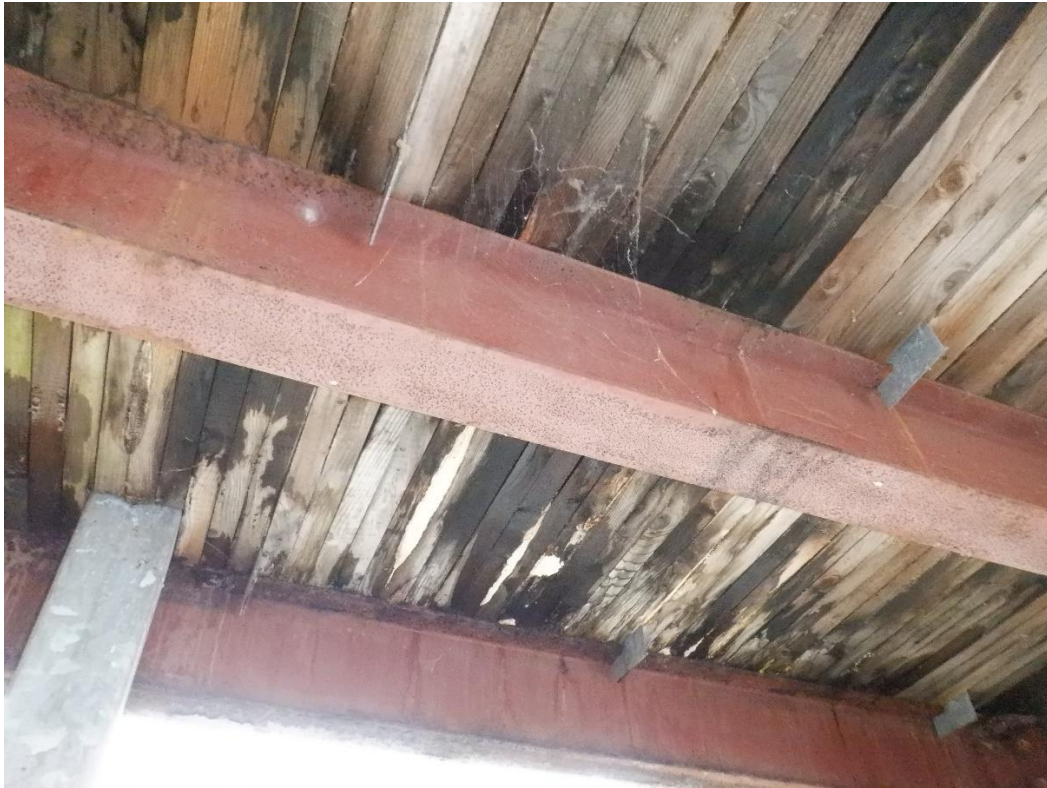
The undersigned continued the inspection moving west by consecutive bays. In general, the condition of the exposed timber soffit was wet to damp along the edges of the deck. The interior portions exhibited generally “drier” conditions. Areas along the south edge of the deck, as shown in Photographs 3, 4, 5 and 6 were wet, actively dripping and exhibited the growth of surface fungus. Decay is anticipated in these areas.

Photograph 3 - Second bay from the east abutment - wet deck 1000 mm west of deck drain - decay taking place.

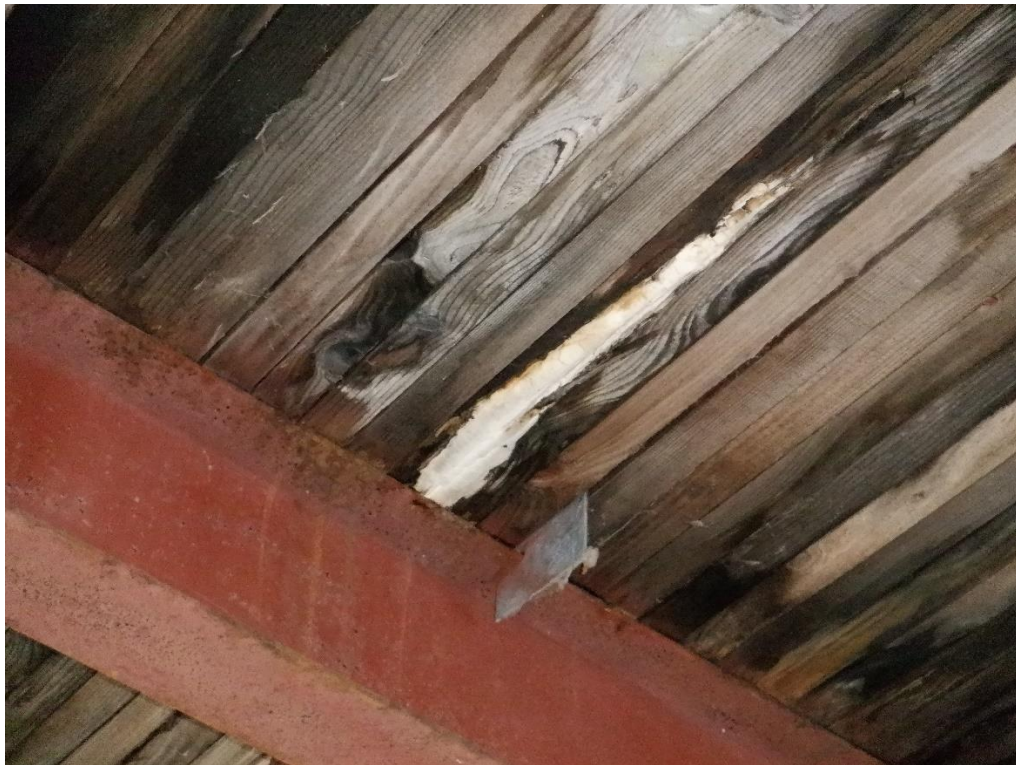
Photograph 4 - Bay #3 from the east abutment, deck north of the second stringer from the south; note the growth of fungus on the wood; rot is occurring.

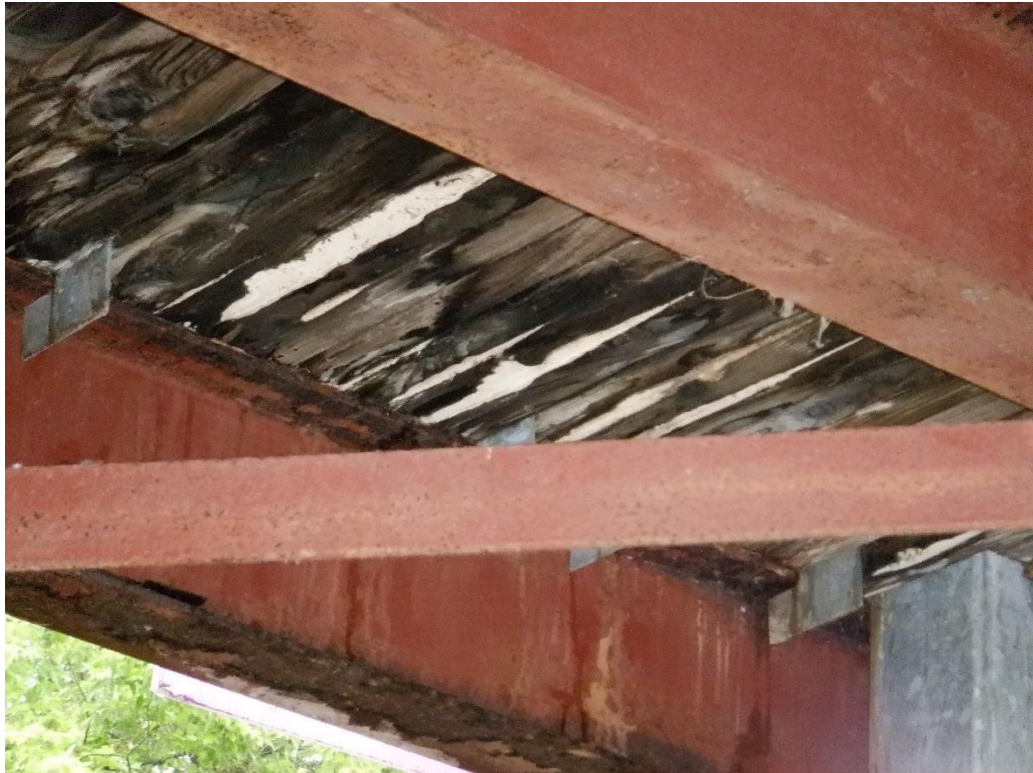
Photograph 5 - Bay #4 from the east abutment north side of south stringer; note wetness and decay.

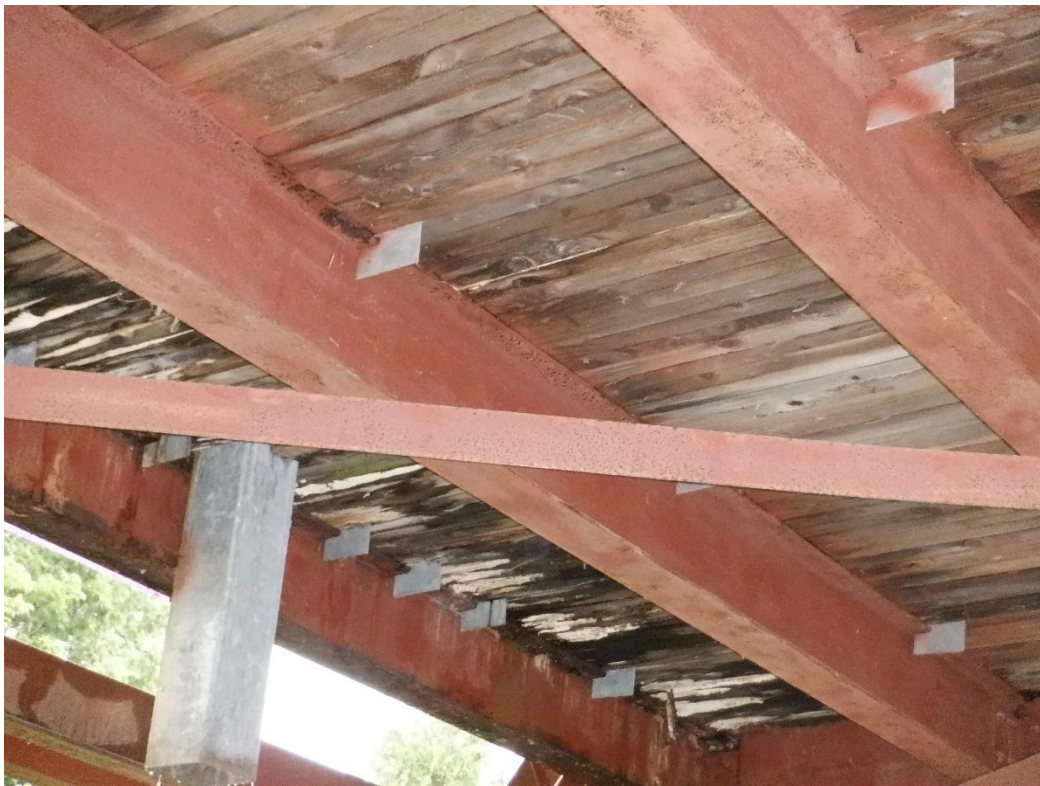
Photograph 6 - Bay #3 from the east abutment between the northmost and interior stringers; note the wetness and decay along the exterior stringer.

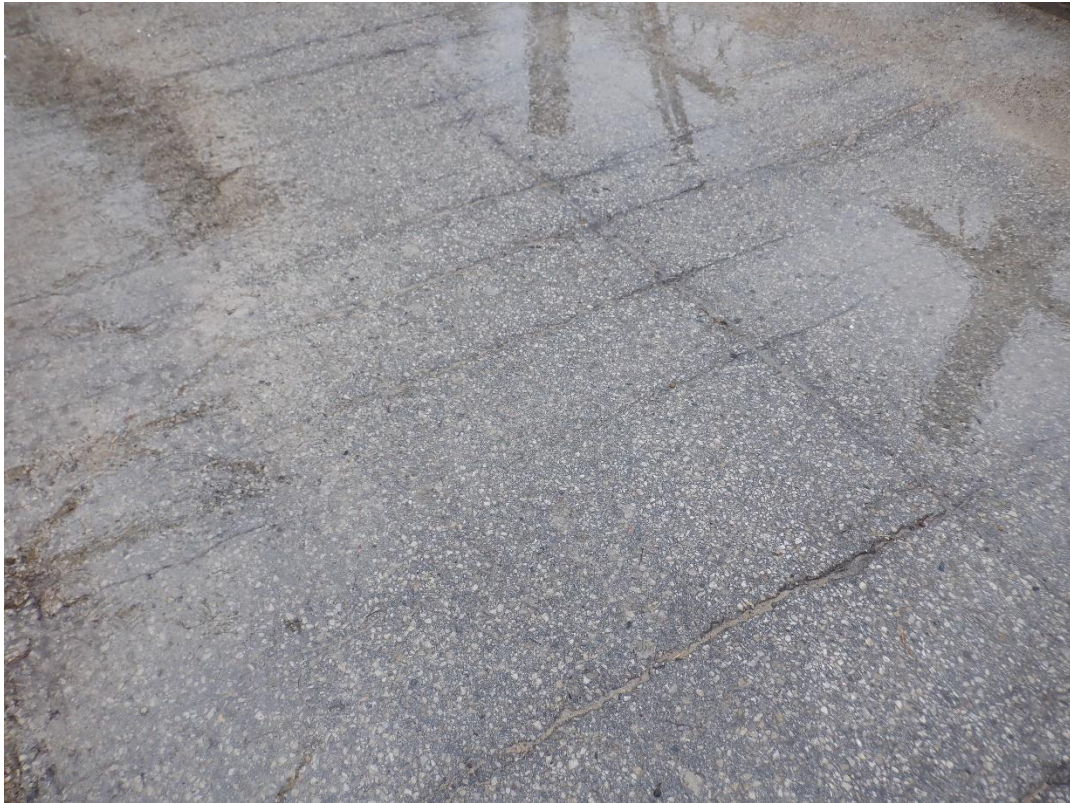
On the deck surface, there was observed significant rutting in the wheel tracks as well as transverse cracks in the “tar and chip” topping. This can be observed in Photographs 7 and 8. We believe this to be the result of the nails used to laminate the timbers becoming “loose” or being corroded. This is causing the loss of the lamination effect and allowing individual timbers to behave independently in flexure and shear.

Photograph 7 - Rutting and transverse cracking of "tar & chip" topping.

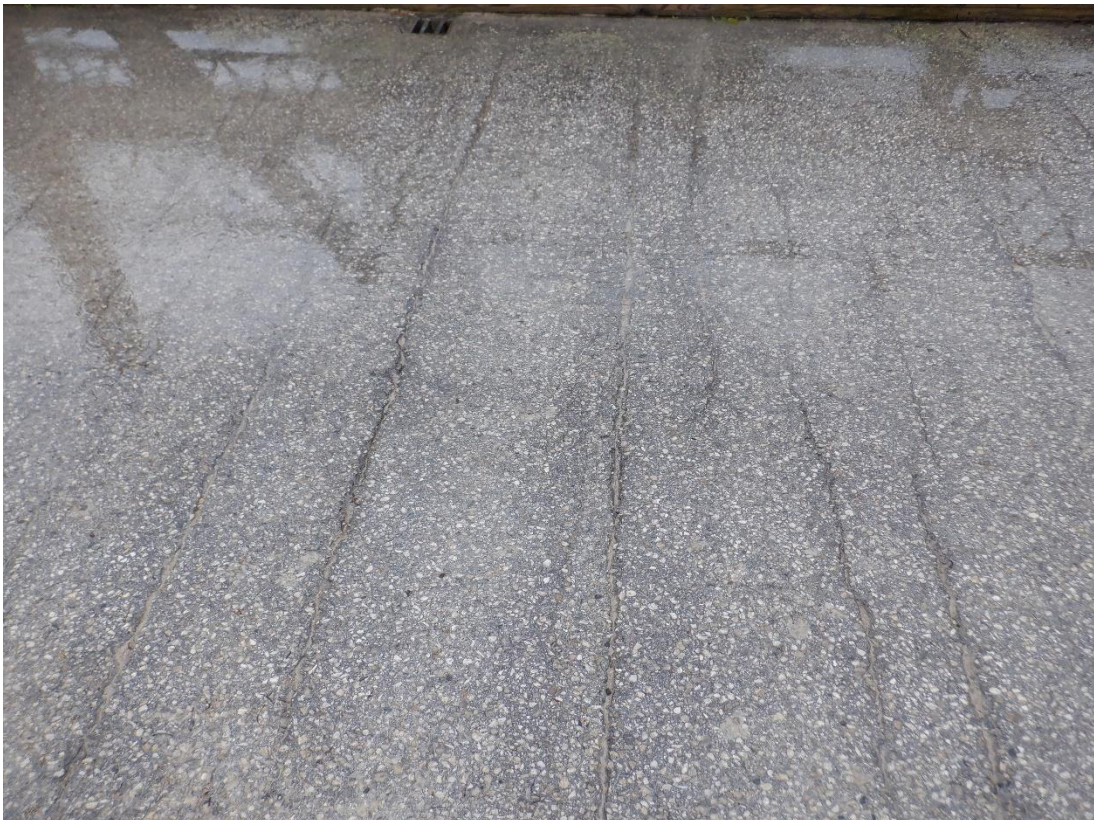
Photograph 8 - Transverse cracks in the deck near west abutment.

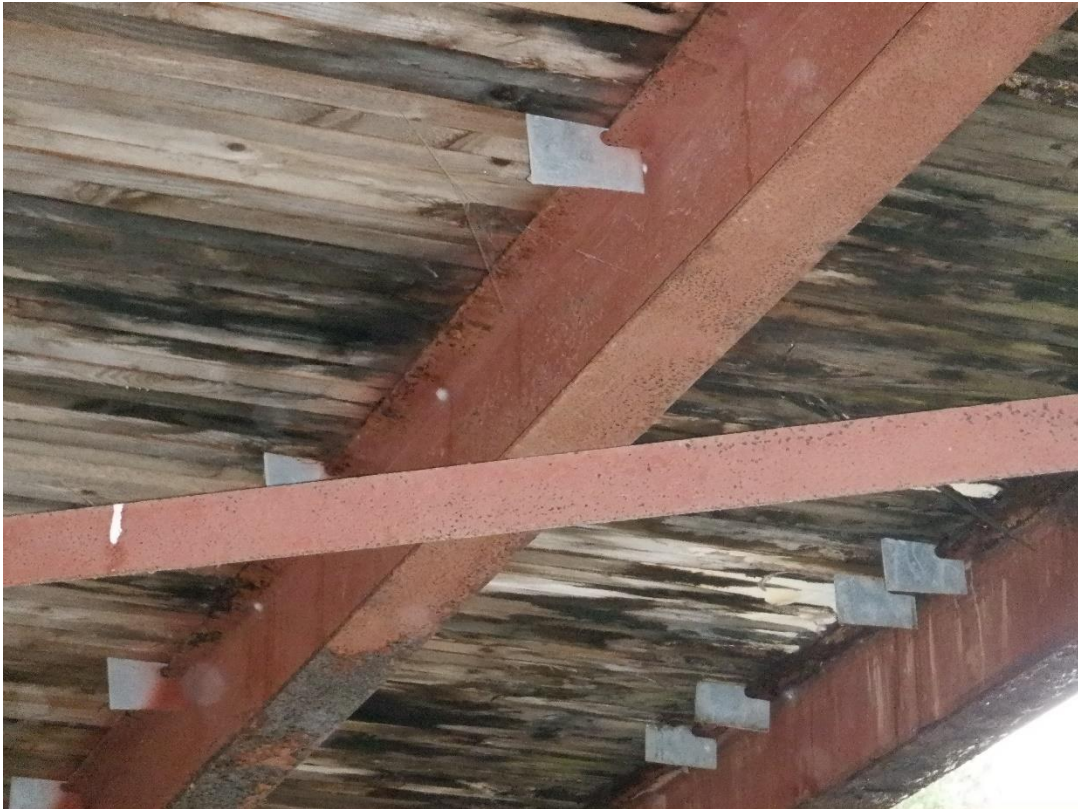
Photograph 9 - Bay #5 from east abutment; note the decay in the deck particularly along the south side of the deck.

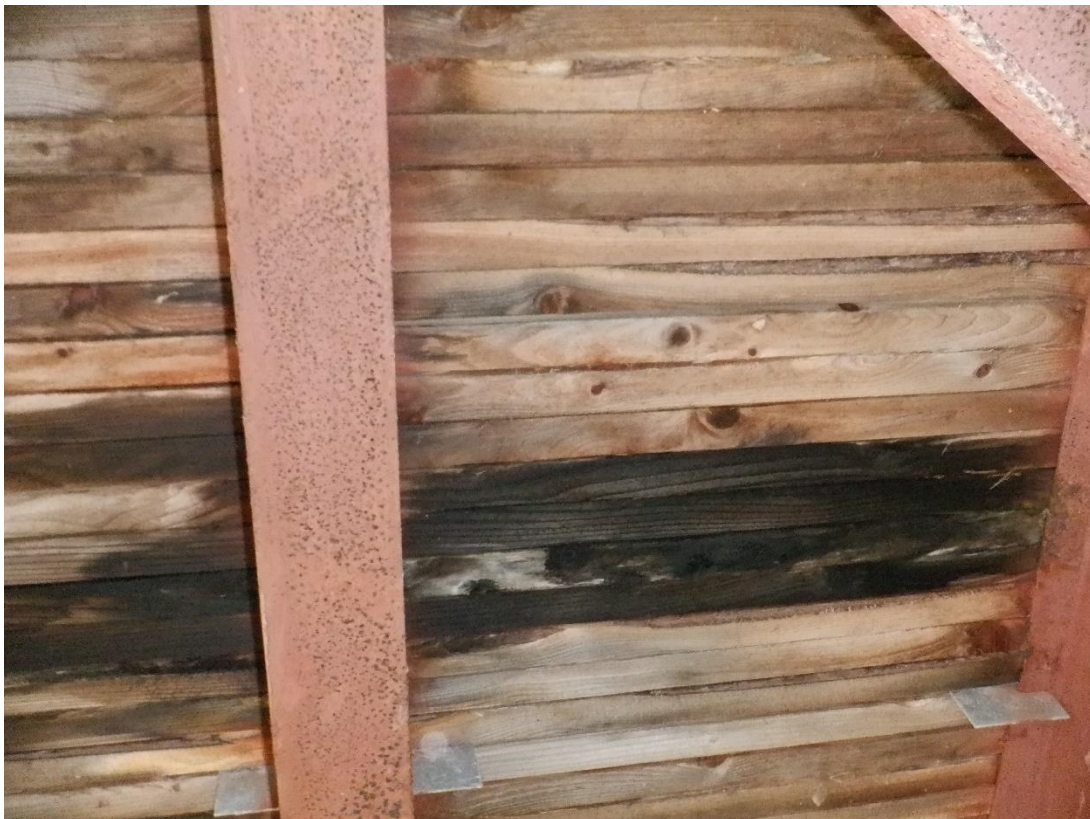
Photograph 10 - Third bay from east abutment; note the very wet local timber.

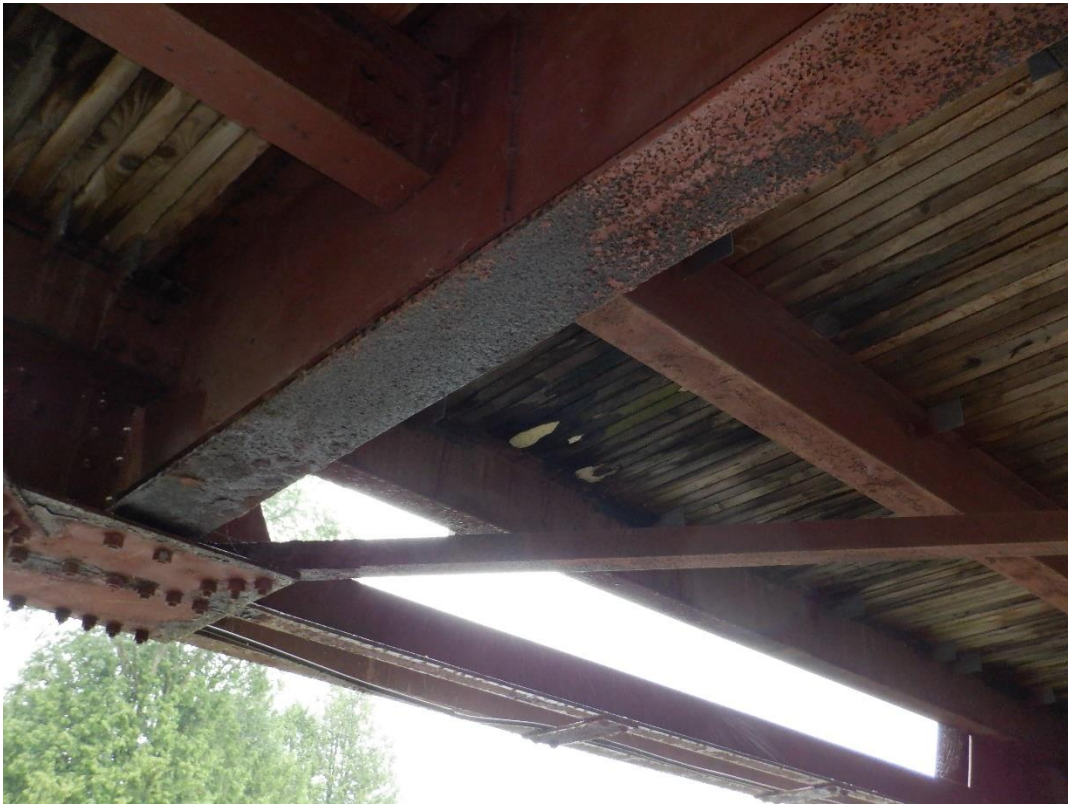
Photograph 13 - Bay #5 north edge; note decay in timbers.

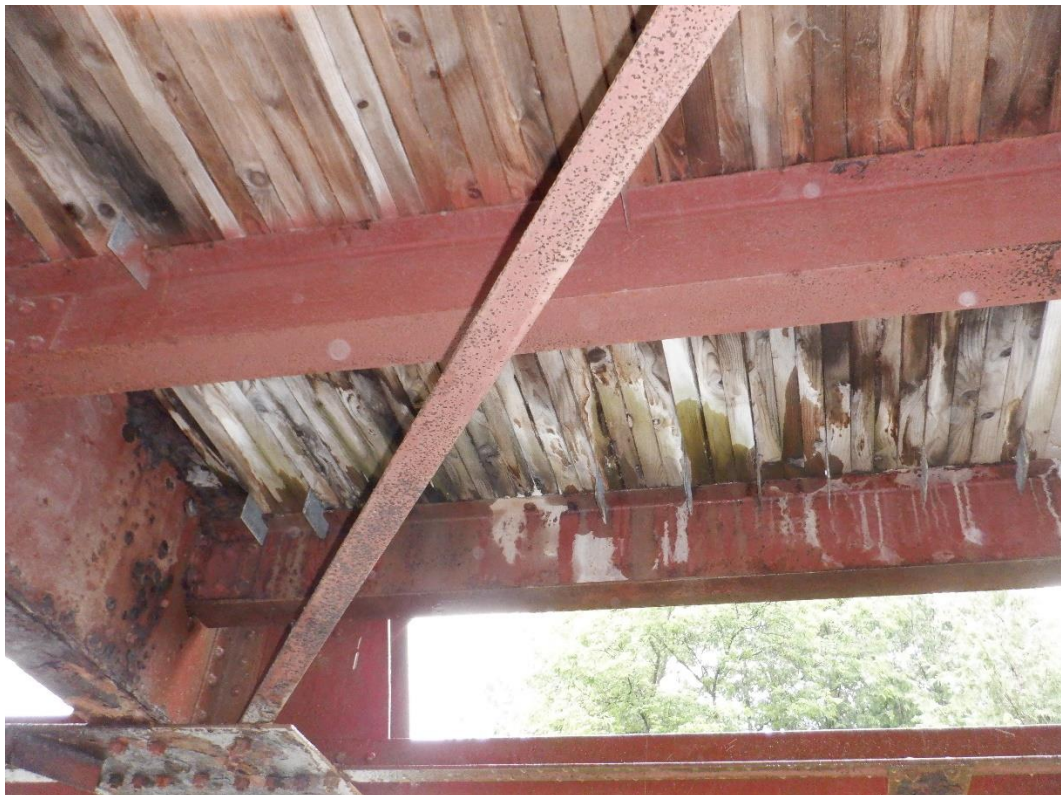
Photograph 14 - Bay #5 north edge; note the wetness and decay.

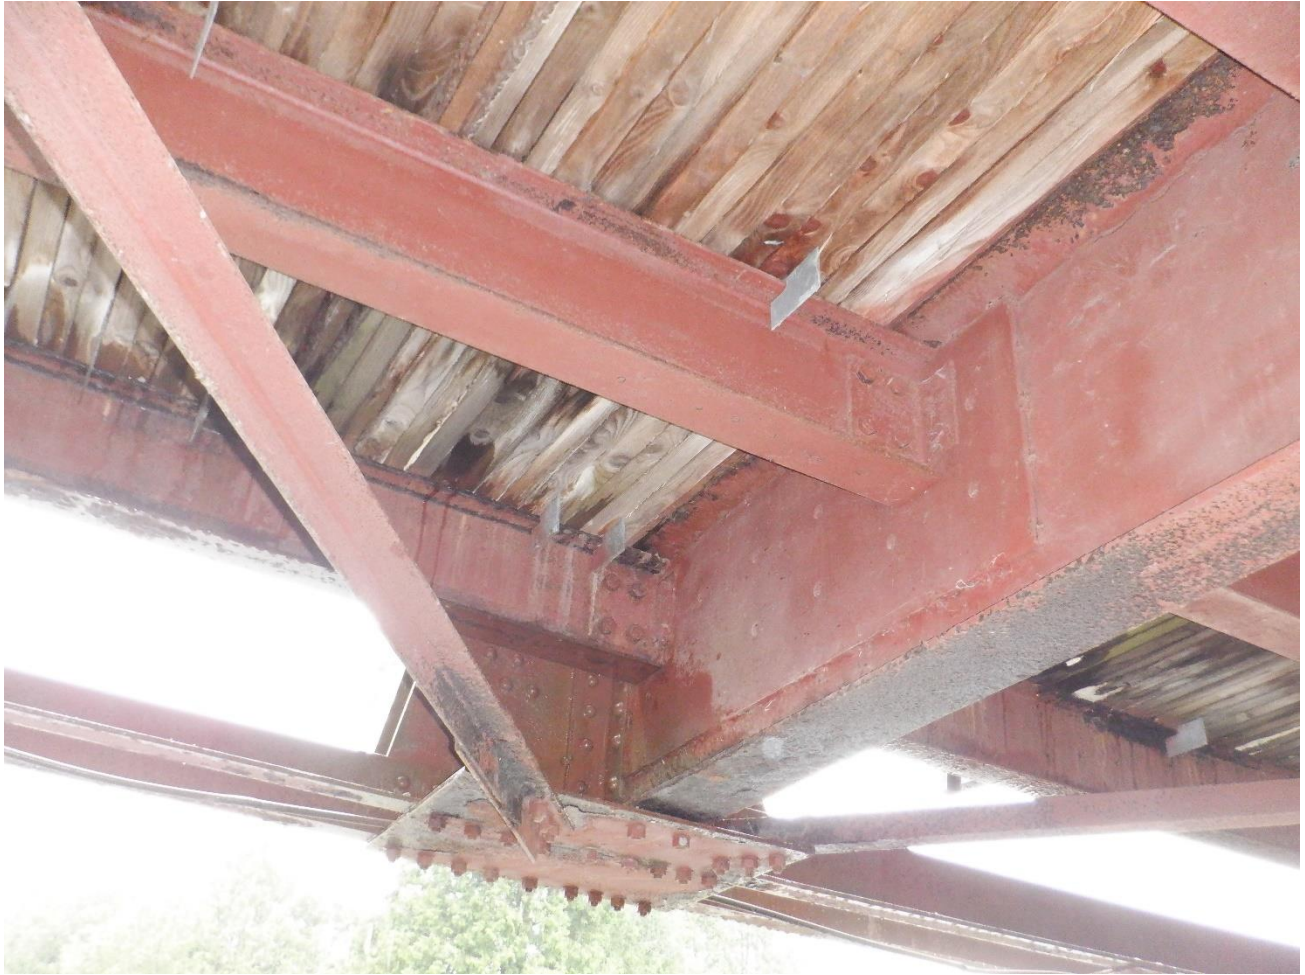
Photograph 15 - Northside between Bay #6 and #5; Bay #6 in the foreground is in better condition.
