Council report

Meeting date:	February 16, 2021
Title:	Health and Safety Report Fire Station, 179 George Street West,
	Durham
Prepared by:	Phil Schwartz, Fire Chief
Reviewed by:	Laura Johnston, Chief Administrative Officer

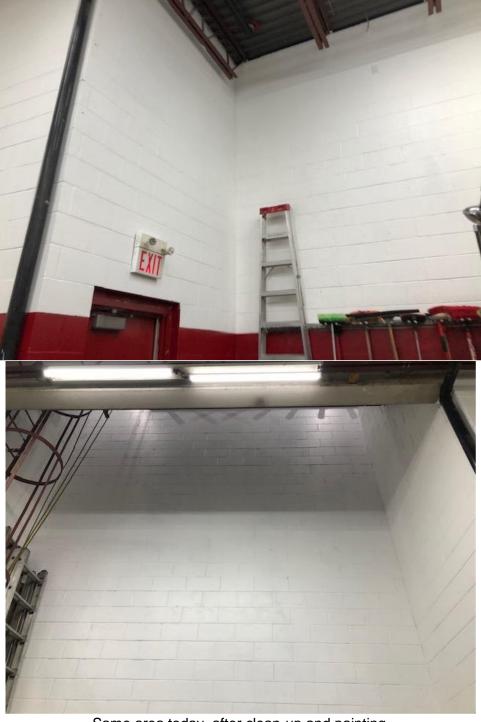
Same area today, after clean-up and painting.

Recently, First General was brought in as part of a mold inspection. Mold was found and subsequently the area was scrubbed and repainted, which has remediated the mold.
