THE MUNICIPALITY OF WEST GREY

FORMER BENTINCK TOWNSHIP STRUCTURE RATING AND RATIONALE REPORT

DECEMBER 11, 2019

PROJECT NO.: 171-04854-00
DATE: DECEMBER 11, 2019

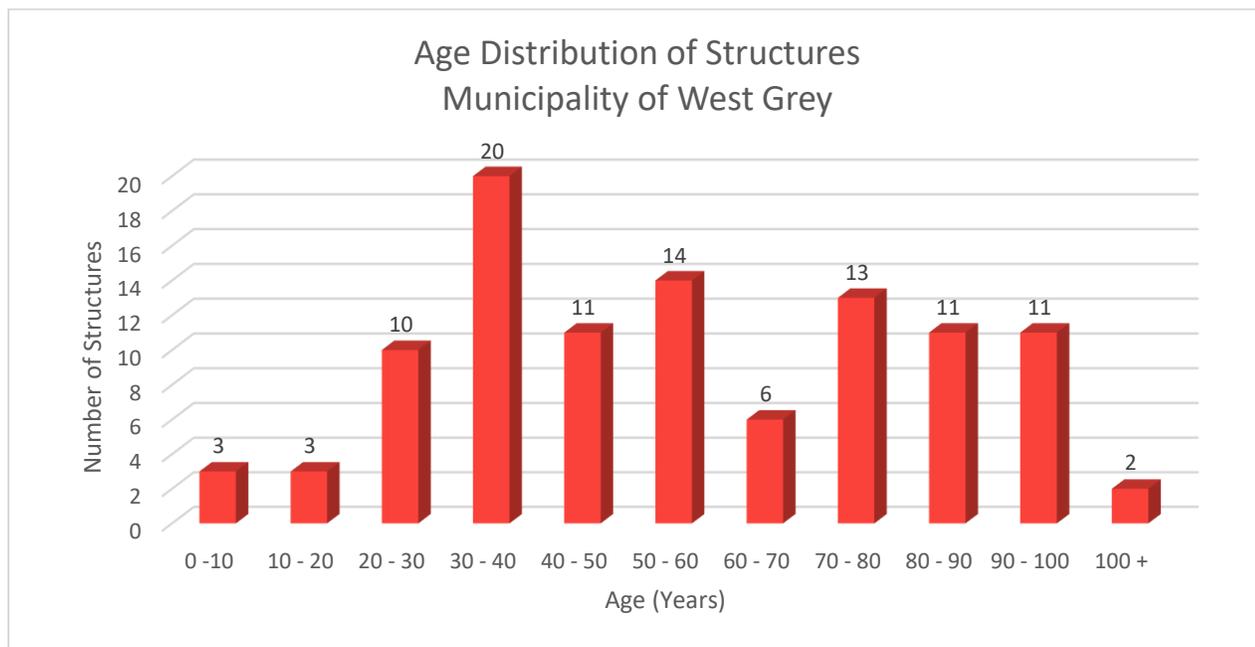
Chart 1 - Age Distribution of Structures - Municipality of West Grey

The Municipality of West Grey has a considerably large number of structure assets. There are a total of one-hundred and six (106) structures, including the Neustadt and Ayton dams, as well as the Durham and Neustadt pedestrian bridges. **Figure 1** shows a location map for all of the structures (found in **Appendix A**). The typical lifespan of a structure is 75 to 100 years, depending on various factors. Many of the bridges within the Municipality were constructed prior to 1950, with thirty-six (36) of those structures at or approaching the end of their useful life span. The below chart depicts the age distribution of the structure (bridge and culvert) assets within the municipality.

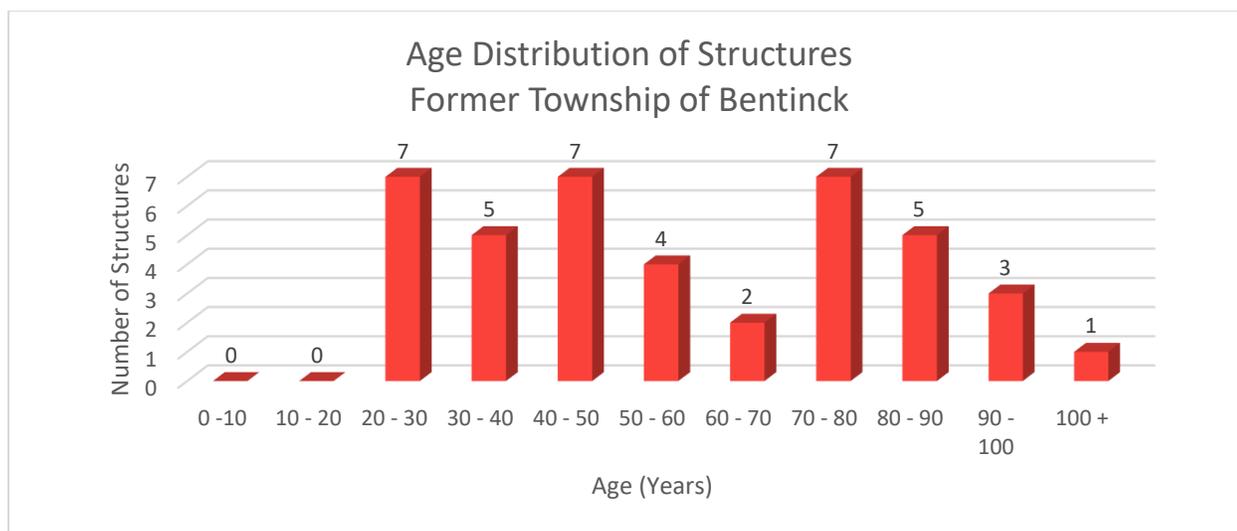
Chart 2 - Age Distribution of Structures - Township of Bentinck

The former Township of Bentinck has forty-one (41) structure assets; twenty-seven (27) bridges and fourteen (14) culverts. **Figure 2** shows a location map for all of the structures (found in **Appendix A**). The structures range in age from twenty-one (21) to one-hundred and five (105) years. The age distribution of the Township of Bentinck’s structures is displayed in **Chart 2** below. The

distribution highlights sixteen (16) structures, which are approaching the end of their useful life span, which without replacement or significant rehabilitation, will face necessary closure in the near future.

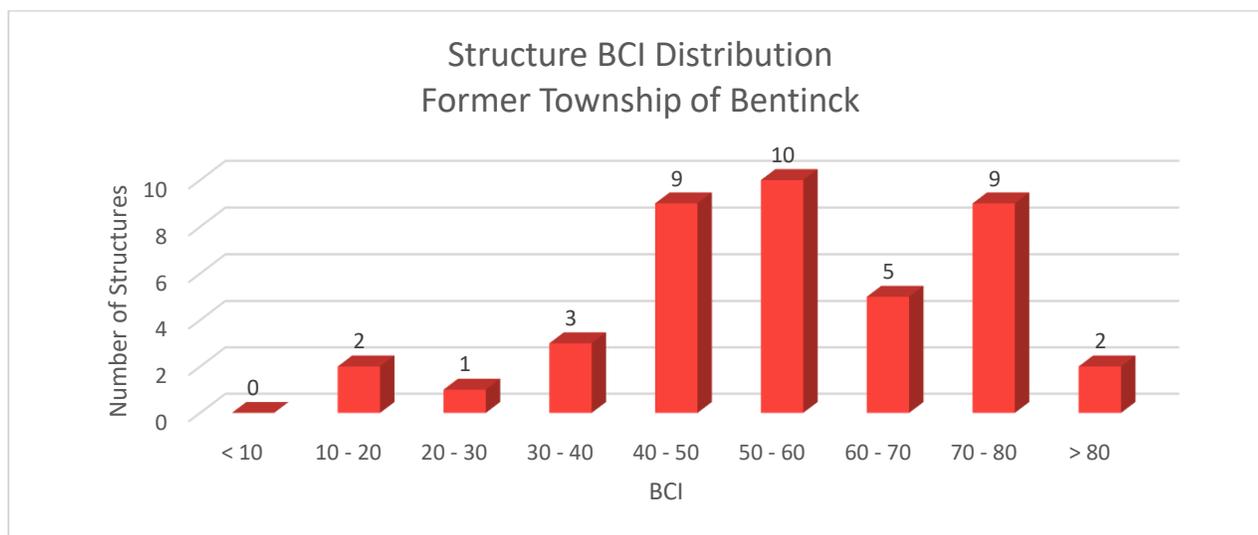
Chart 3 - Structure BCI Distribution – Former Township of Bentinck

A mandatory biennial inspection and report based on the Ontario Structure Inspection Manual (OSIM) is undertaken for each structure (as defined within the OSIM) within the province of Ontario. One component generated during these inspections and reporting is the Bridge Condition Index (BCI), which weights the condition of each of the various elements of each structure and provides a numeric rating of its overall condition. This value is often one of the measures used in determining allocation of provincial funding. The BCI's range from 0 (poor condition) to 100 (excellent condition). As a general rule, structures with a BCI of less than 40 should be considered for immediate repair, rehabilitation, replacement, or closure. It is also recommended that planning for future rehabilitation and repairs be initiated for structures with a BCI between 40 and 60. **Chart 3** below illustrates the BCI distribution of the structures in the former Township of Bentinck.

In analyzing this distribution, it is noted that six (6) structures in Bentinck have BCI values lower than 40, indicating that rehabilitation or replacement of the structure should be scheduled immediately if they are to remain in safe and useful operating condition. This distribution also highlights that nineteen (19) structures fall within the BCI range of 40 to 60, and future planning for rehabilitation should be initiated.

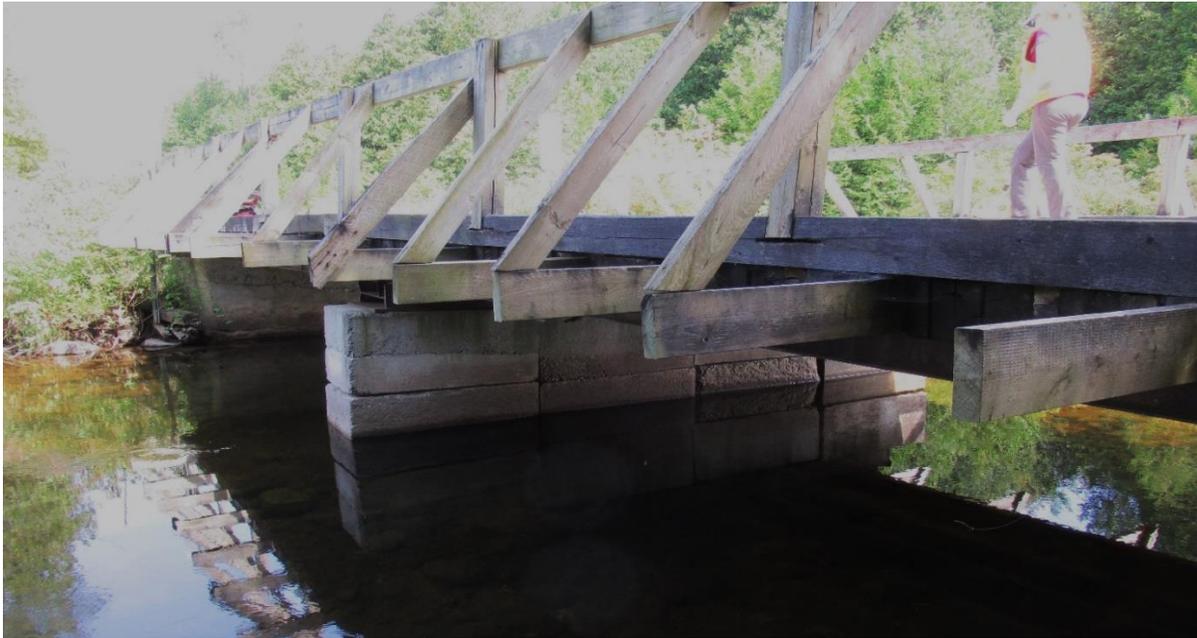
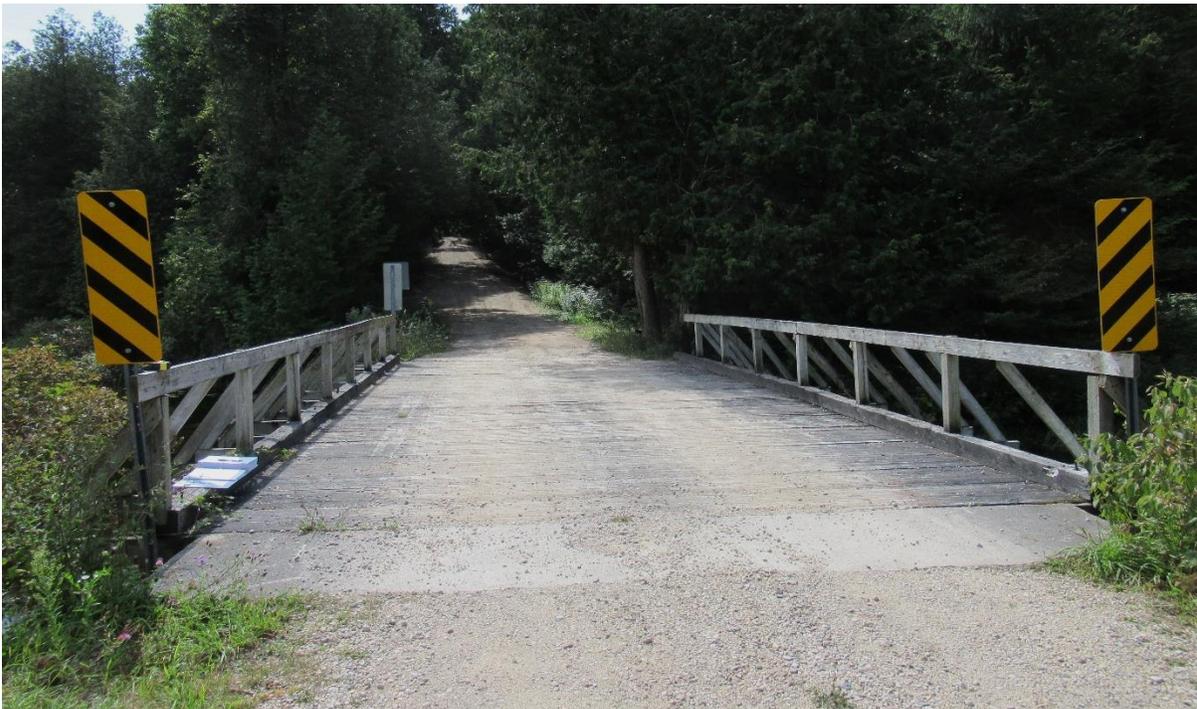
Image 1 - B-007 Elevation View

Structure B-007 is located on the 30th Sideroad between Concession 12 and Concession 10 in the northeast portion of the former Township of Bentinck (see *Figure 2 – Structure location map* in **Appendix A**). The structure received the lowest rating in Bentinck, 23 out of a possible 100 points, primarily attributable to its type, location, and current condition. The structure was originally constructed in 1975, having concrete block abutments and pier, steel beams, and a wooden deck and barrier railing. A view of the structure elevation and from the north approaching perspective are shown in *Images 1 and 2* below.

Structure B-007 serves a very small number of road users as it is located at a point on the 30th sideroad where the roadway is not maintained during the winter, and has a very low level of service considered substandard for typical travel. The structure is in poor overall condition, with recent inspections indicating that if it is to remain open, the structure requires significant immediate repairs. It is currently unsafe for public use due to the substandard barrier as well as the lack of any approach barrier protection with a significant hazard area, especially at the north approach. Due to the asset value and importance within the municipality, as well as the significant hazard and liability posed by the structure in its current condition, structure B-007 warrants consideration for closure by the Municipality in its future strategic planning.

Structure	Recommended Action
B-007	Permanent Closure
B-008	Continued Monitoring, Completion of Rehabilitation Work, Potential Closure at end of Lifecycle
B-020	Permanent Closure
B-025	Permanent Closure
B-113	Completion of Rehabilitation Work, Replacement at end of Lifecycle
B-114	Completion of Rehabilitation Work, Potential Closure at end of Lifecycle
B-118	Completion of Rehabilitation Work, Replacement at end of Lifecycle
B-120	Completion of Rehabilitation Work, Replacement at end of Lifecycle

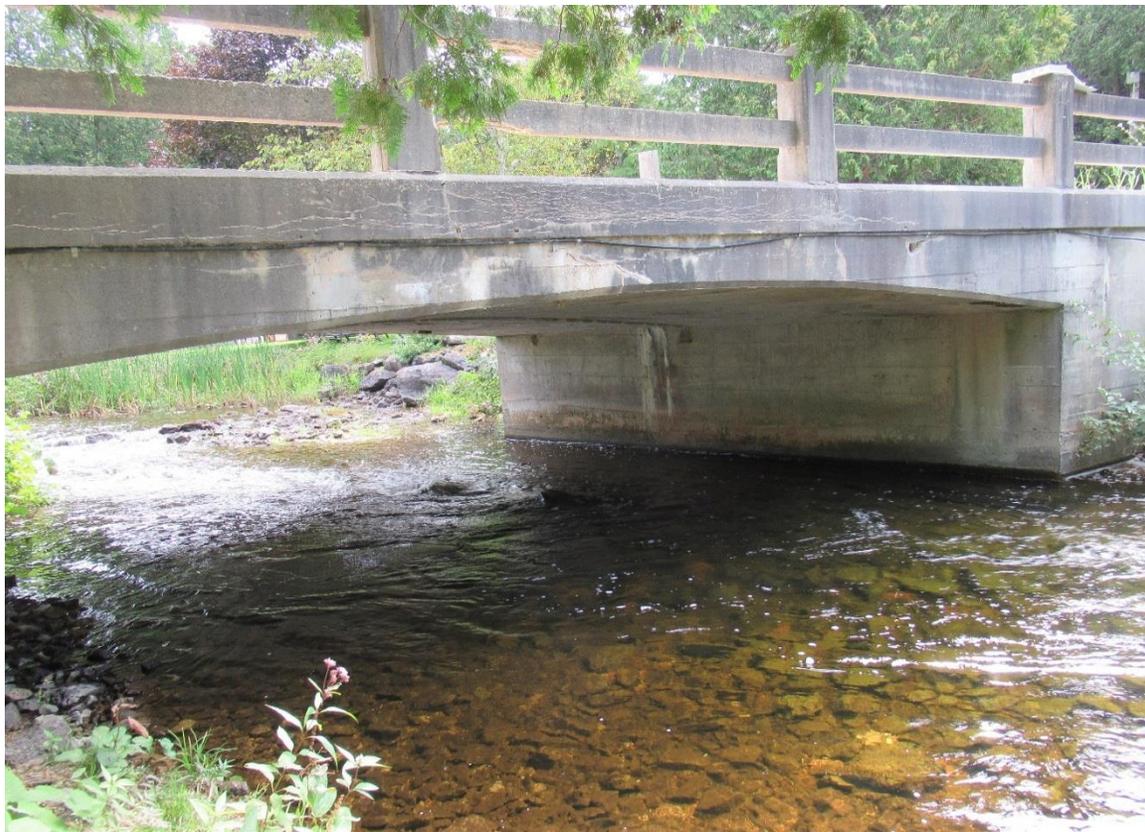
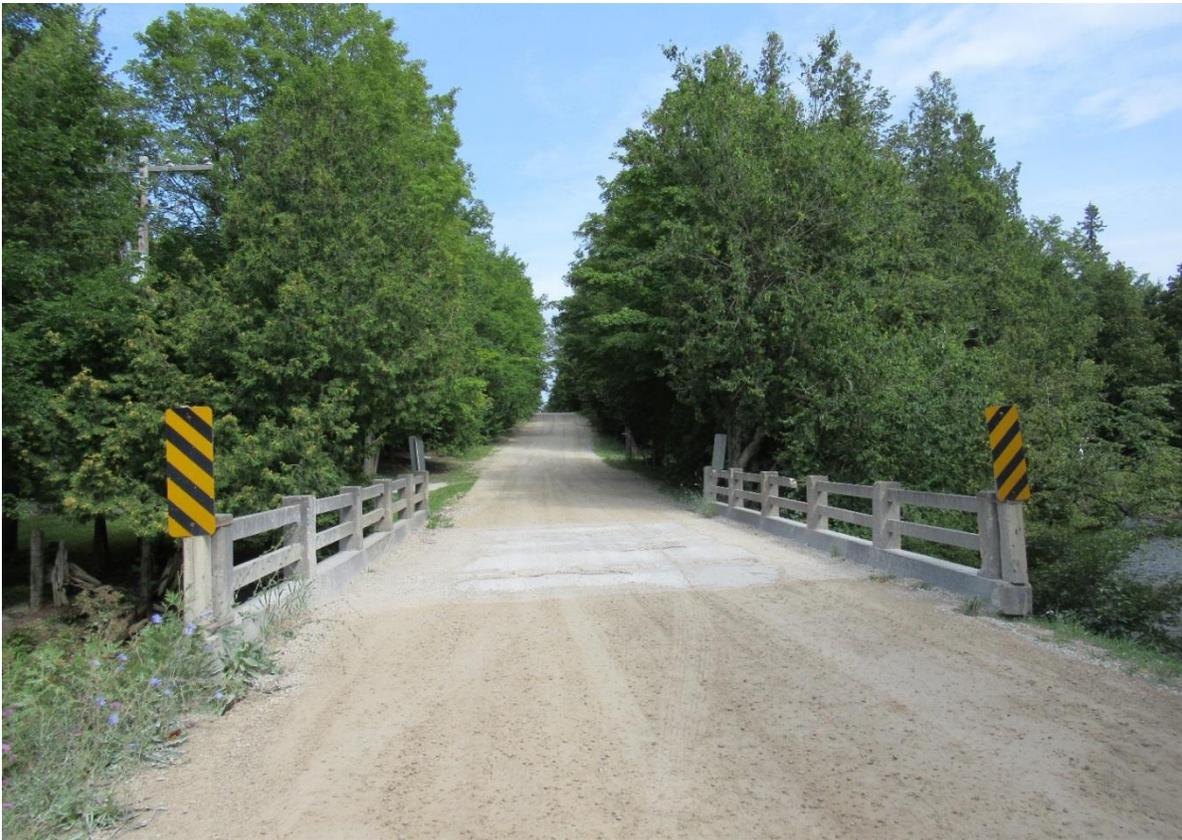
Image 3 - B-008 Elevation View

Structure B-008 is located on the Baseline Road between Concession 12 and Concession 10 in the northeast portion of the former Township of Bentinck (see **Figure 2 – Structure location map** in **Appendix A**). The structure received a rating of 45 points out of a possible 100 points, primarily attributable to its location, and current condition. The structure was originally constructed in 1935, having few, if any, repairs completed since. The structure spans nine (9) metres and is a rigid frame concrete structure with concrete barrier railing and an exposed concrete deck. A view of the structure in elevation and from the south approaching perspective are shown in **Images 3 and 4** below.

Structure B-008 serves a relatively low number of road users with respect to other structures in the Municipality, as it is located on Baseline Road, which is discontinuous and varies in condition throughout its north/south length. Portions of Baseline Road are not maintained during the winter, or are not traversible to the standard vehicle. The structure is in poor overall condition, with recent inspections indicating that significant repairs are required if it is to remain open. Concrete produced and placed at the time of this structures original construction is known to be of significantly poorer quality than that of following periods, and therefore extensive concrete repairs are anticipated in the immediate future. The structure has an approximate replacement value of \$650,000, and the estimated cost to complete the immediate repairs required for the structure to remain open and in a safe condition is \$100,000. If the necessary repairs are completed, the structure could continue to serve road users for approximately 25 more years before requiring replacement. The structure has close proximity to Welbeck, Grey Road 25, and Provincial Highway 6, and may have future potential for serving an increased number of road users if the Baseline Road is improved.

As structure B-008 is a viable candidate for rehabilitation and has the potential for future increase in importance of this asset within the Municipality of West Grey, the Municipality may consider the scheduling of repairs in order to remain open and in a safe operating condition. In the future, when rehabilitation is no longer a viable option, the structure may warrant consideration for closure by the Municipality in its future strategic planning.

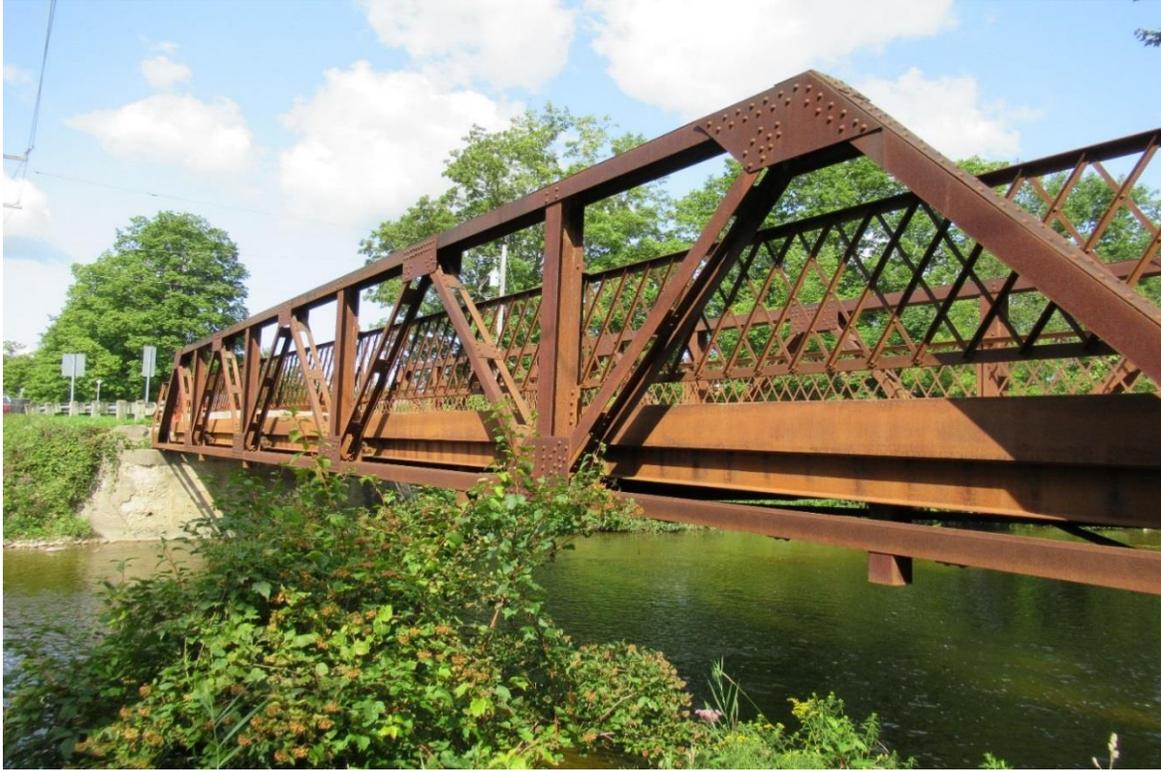
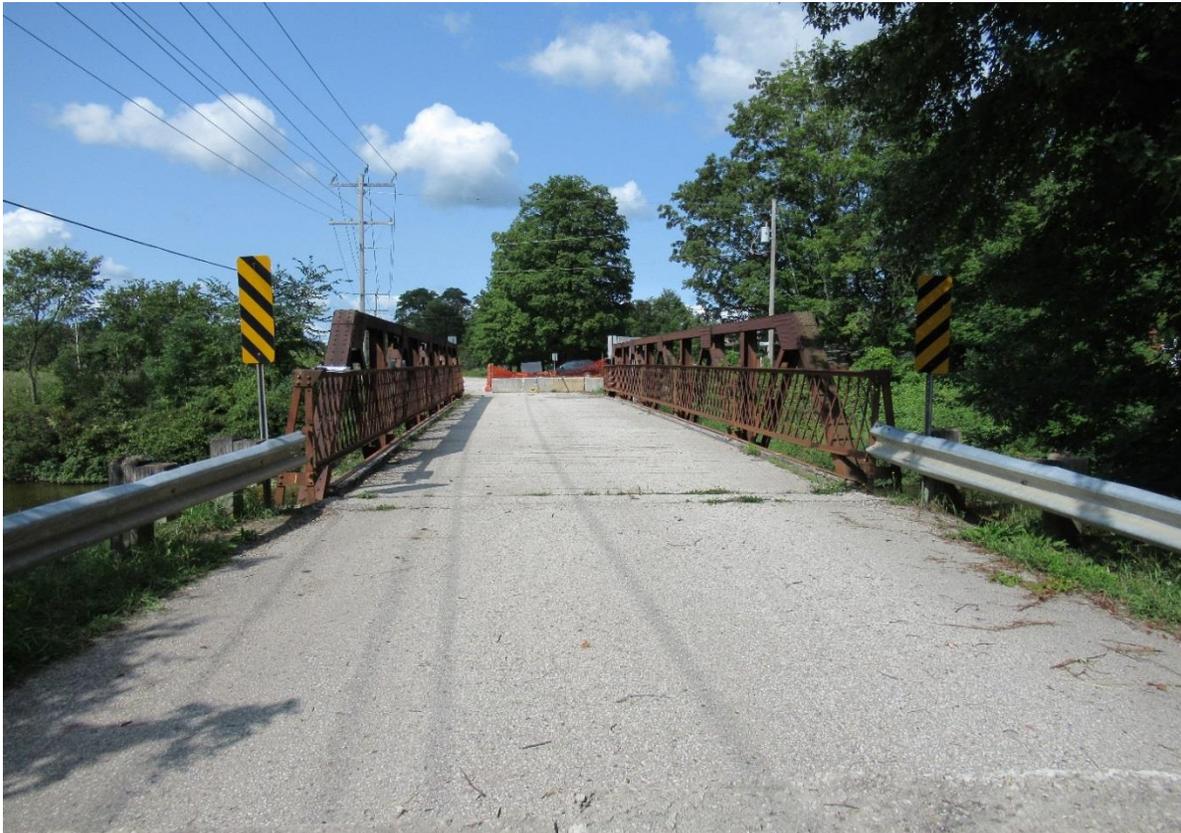
Image 5 - B-020 Elevation View

Structure B-020, known as the Kennedy Bridge, is located on Concession 2 between Grey Road 3 and Allen Park Road in the south-central portion of the former Township of Bentinck (see *Figure 2 – Structure location map in Appendix A*). The structure received a rating of 43 points out of a possible 100 points, primarily attributable to its currently unsafe structural condition, which has resulted in the structures interim closure. The structure was originally constructed in 1920, having only minor repairs completed since. The structure spans approximately twenty-three (23) metres and is a steel pony truss structure with concrete abutments and timber deck overlain by an asphalt wearing surface. A view of the structure elevation and from the approaching perspective are shown in *Images 5 and 6* below.

Prior to its closure, structure B-020 served a relatively high number of road users with respect to other structures in the Municipality, as it is located on Concession 2, which has a high level of service and serves as an indirect, but well travelled route between the Hanover and Durham areas. The structure is in very poor and unsafe condition, resulting in its interim closure, while all potential options regarding its future are considered. Recent inspections of structure B-020 indicate that rehabilitation of the structure is no longer an economically viable option due to the high cost of the repairs compared to the poor condition of its foundation, which will ultimately limit the lifespan of the structure once rehabilitated. In addition to the foundation concerns, steel bridges constructed during this era were typically designed for a load of 15 imperial tons, which is the equivalent of 13.6 metric tonnes, and therefore a full rehabilitation of the structure would still require an imposed load limit posting of 13 tonnes. Due to its necessary closure, provisions have already been made in establishing alternate detour routing of traffic and emergency and municipal services in the area, which will lessen the burden of a permanent closure. The current estimated replacement value of this structure is \$1,000,000 due to its long span and high level of service.

In the case of this structure, replacement or closure are the two feasible options, each warranting consideration by the Municipality in its future strategic planning.

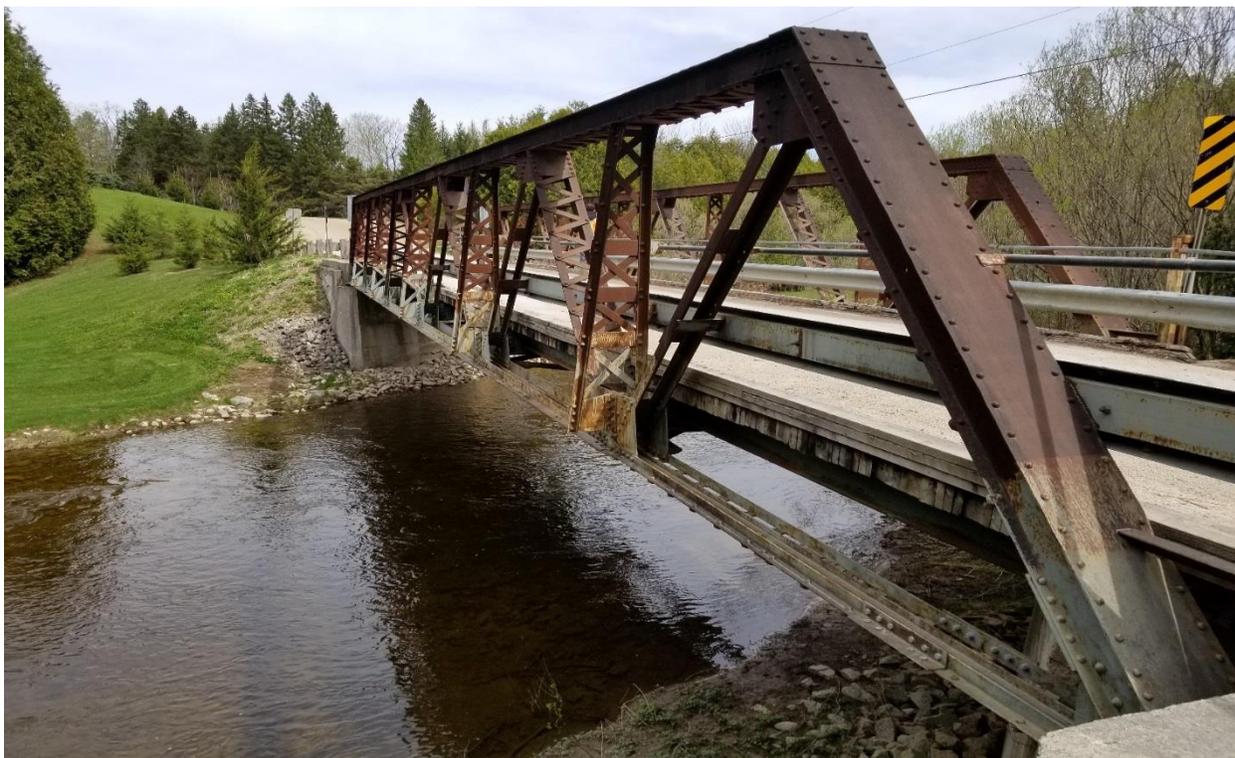
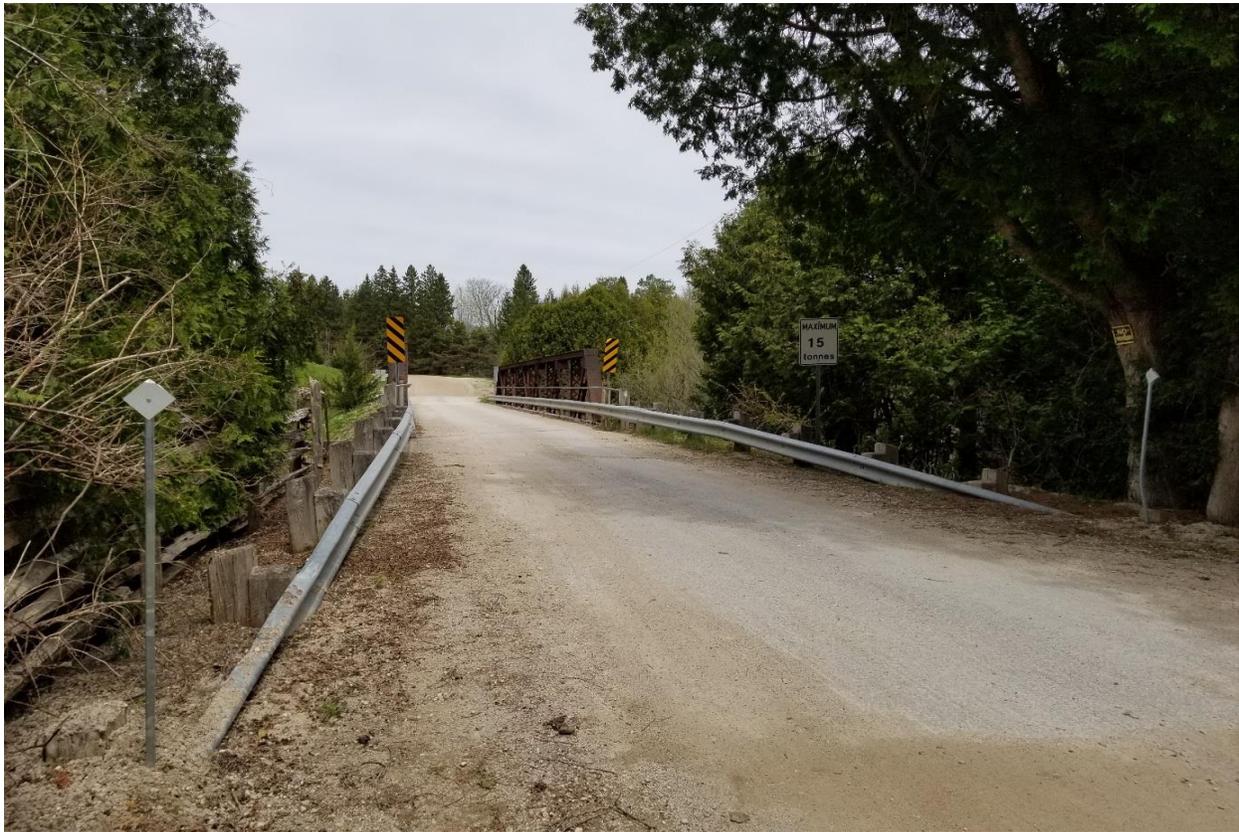
Image 7 - B-025 Elevation View

Structure B-025, known as the Hudson bridge, is located on Sideroad 10 between Concession 2 and the Normanby Bentinck Townline in the southwest portion of the former Township of Bentinck (see *Figure 2 – Structure location map in Appendix A*). The structure received a rating of 29 points out of a possible 100 points, primarily attributable to poor condition of its main structural elements and its location and importance within the overall transportation network. The structure was originally constructed in 1918, having only minor repairs completed since. The structure spans approximately twenty-nine (29) meters and is a steel pony truss structure with concrete abutments and timber deck overlain by an asphalt wearing surface. A view of the structure elevation and from the approaching perspective are shown in *Images 7 and 8* below.

Structure B-025 serves a relatively low number of road users with respect to other structures in the Municipality, as it is located on Sideroad 10, which has a low level of service and is not a through road at either Concession 2 or the Normanby Bentinck Townline. The structure is in poor condition, and is approaching the end of its lifecycle, with necessary closure or replacement required in the immediate future. Recent inspections of structure B-025 indicate that rehabilitation of the structure is no longer an economically viable option due to the high cost of the repairs compared to the poor condition of its abutments, which will ultimately limit the lifespan of the structure once rehabilitated. In addition to the foundation concerns, steel bridges constructed during this era were typically design for a load of 15 imperial tons, which is the equivalent of 13.6 metric tonnes, and therefore a full rehabilitation of the structure would still require an imposed load limit posting of 13 tonnes. The current estimated replacement value of this structure is relatively high at \$1,250,000 due to its long span.

In the case of this structure, replacement or closure are the two feasible options. Due to the high cost of replacement and low overall importance within the municipal transportation network, structure B-025 warrants consideration for closure by the Municipality in its future strategic planning.

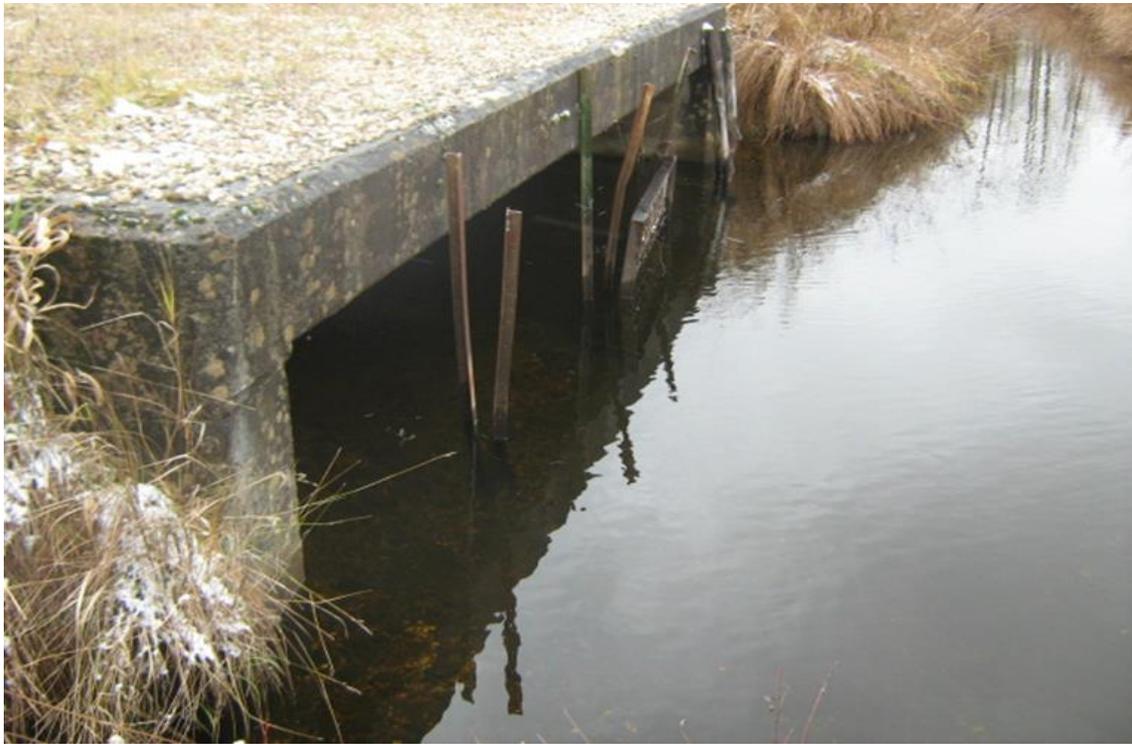
Image 9 - B-113 Elevation View

Structure B-113 is located on the 3rd Sideroad between Concession 2 and Baseline Road in the northeast portion of the former Township of Bentinck (see *Figure 2 – Structure location map* in **Appendix A**). The structure received a rating of 45 points out of a possible 100 points, primarily attributable to its location and overall importance within the West Grey transportation network. The structure was originally constructed in 1960, having few, if any, repairs completed since. The structure spans five (5) metres and is an open footing rigid frame concrete structure overlain by a granular wearing surface. A view of the structure elevation is shown in *Image 9* below.

Structure B-113 serves a relatively low number of road users with respect to other structures in the Municipality, as it is located on the low traffic volume 3rd Sideroad between Baseline Road and Concession, which both also receive minimal traffic in this area. Recent inspections indicate that the structure is in fair overall condition, and with rehabilitation and regular maintenance, the structure still has significant lifespan remaining. The structure has an approximate replacement value of \$525,000. If repairs are scheduled as they become necessary, the structure could continue to serve road users within the Municipality for approximately 40 more years before requiring replacement. The structure has close proximity to Welbeck, Grey Road 25, and provincial Highway 6, and may have future potential for serving an increased number of road users if the area becomes busier and the level of service of the adjoining roads are improved.

As structure B-113 is a viable candidate for rehabilitation and has the potential for future increase in importance of this asset, it may be considered for the scheduling of repairs in order to remain open and in a safe operating condition. In the future, when rehabilitation is no longer a viable option, the structure may warrant consideration for closure by the Municipality in its future strategic planning.

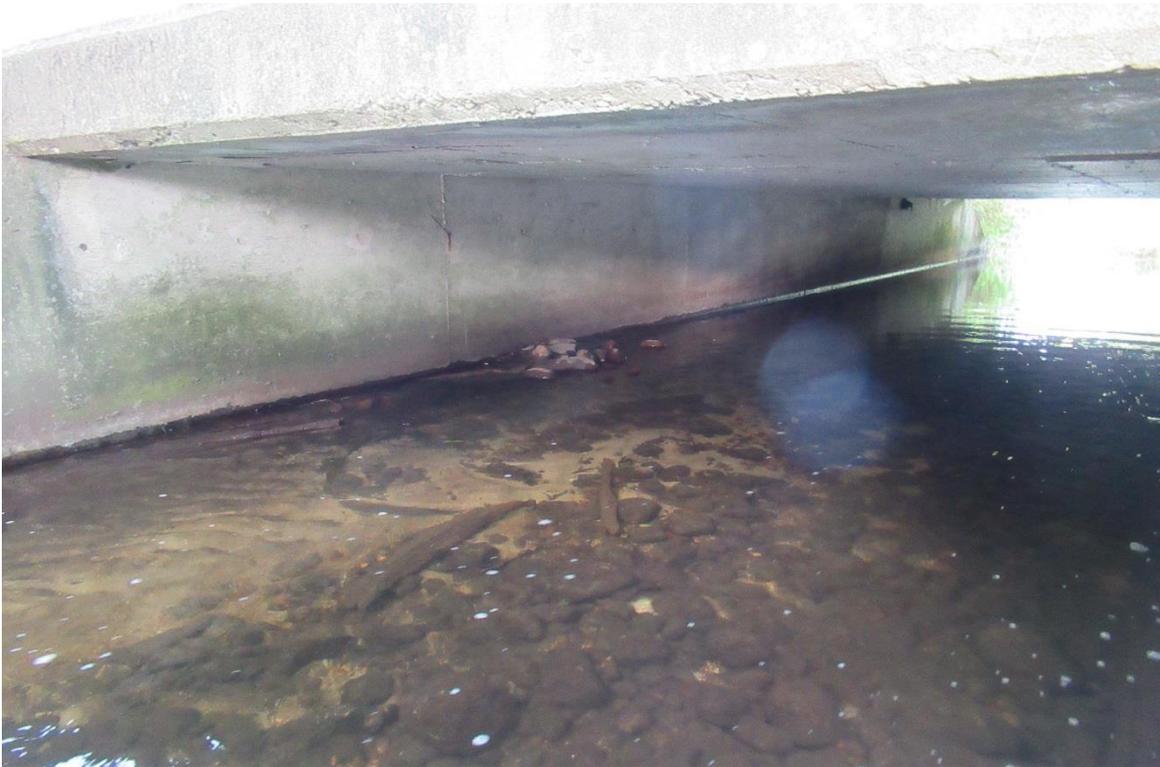
Image 10 - B-114 Elevation View

Structure B-114 is located on the dead-end road Old Bridge Road South north of Grey Road 4 in the south-central portion of the former Township of Bentinck (see *Figure 2 – Structure location map* in **Appendix A**). The structure received a rating of 46 points out of a possible 100 points, primarily attributable to its location and overall importance within the West Grey transportation network. The structure was originally constructed in 1950, having few, if any, repairs completed since. The structure spans just over three (3) metres and is an open footing rigid frame concrete structure overlain by an asphalt wearing surface. A view of the structure elevation is shown in *Image 10* below.

Structure B-114 serves a relatively low number of road users with respect to other structures in the Municipality, as it is located on Old Bridge Road South, and primarily serves the two (2) resident properties between the structure and its dead-end. Were the structure to be closed, the relocation of these two entrances would need to be coordinated in order to prevent stranding of the properties. Recent inspections indicate that the structure is in fair overall condition, and with rehabilitation and regular maintenance, the structure still has significant lifespan remaining. The structure has an approximate replacement value of \$500,000. If repairs are scheduled as they become required, the structure could continue to serve road users within the Municipality for approximately 30 more years before requiring replacement. At the end of the structures lifespan, when replacement becomes required, there is the potential to replace the structure with a more cost effective alternative, such as twin pipe culverts or an open-footed arch pipe.

Structure B-114 is a viable candidate for rehabilitation. The Municipality may wish to consider the scheduling of repairs as they become necessary in order for the structure to remain open and in a safe operating condition. In the future, when rehabilitation is no longer a viable option, the structure may warrant consideration for closure by the Municipality in its future strategic planning.

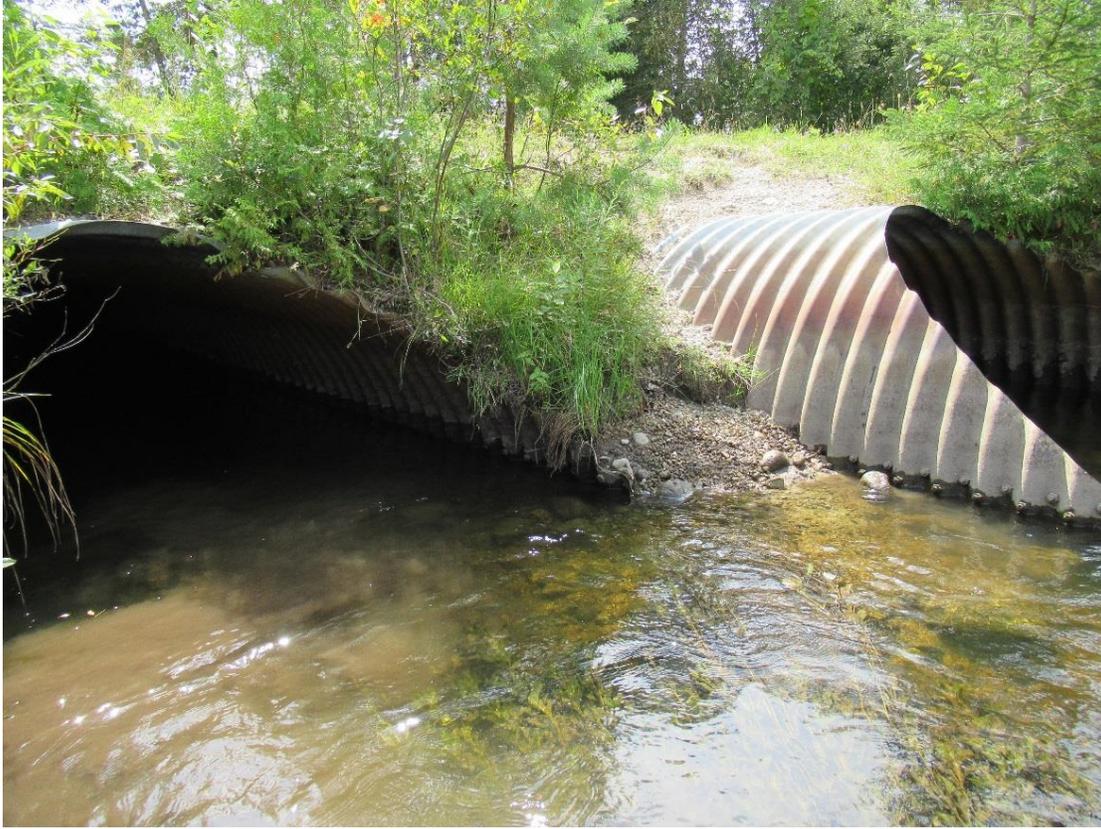
Image 11 - B-118 Elevation View

Structure B-118 is located on Concession 14 between Grey Road 3 and the 10th Sideroad in the northwest portion of the former Township of Bentinck (see *Figure 2 – Structure location map* in **Appendix A**). The structure received a rating of 45 points out of a possible 100 points, primarily attributable to its location, asset value, and overall importance within the West Grey transportation network. The structure was originally constructed in 1980, having only regular maintenance completed since. The structure consists of two elliptical twin corrugated steel pipes, each with a width of 2.4 meters and a height of 1.9 meters. A view of the structure elevation is shown in *Image 11* below.

Structure B-118 serves a relatively low number of road users with respect to other structures in the Municipality, as it is located on an unpaved, low traffic portion of Concession 14. Recent inspections indicate that the structure is in fair-to-good overall condition, and with regular maintenance and repairs as required, the structure still has significant lifespan remaining. The structure has an approximate replacement value of \$350,000. If repairs are scheduled as they become required, the structure could continue to serve road users within the Municipality for approximately 25 more years before requiring replacement. At the end of the structures lifespan, when replacement becomes required, the structure could be replaced with similar elliptical pipes.

As structure B-118 is a viable candidate for rehabilitation, the Municipality may wish to consider the scheduling of repairs as they become necessary in order to maintain the structure in its current condition. At the end of the structures lifespan, it will warrant consideration by the Municipality for replacement as it is relatively inexpensive and will enable the preservation of a through road with the potential for increased future importance.

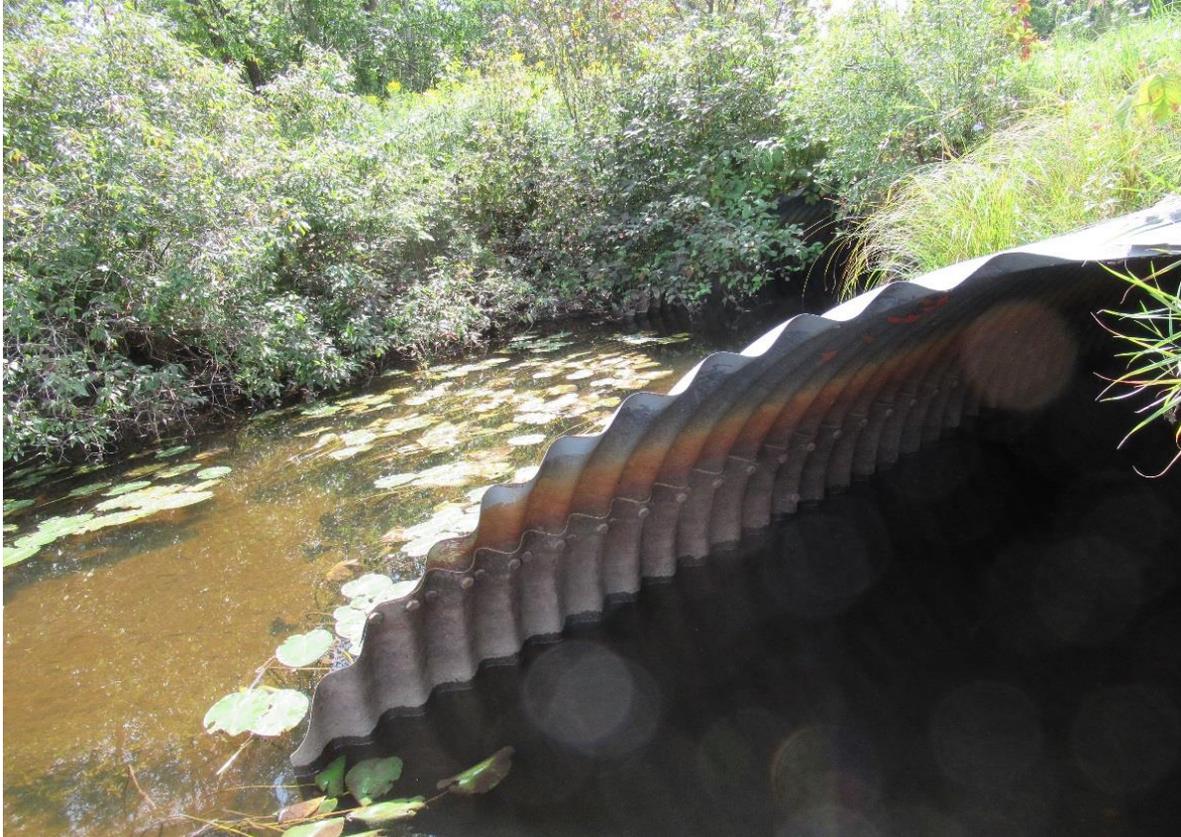
Image 12 - B-120 Elevation View

Structure B-120 is located on the 10th Sideroad between Concession 12 and Concession 14 Sideroad in the northwest portion of the former Township of Bentinck (see **Figure 2 – Structure location map** in **Appendix A**). The structure received a rating of 43 points out of a possible 100 points, primarily attributable to its location, asset value, and overall importance within the West Grey transportation network. The structure was originally constructed in 1981, having only regular maintenance completed since. The structure consists of two elliptical twin corrugated steel pipes, each with a width of 2.4 meters and a height of 1.7 meters. A view of the structure elevation is shown in **Image 12** below.

Structure B-120 serves a relatively low number of road users with respect to other structures in the Municipality, as it is located on an unpaved, low traffic portion of the 10th Sideroad. Recent inspections indicate that the structure is in fair-to-good overall condition, and with regular maintenance and repairs as required, the structure still has significant lifespan remaining. The structure has an approximate replacement value of \$300,000. If repairs are scheduled as they become required, the structure could continue to serve road users within the Municipality for approximately 25 more years before requiring replacement. At the end of the structure's lifespan, when replacement becomes required, the structure could be replaced with similar elliptical pipes.

As structure B-120 is a viable candidate for rehabilitation, the Municipality may wish to consider the scheduling of repairs as they become necessary in order to maintain the structure in its current condition. At the end of the structure's lifespan, it will warrant consideration by the Municipality for replacement as it is relatively inexpensive and will enable the preservation of a through road with the potential for increased future importance.
