THE MUNICIPALITY OF WEST GREY

GLENELG STRUCTURE RATING AND RATIONALE REPORT

DECEMBER 11, 2019

PROJECT NO.: 171-04854-00
DATE: DECEMBER 11, 2019

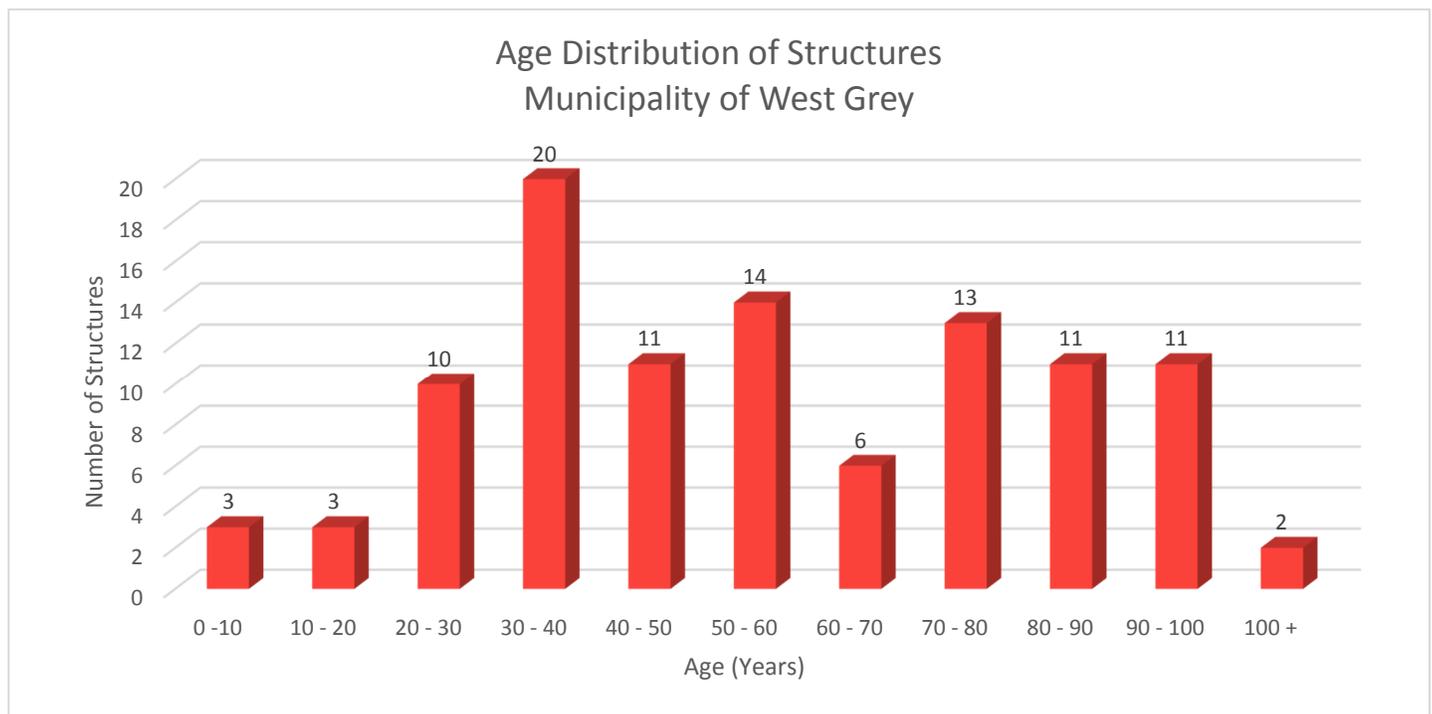
Chart 1 - Age Distribution of Structures - Municipality of West Grey

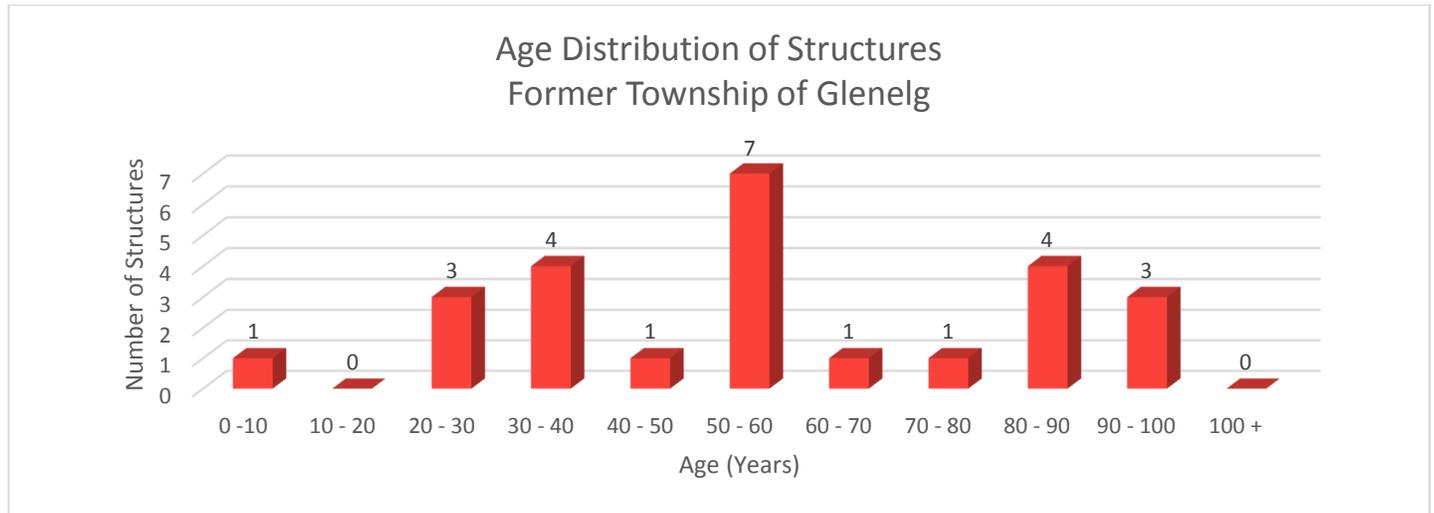
Chart 2 - Age Distribution of Structures - Township of Glenelg

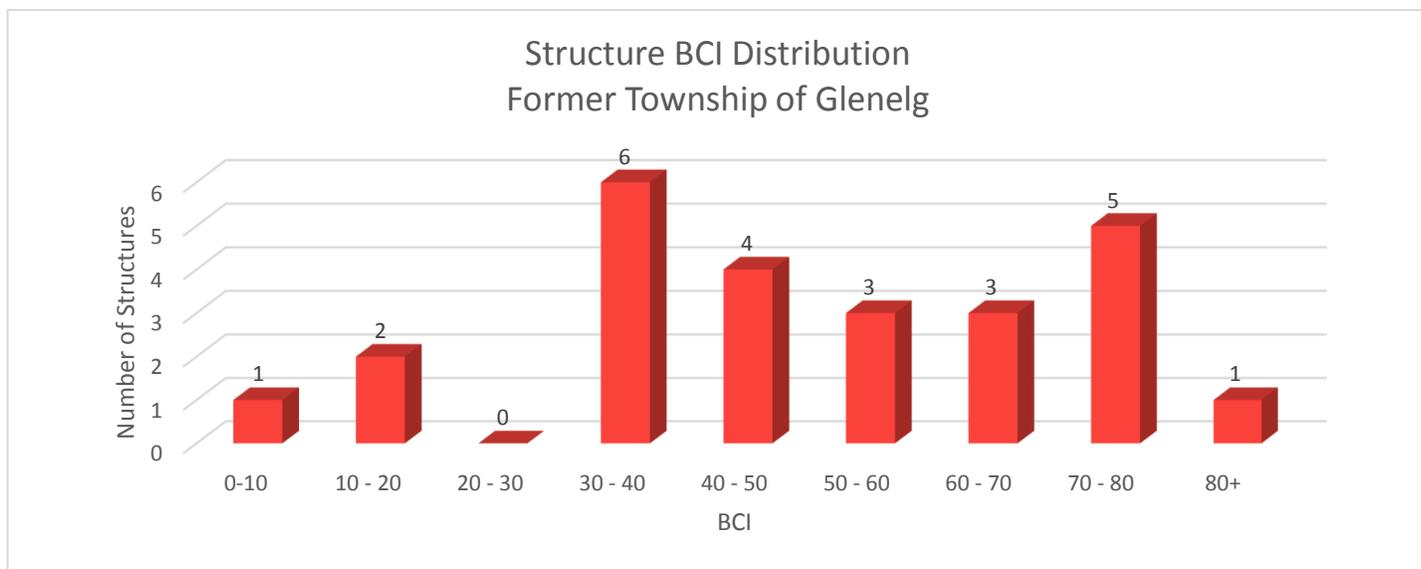
Chart 3 - Structure BCI Distribution - Township of Glenelg

In analyzing this distribution, it is noted that nine (9) structures in Glenelg have BCI values lower than 40, indicating that rehabilitation or replacement of the structure should be scheduled immediately if they are to remain in safe and useful operating condition. This distribution also highlights that seven (7) structures fall within the BCI range of 40 to 60, and future planning for rehabilitation should be initiated.

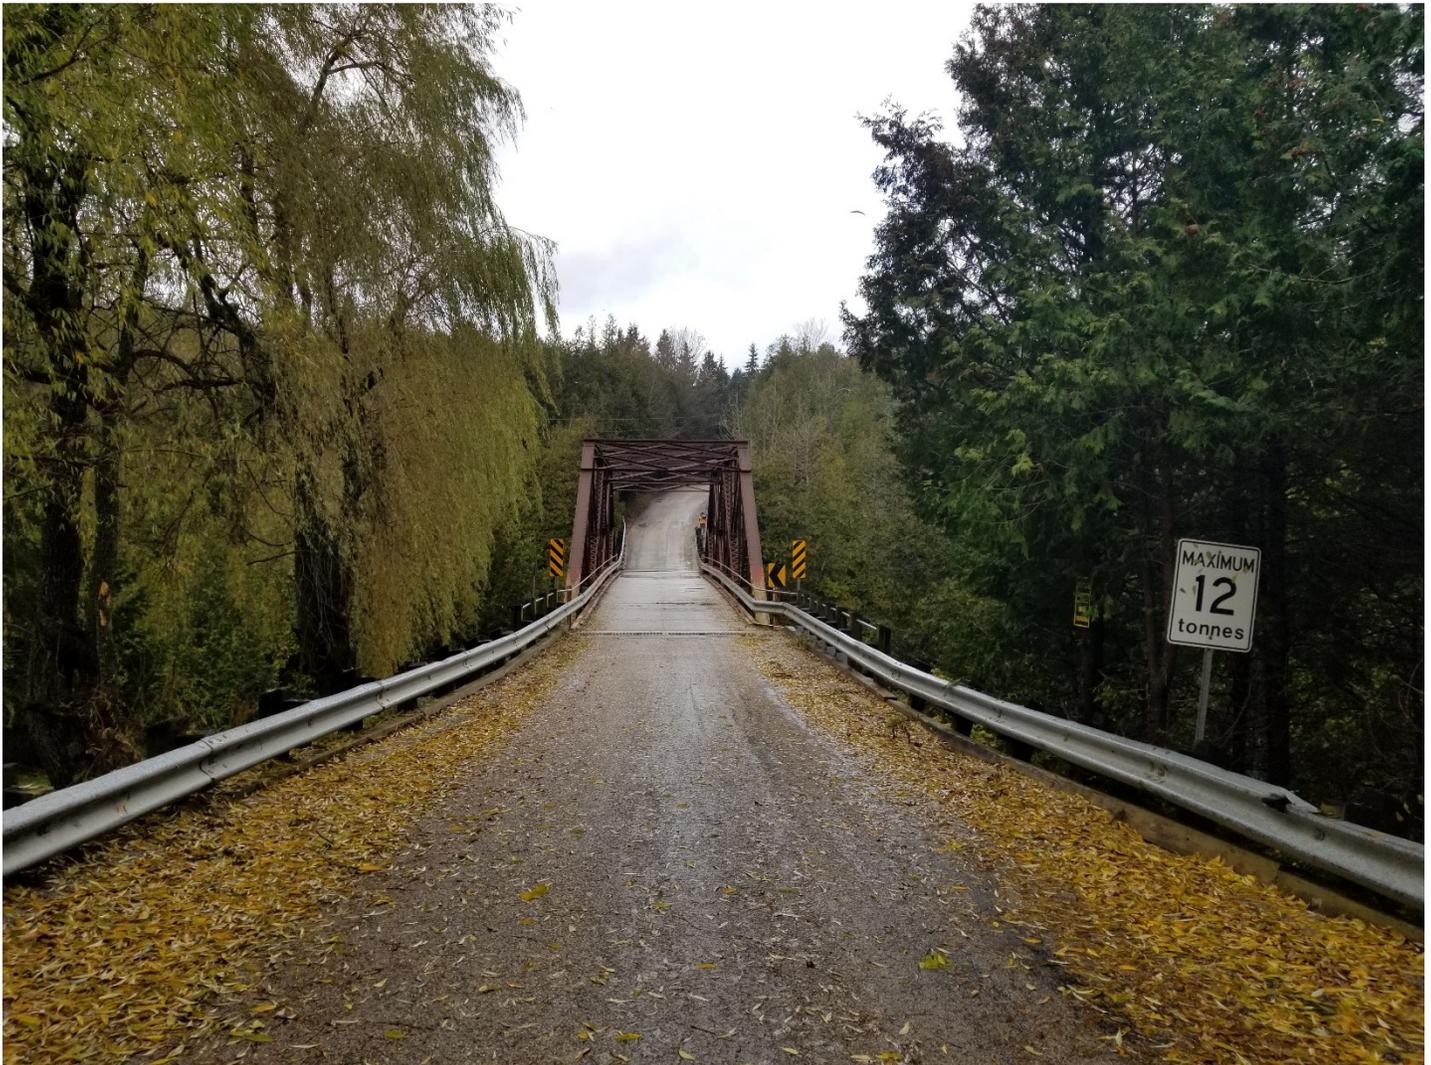
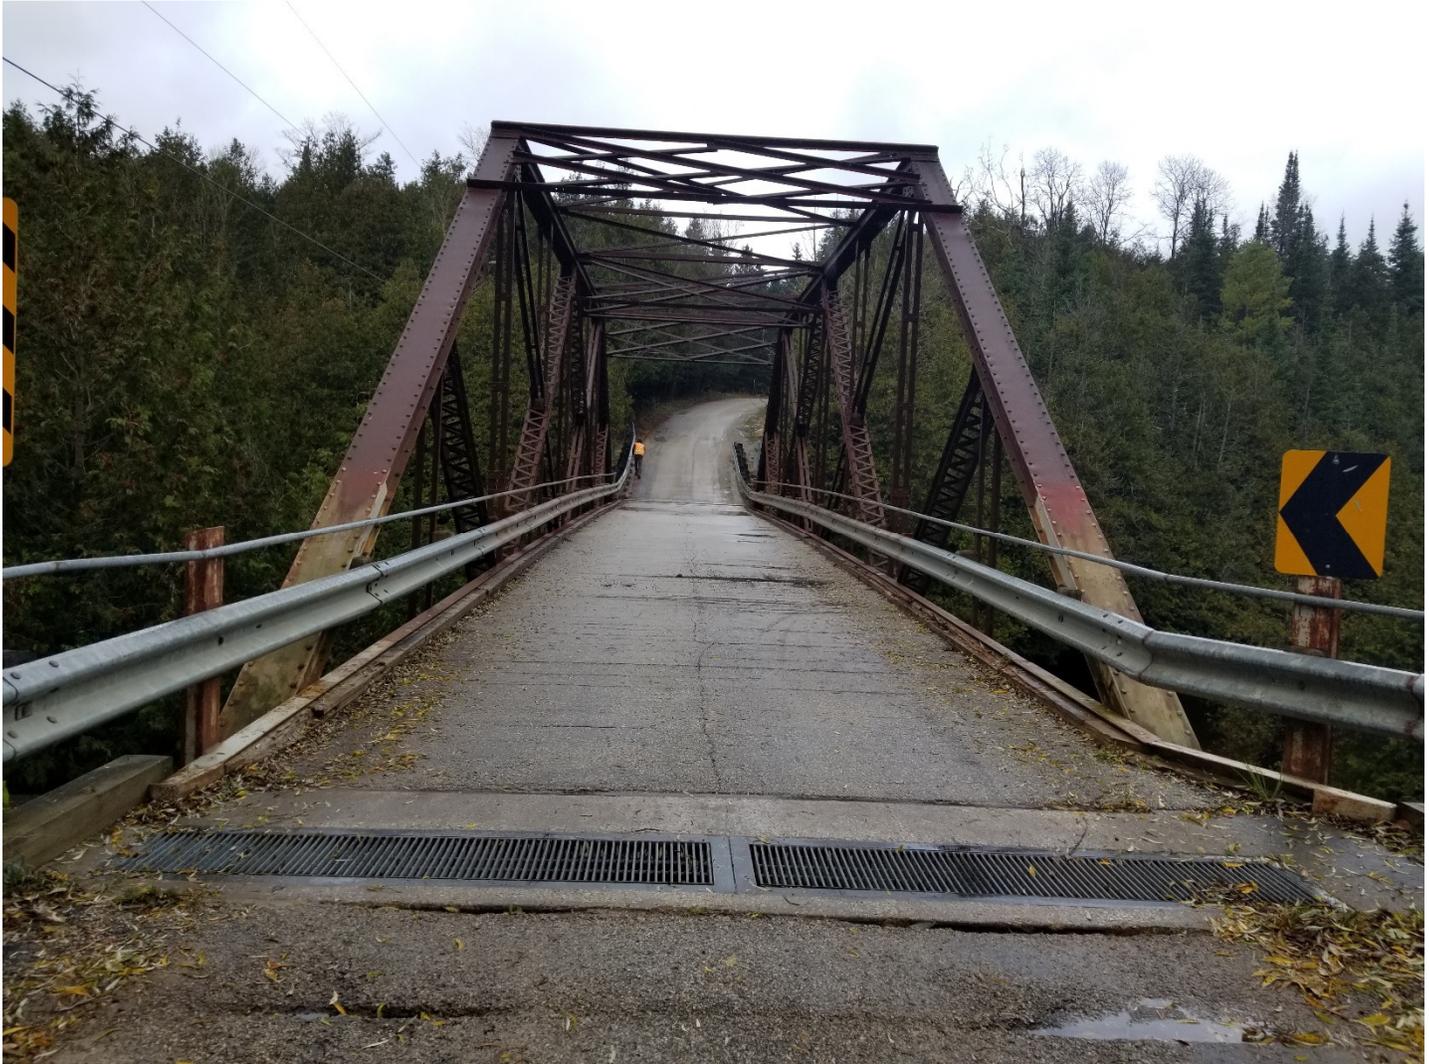
Image 1 – G-033 View from South Approach

Image 2 - G-033 View from South Approach

Prior to its closure in 2018, structure G-033 (Traverston Bridge) served a relatively low number of road users with respect to other structures in the Municipality and is located on Traverston Road, which has a moderate level of service. The structure is in very poor overall condition and bearing instability was observed by municipal employees resulting in the interim closure of the structure, necessary for the preservation of public safety. Recent inspections have noted the overall poor condition of both the superstructure and substructure and indicated the need for additional indepth investigations to determine the safe load carrying capacity and material conditions. If further investigation determines the substructure has adequate load carrying capacity and the structure is to be re-opened, it will require significant rehabilitation including the replacement of the majority of the superstructure. Should detailed investigations indicate the substructure does not have adequate load carrying capacity, the structure will require full replacement, and holds one of the highest replacement costs of all structures within the Municipality of West Grey. In addition to the structural concerns, steel bridges constructed during this era were typically designed for a load of 15 imperial tons, which is the equivalent of 13.6 metric tonnes, and therefore, a full rehabilitation of the structure would still require an imposed load limit posting of 13 tonnes. Due to its necessary closure, provisions have already been made in establishing alternate detour routing of traffic and emergency and municipal services in the area, which will lessen the burden of a permanent closure. The current estimated replacement value of this structure is \$1,500,000 due to its long span and level of service.

In the case of this structure, replacement or permanent closure are the two feasible options. Due the high cost of replacement and low overall importance within the municipal transportation network, structure G-033 warrants consideration for closure by the Municipality in its future strategic planning.

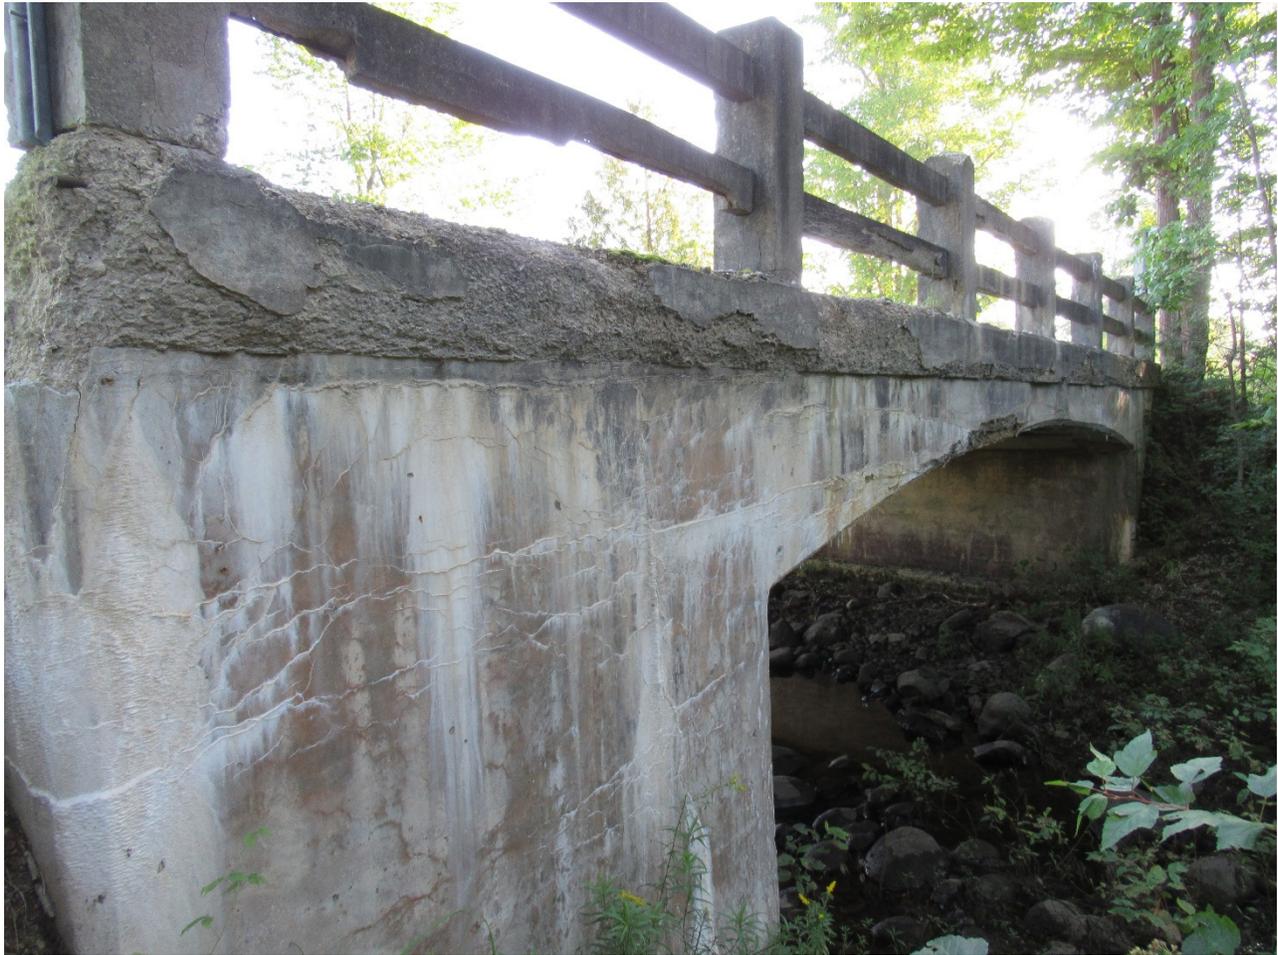
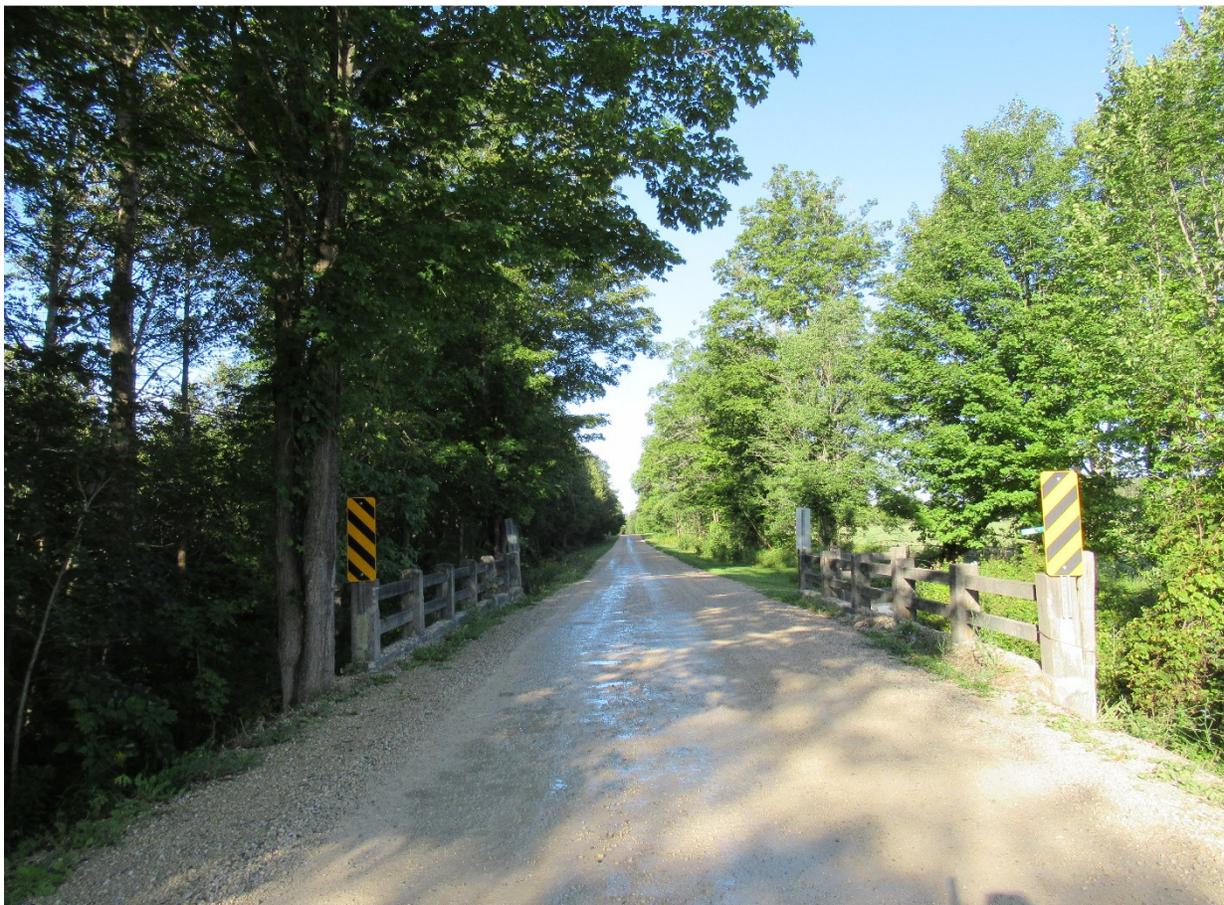
Image 3 - G-037 Elevation View

Image 4 - G-037 View from West Approach

Structure G-037 serves a relatively low number of road users with respect to other structures in the Municipality, as it is located on the North Line, which provides a low level of service and varies in condition throughout its east/west length. The structure is in poor overall condition, with recent inspections indicating that significant repairs are required if it is to remain open in a safe operating condition. The structure has an approximate replacement value of \$675,000, and the estimated cost to complete the immediate repairs required for the structure to remain open and in a safe condition is \$250,000. If the necessary repairs are completed, the structure could continue to serve road users for approximately 25 more years before requiring replacement. The structure has close proximity to Durham, Grey Road 4, and Concession 2, and may have future potential for serving an increased number of road users if the North Line is improved.

As structure G-037 is a viable candidate for rehabilitation and has the potential for future increase in importance of this asset within the Municipality of West Grey, the Municipality may consider the scheduling of repairs in order for it to remain open and in a safe operating condition. In the future, when rehabilitation is no longer a viable option, the structure may warrant consideration for closure by the Municipality in its future strategic planning.

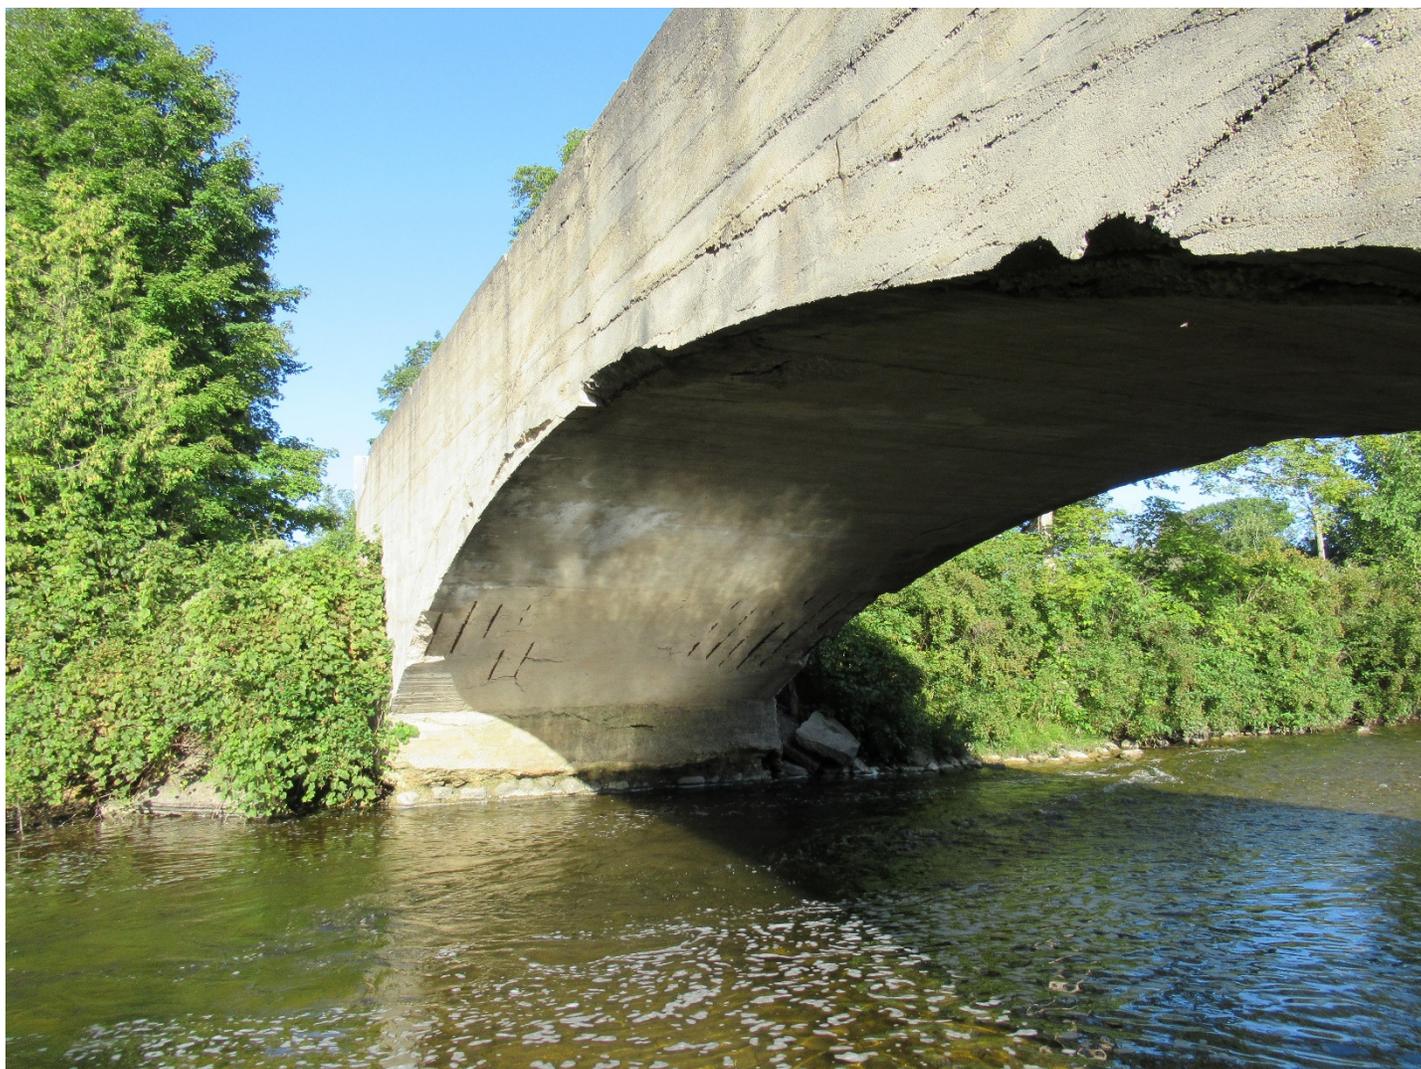
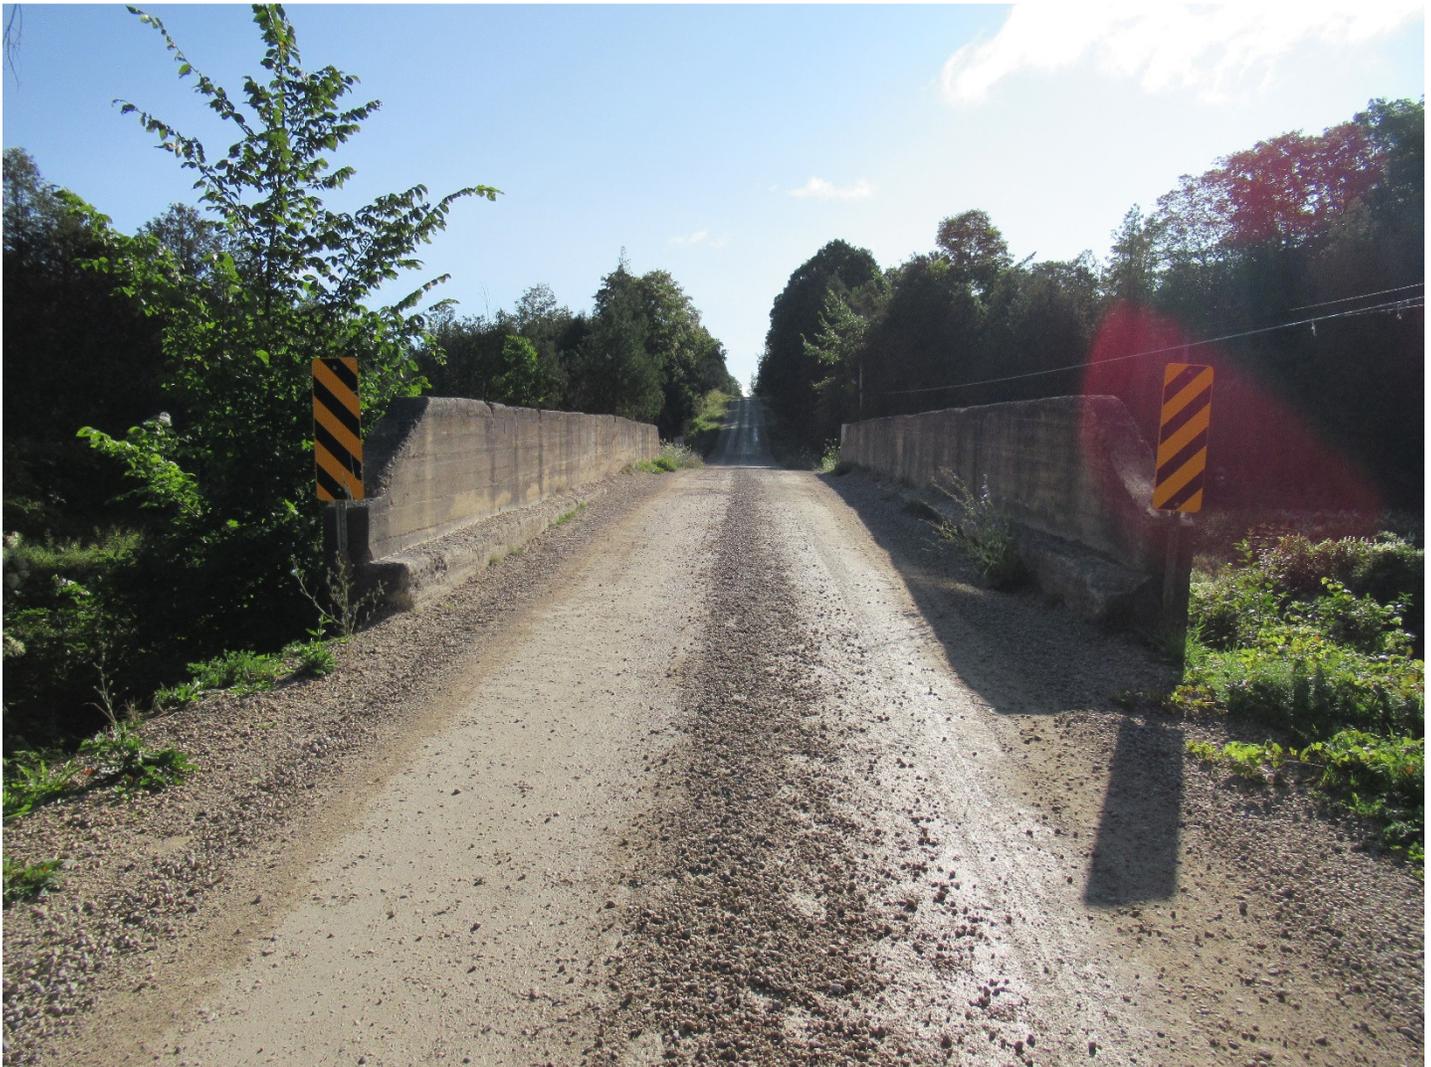
Image 5 - G-038 Elevation View

Image 6 – G-038 View from East Approach

Structure G-038 serves a relatively low number of road users with respect to other structures in the Municipality, as it is located on the North Line, which provides a low level of service and varies in condition throughout its east/west length. The structure is in poor overall condition, with recent inspections indicating that rehabilitation is no longer an economically viable option. Replacement of the structure is required if it is to remain open in a safe operating condition. The structure has an approximate replacement value of \$800,000. The structure has close proximity to Durham, Grey Road 4, and Concession 2, and may have future potential for serving an increased number of road users if the North Line is improved.

In the case of structure G-038, replacement or permanent closure are the two feasible options. Due the high cost of replacement and low overall importance within the municipal transportation network, the structure warrants consideration for closure by the Municipality in its future strategic planning.

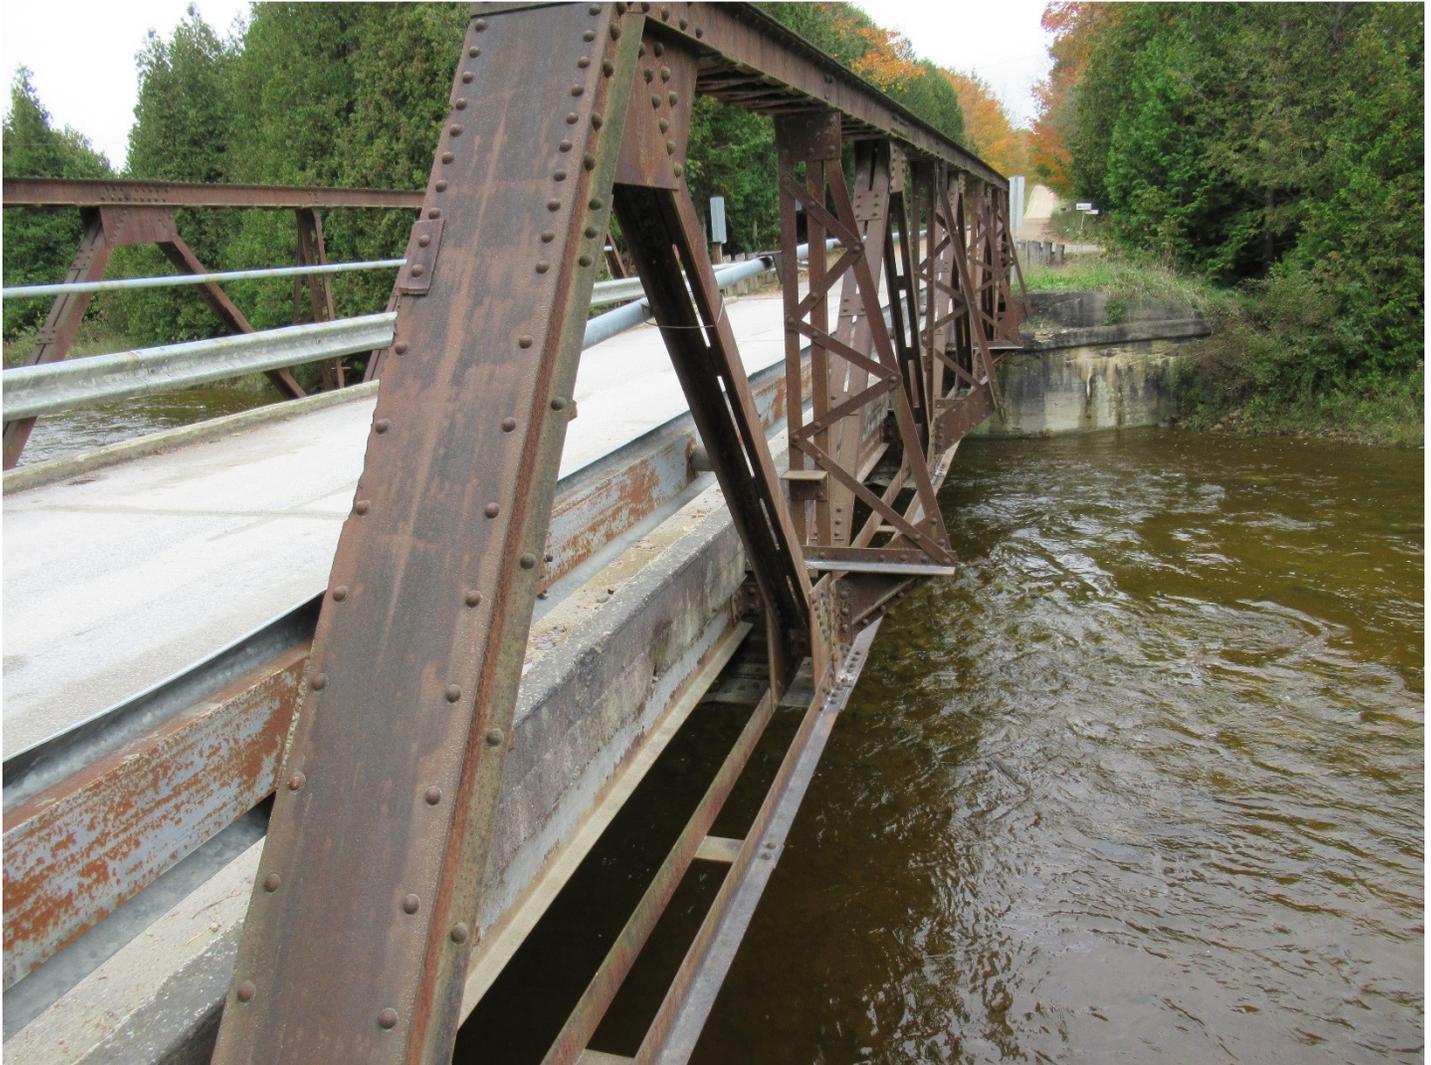
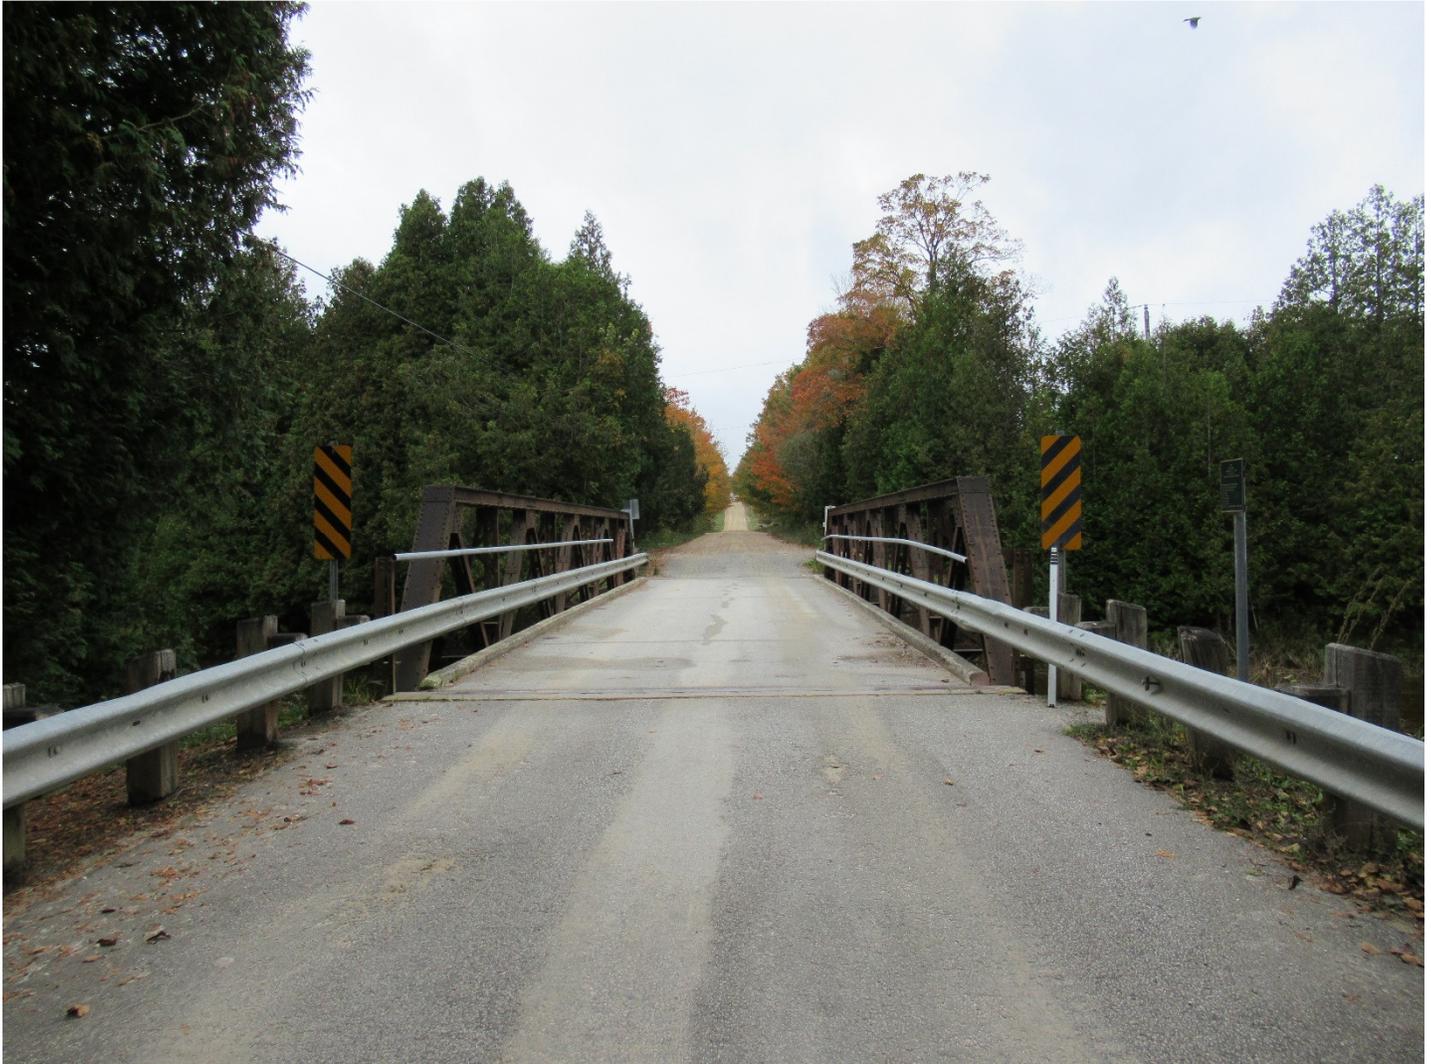
Image 7 – G-040 Elevation View

Image 8 – G-040 View from East Approach

Structure G-040 serves a relatively low number of road users with respect to other structures in the Municipality, as it is located on Concession 4, which has a moderate level of service throughout its length. The structure is in poor condition, and is approaching the end of its lifecycle, with necessary closure or replacement required in the immediate future. Recent inspections of structure G-040 indicate that rehabilitation of the structure is no longer an economically viable option due to the high cost of the repairs compared to the poor condition of its abutments, which will ultimately limit the lifespan of the structure once rehabilitated. In addition to the foundation concerns, steel bridges constructed during this era were typically designed for a load of 15 imperial tons, which is the equivalent of 13.6 metric tonnes, and therefore, a full rehabilitation of the structure would still require an imposed load limit posting of 13 tonnes. The current estimated replacement value of this structure is \$1,000,000 due to its large span.

In the case of this structure, replacement or closure are the two feasible options. Due to the high cost of replacement and low overall importance within the municipal transportation network, structure G-040 warrants consideration for closure by the Municipality in its future strategic planning.

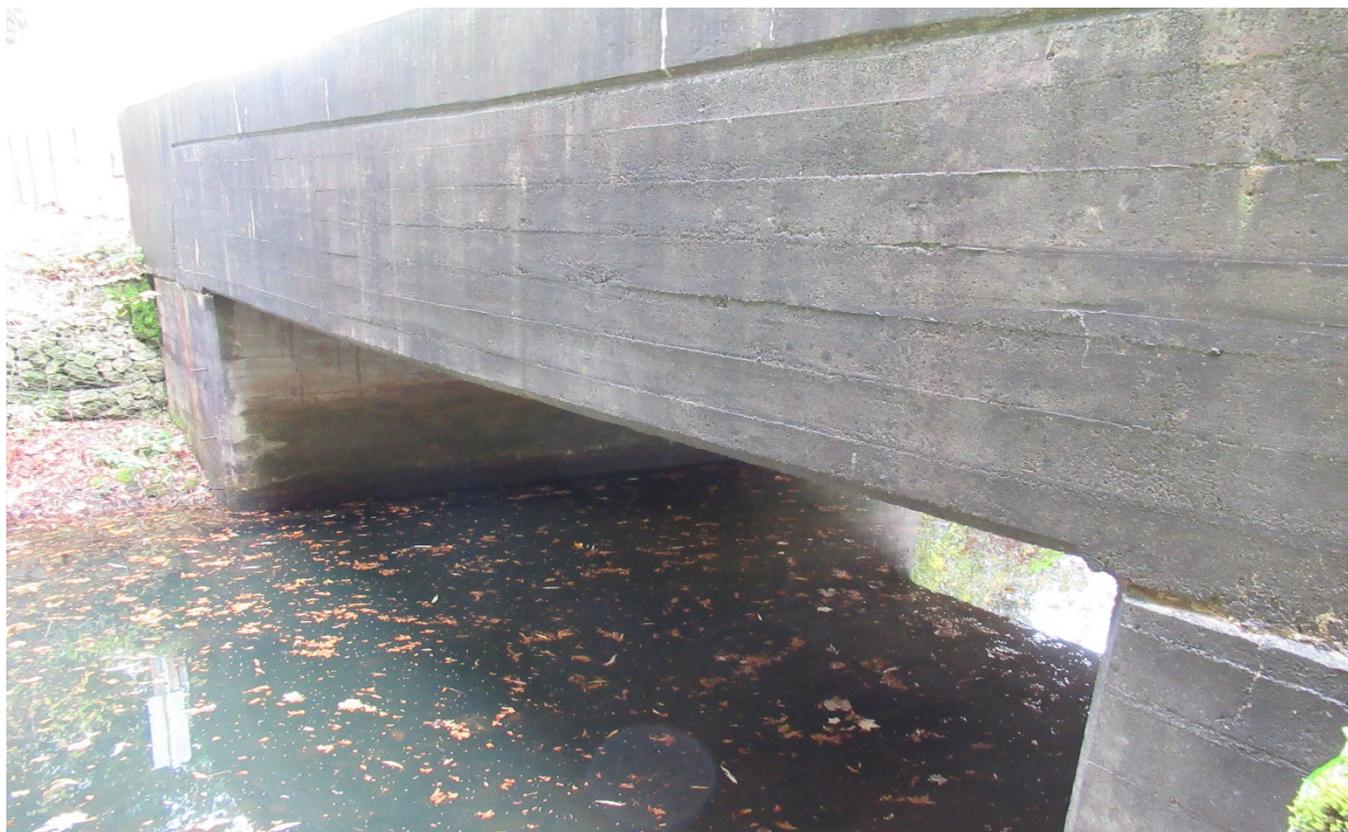
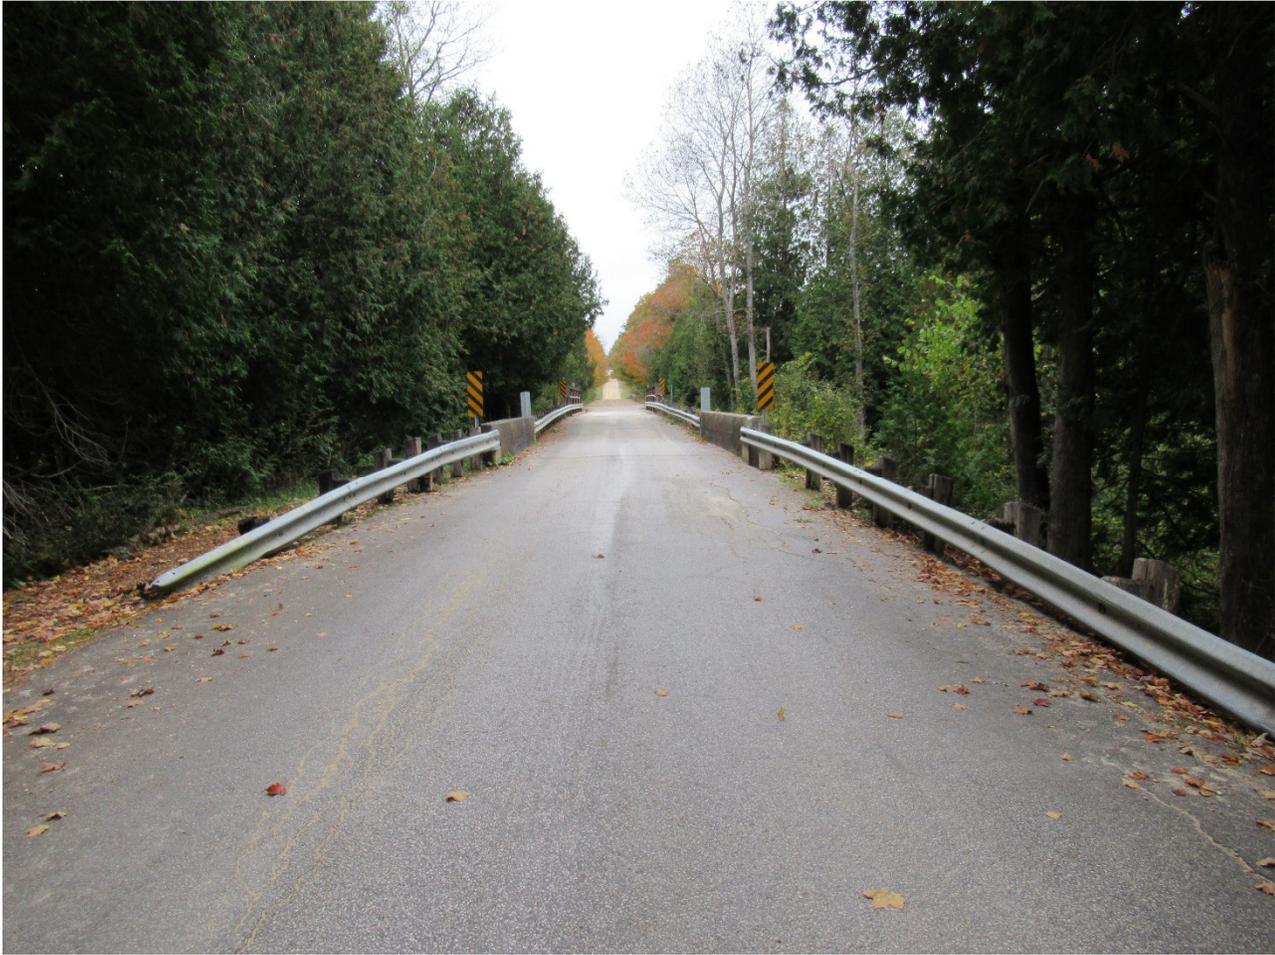
Image 9 – G-041 Elevation View

Image 10 – G-041 East Approaching Perspective

Structure G-041 serves a relatively low number of road users with respect to other structures in the Municipality, as it is located on the Concession 4, which has a moderate level of service throughout its length. The structure is in fair overall condition, with recent inspections indicating that repairs and barrier protection upgrades are required if it is to remain open in a safe operating condition. The structure has an approximate replacement value of \$600,000 and the estimated cost to complete the immediate repairs required for the structure to remain open and in a safe condition is \$45,000. If the necessary repairs are completed, the structure could continue to serve road users for approximately 30 more years before requiring replacement.

As structure G-041 is a viable candidate for rehabilitation and has the potential to continue to serve the Municipality for many more years, the Municipality may consider the scheduling of repairs in order for it to remain open and in a safe operating condition. In the future, when rehabilitation is no longer a viable option, the structure may warrant consideration for closure by the Municipality in its future strategic planning.

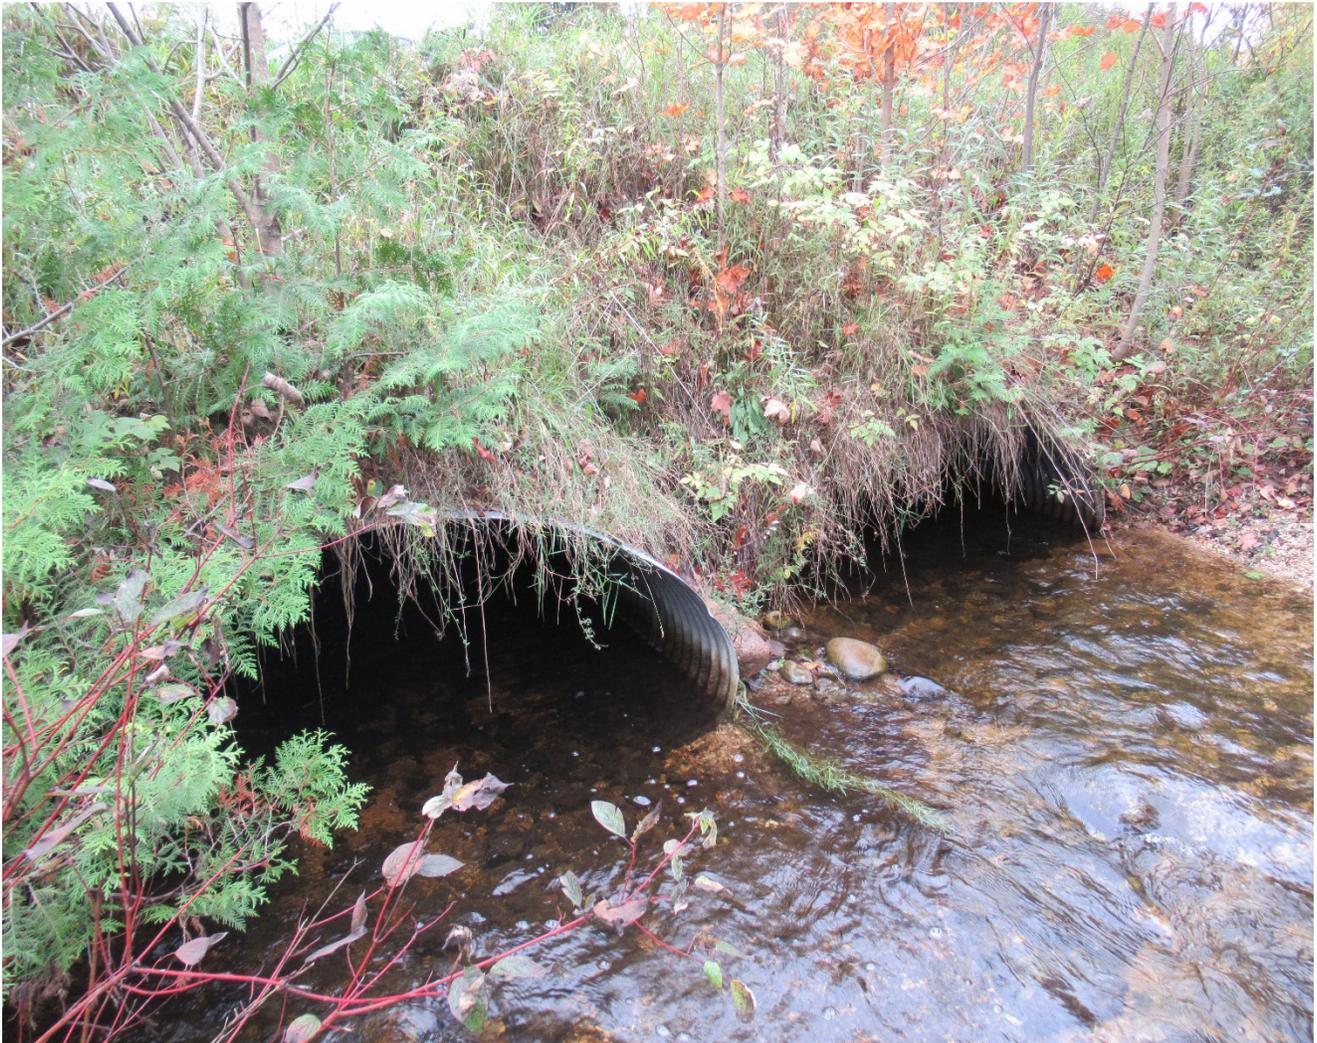
Image 11 – G-126 Elevation View

Structure G-126 serves a relatively low number of road users with respect to other structures in the Municipality, as it is located on Baptist Church Road between Concessions 8 and 6. Recent inspections indicate that the north culvert is in fair overall condition, and the south culvert has an observed mid-span failure (depression) and will require replacement in the near future if the structure is to remain open and in a safe operating condition. The structure has an approximate replacement value of \$250,000, and the estimated cost to complete the necessary replacement of the south pipe is \$150,000. Due to constructibility and to achieve the optimum

economy, it is advisable to consider the simultaneous replacement of both pipes, which could then go on to serve the Municipality of West Grey for 75 years.

As structure G-126 has a relatively low cost of replacement, the Municipality may wish to consider the scheduling of the replacement in the near future in order for the structure to remain open and in a safe operating condition.

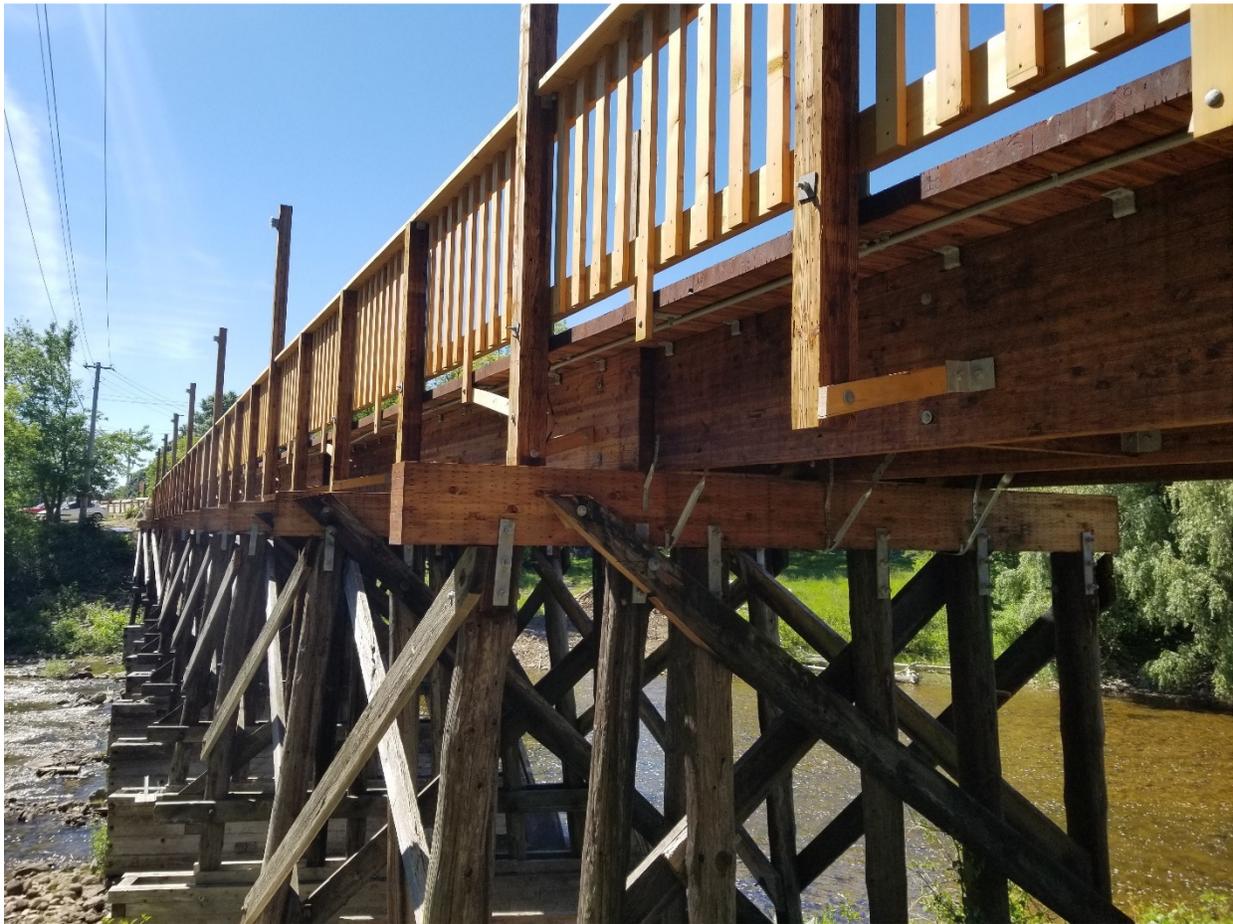
Image 12 – P-101, Durham Pedestrian Bridge Elevation View

The Durham Pedestrian Bridge (P-101) is in excellent overall condition and it is recommended that the Municipality continue the maintenance schedule in order to maintain its current condition.
