THE MUNICIPALITY OF WEST GREY

GLENELG STRUCTURE RATING AND RATIONALE REPORT

DECEMBER 11, 2019

PROJECT NO.: 171-04854-00
DATE: DECEMBER 11, 2019

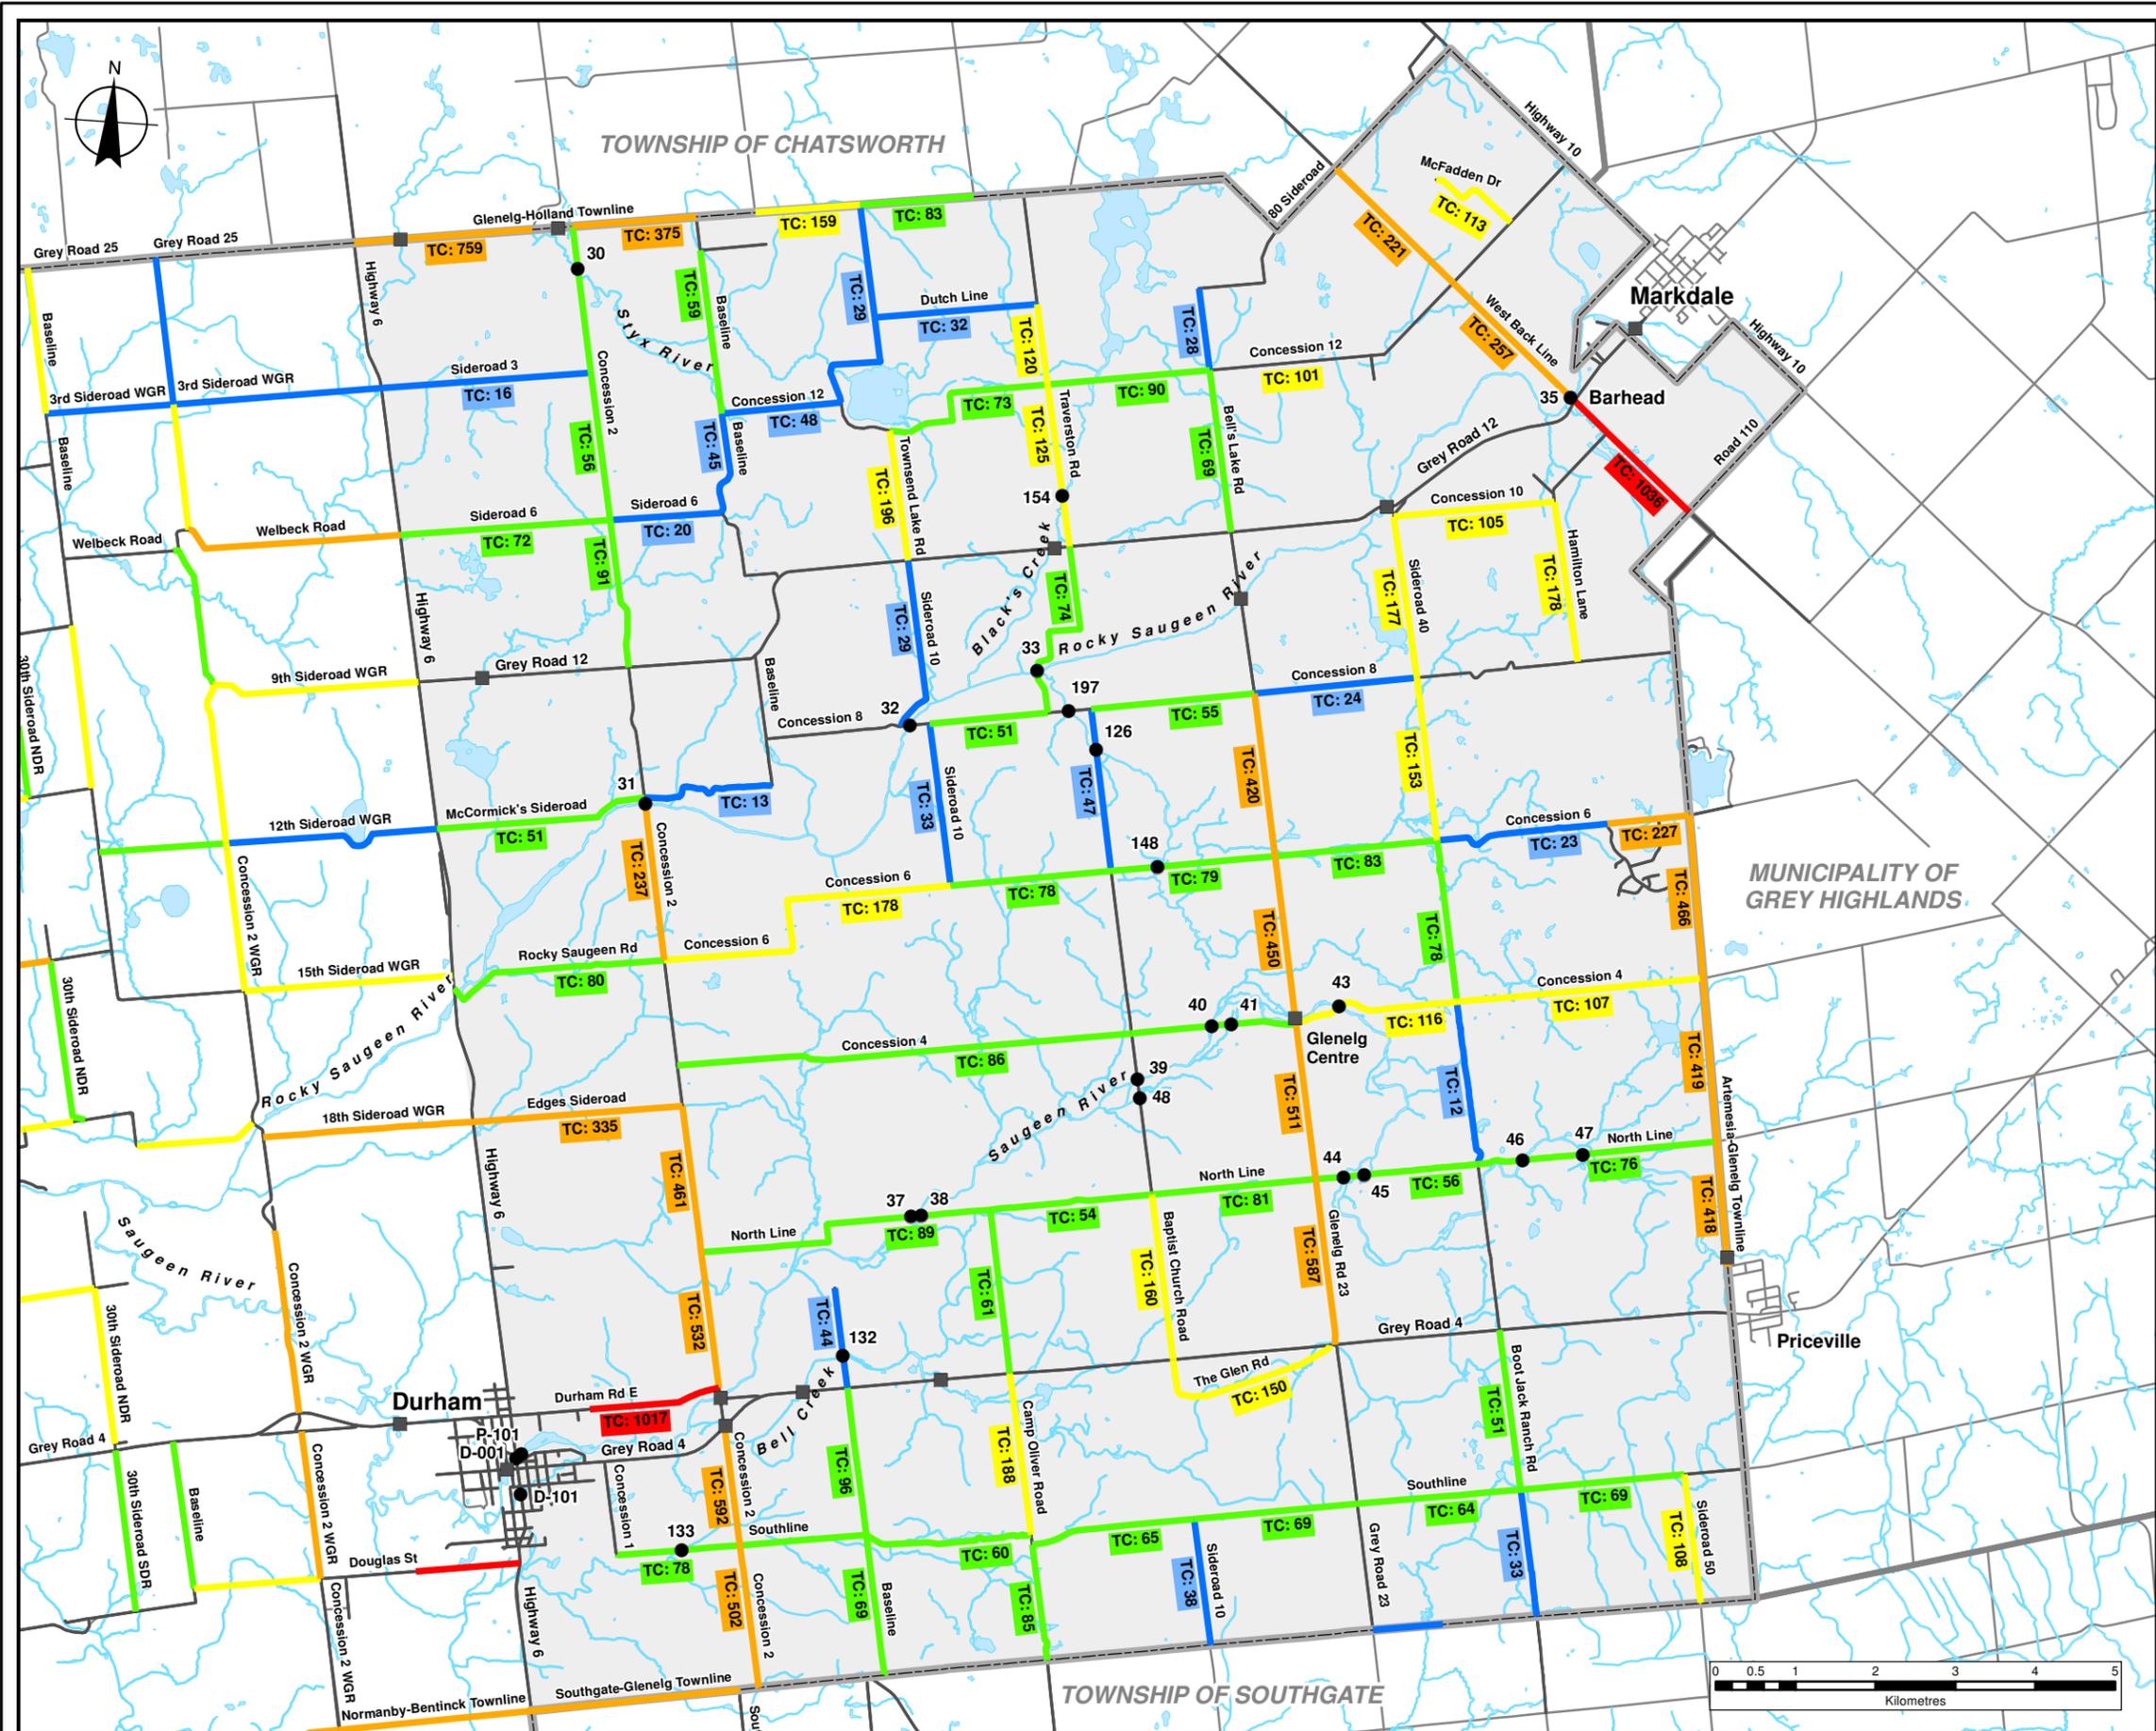
SCALE:	1:85,000	DATE:	DEC 2019
DRAWN:	JET	PROJECT:	191-10406-00
APPROVED:	KH/CW	FIGURE:	3

Figure 3 illustrates the traffic volume data collected in the Glenelg area by the Public Works Department, and can be found in **Appendix A**. Each section of road has been colour coded and categorized by volume, and given a rating range which can be applied to each structure as follows:

**TRAFFIC COUNT DATA
STRUCTURE RATING AND RATIONAL REPORT
FORMER GLENELG TOWNSHIP
MUNICIPALITY OF WEST GREY**
