THE MUNICIPALITY OF WEST GREY

NORMANBY STRUCTURE RATING AND RATIONALE REPORT

DECEMBER 11, 2019

PROJECT NO.: 171-04854-00
DATE: DECEMBER 11, 2019

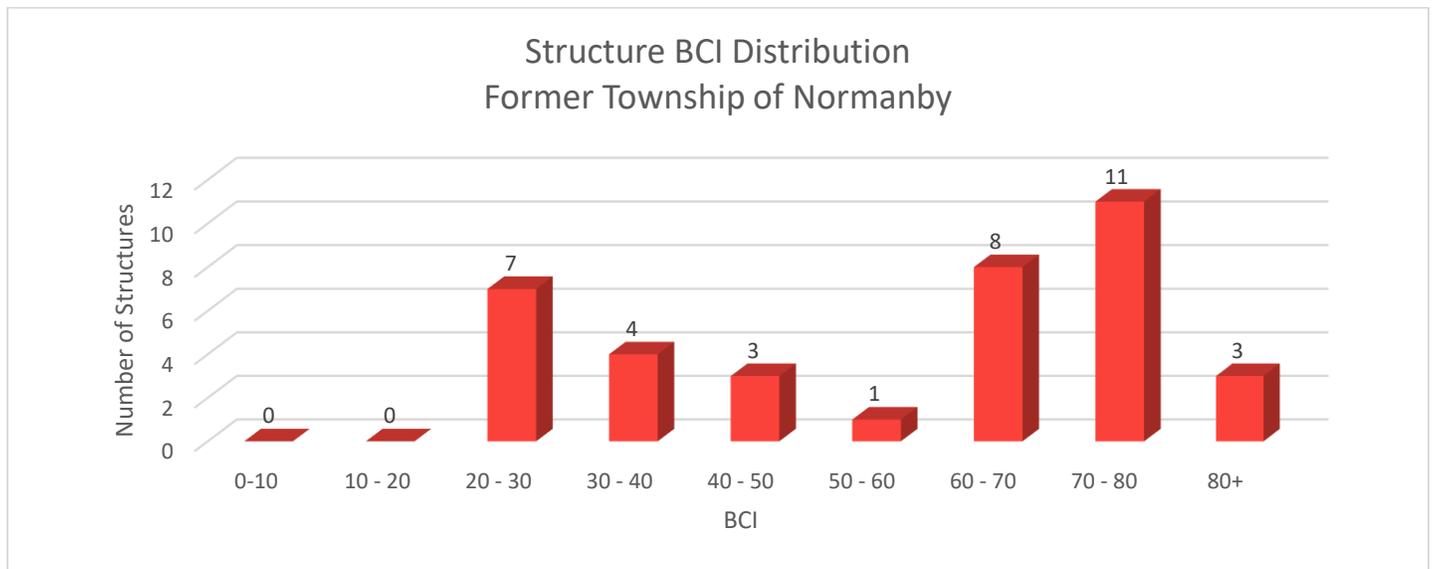
Chart 3 - Structure BCI Distribution - Township of Normanby

In analyzing this distribution, it is noted that eleven (11) structures in Normanby have BCI values lower than 40, indicating that rehabilitation or replacement of the structure should be scheduled immediately if they are to remain in safe and useful operating condition. This distribution also highlights that five (5) structures fall within the BCI range of 40 to 60, and future planning for rehabilitation should be initiated.

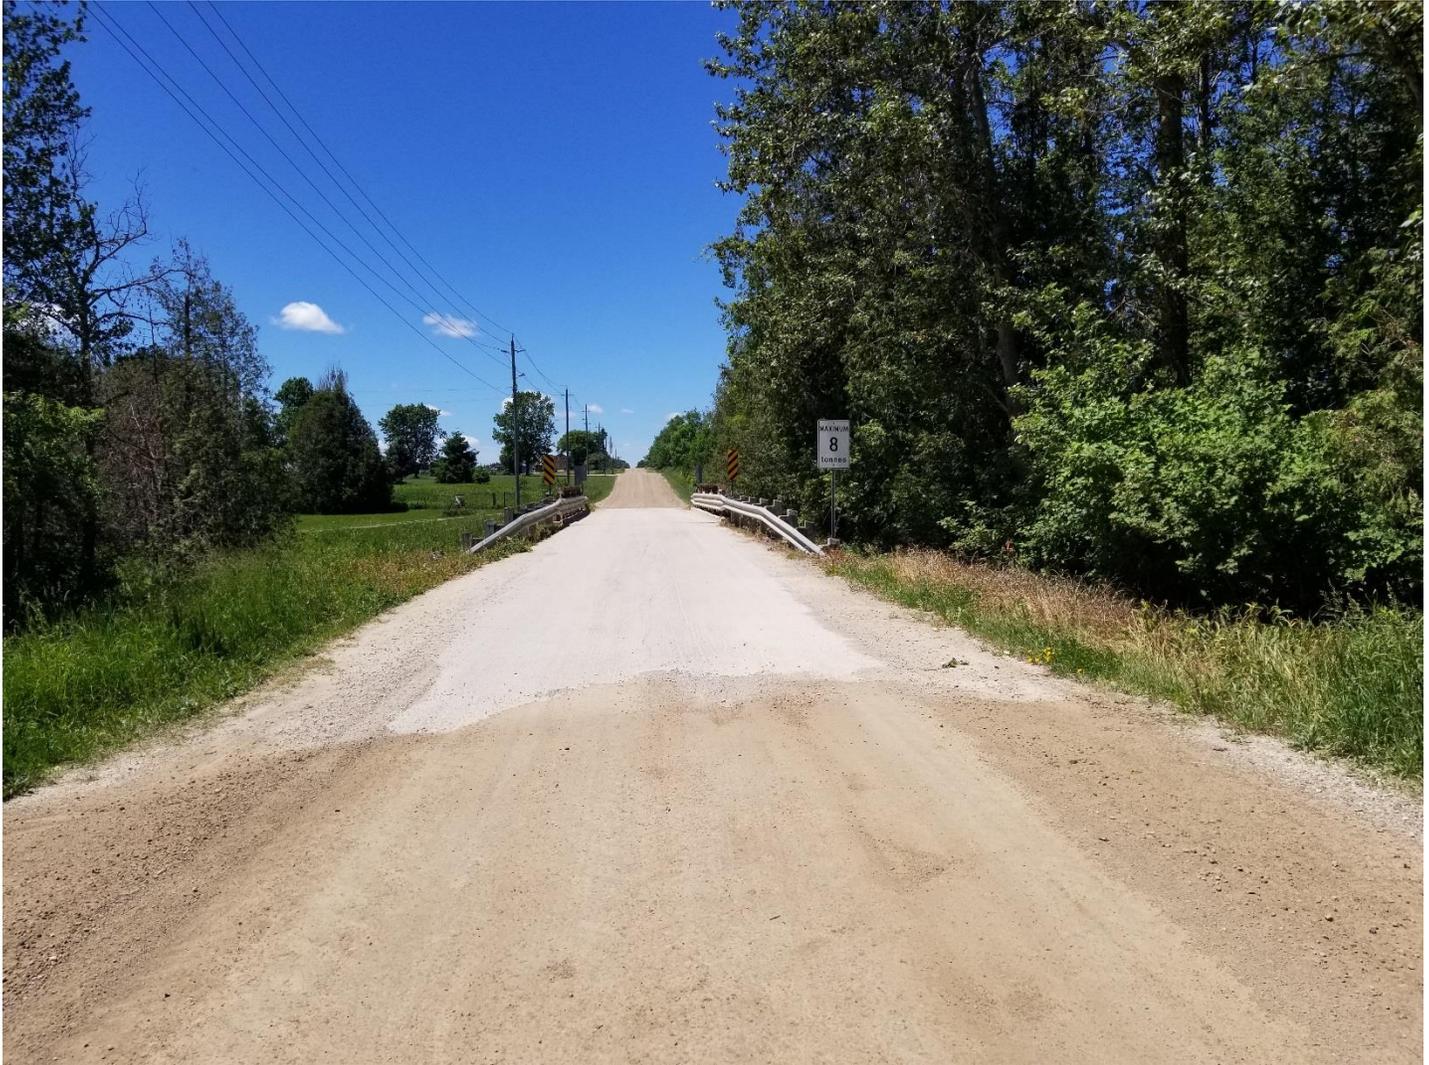
Image 1 – N-061 View from East Approach

structure was originally constructed in 1920, having some minor rehabilitation work and maintenance completed since. The structure spans approximately fifteen (15) metres and is a steel pony truss structure with concrete abutments and a timber deck overlain by an asphalt wearing surface. A view of the structure from the east approaching and north elevation perspectives are shown in *Images 1 and 2* respectively below.

In the case of this structure, a structure condition assessment and rehabilitation, replacement (near future), or permanent closure are the feasible options. Due to the moderate cost of replacement and potential for future increase in overall importance within the municipal transportation network, structure N-061 warrants consideration for rehabilitation and eventual replacement by the Municipality in its future strategic planning.

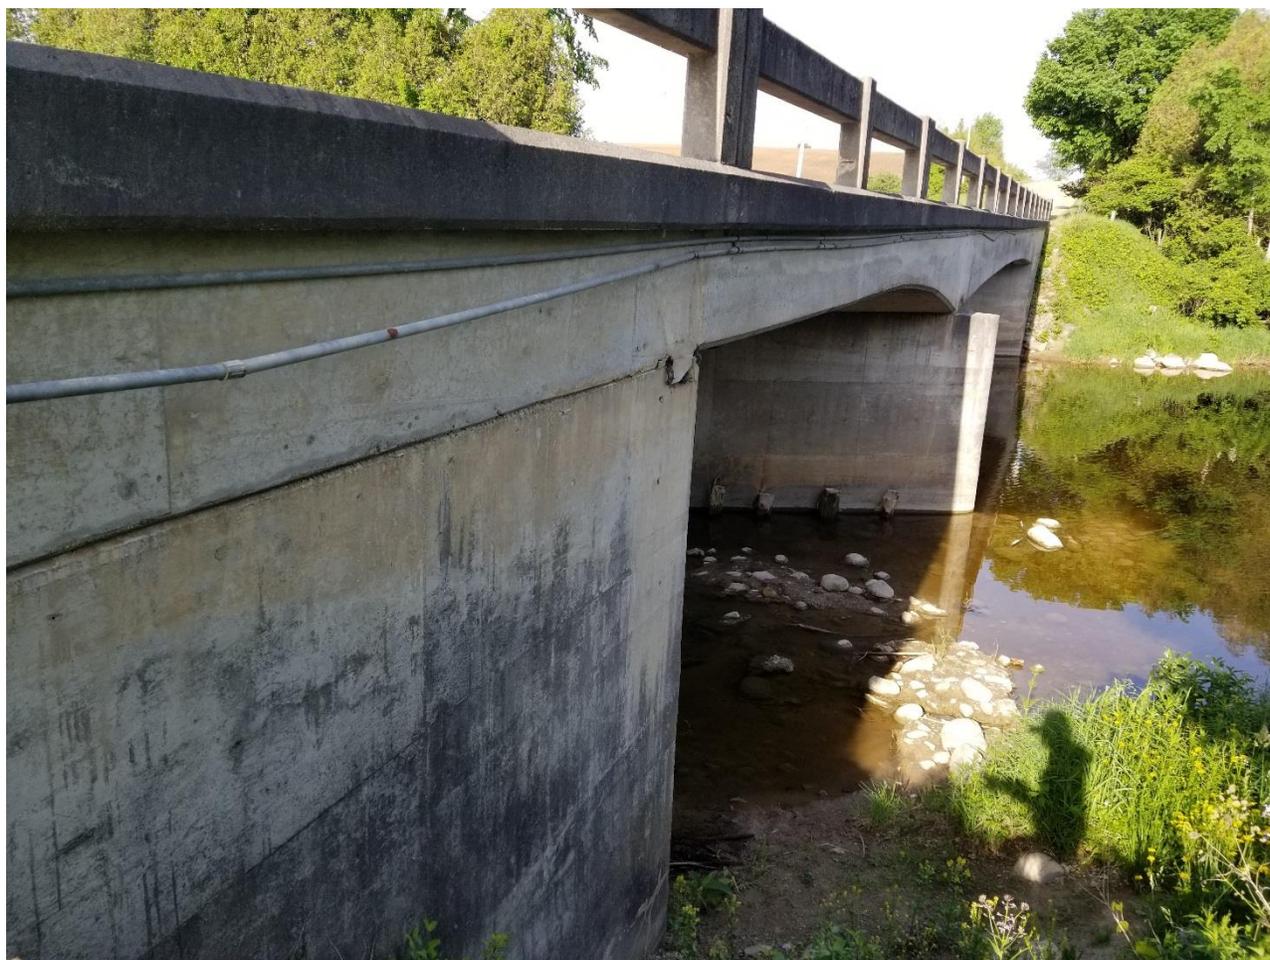
Image 3 – N-066 Elevation View

Structure N-066 serves a relatively low number of road users with respect to other structures in the Municipality, as it is located on the Concession 6, which provides a low-to-moderate level of service and varies in condition throughout its east/west length. The structure is in fair to good overall condition, following repairs in 2018. The structure has a very high replacement value of \$1,750,000. If the maintenance and repair schedule is continued, the structure could continue to serve road users for approximately 40 more years before requiring replacement. The structure has close proximity to Grey Road 3, and may have future potential for serving an increased number of road users, increasing its overall importance within the local and municipal transportation network.

As structure N-066 is in overall fair to good condition, is a viable candidate for ongoing maintenance and rehabilitation, and has the potential for future increase in importance of this asset within the Municipality of West Grey, the Municipality may consider maintaining it and continuing to schedule repairs as necessary in order for it to remain open and in a safe operating condition. In the future, when rehabilitation is no longer a viable option, the structure may warrant consideration for closure by the Municipality in its future strategic planning.

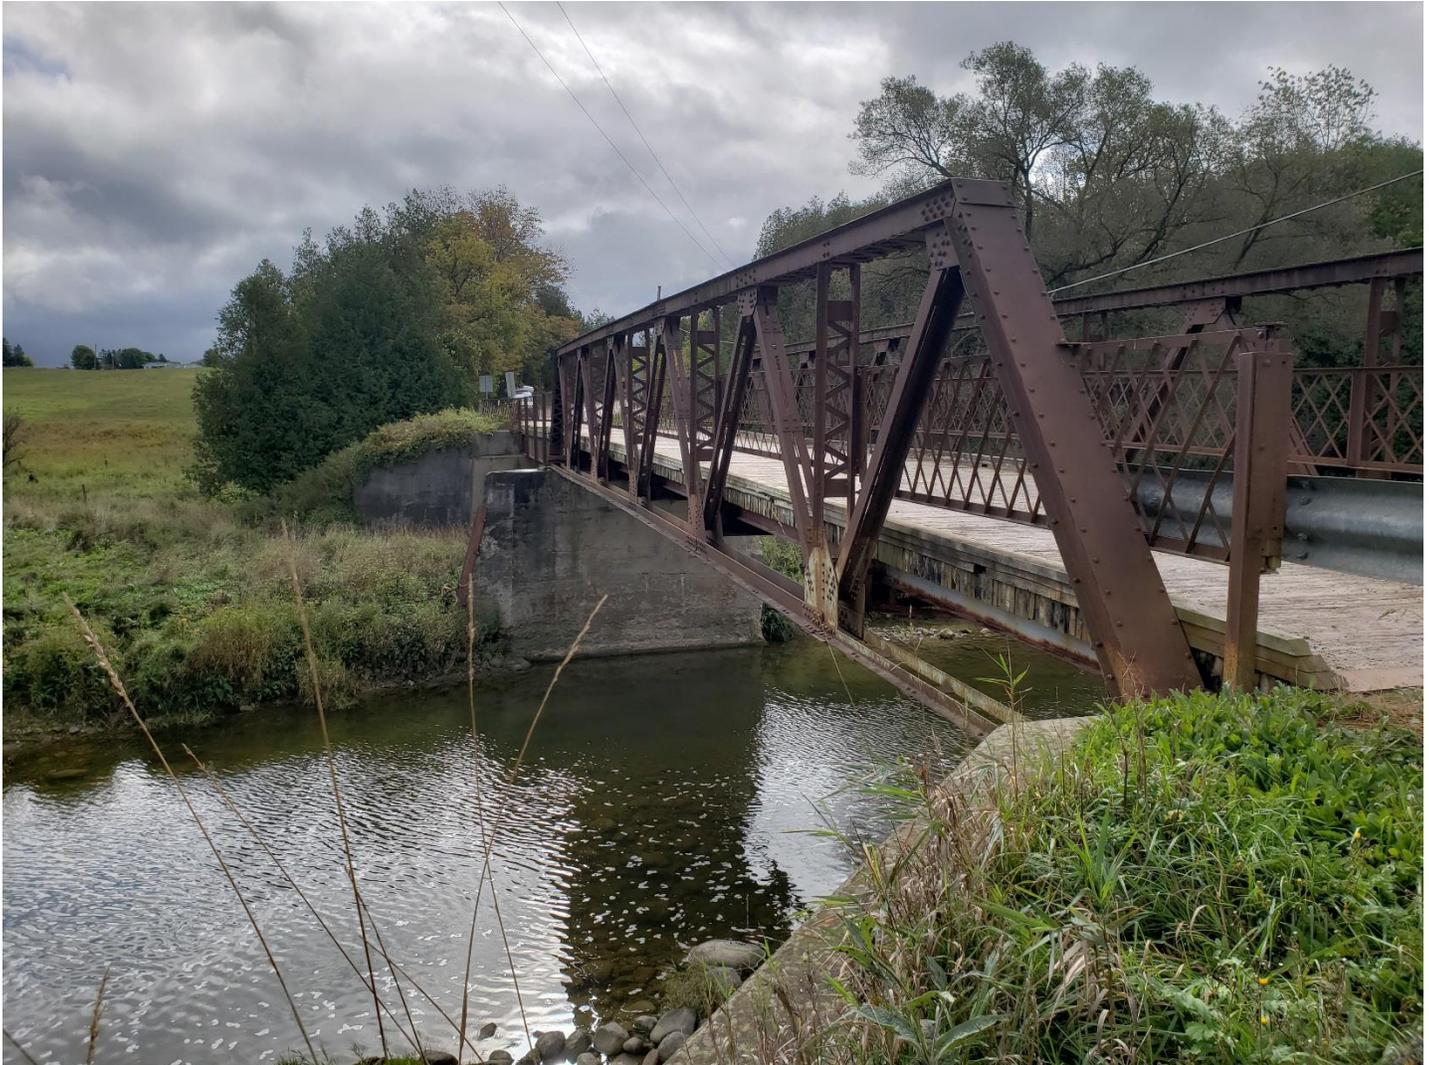
Image 5 – N-070 Elevation View

Structure N-070 serves a relatively low number of road users with respect to other structures in the Municipality, as it is located on the Concession 2 WGR, which provides a low level of service and is discontinuous throughout its north/south length. The structure is in poor overall condition, with recent inspections indicating that rehabilitation is no longer an economically viable option. Replacement of the structure is required if it is to remain open in a safe operating condition. The structure has an approximate replacement value of \$1,500,000. The structure has close proximity to Mount Forest and Highway 89, and may have future potential for serving an increased number of road users if the roadway level-of-service is improved.

In the case of structure N-070, replacement or permanent closure are the two feasible options. Due the high cost of replacement and low overall importance within the municipal transportation network, the structure warrants consideration for closure by the Municipality in its future strategic planning.

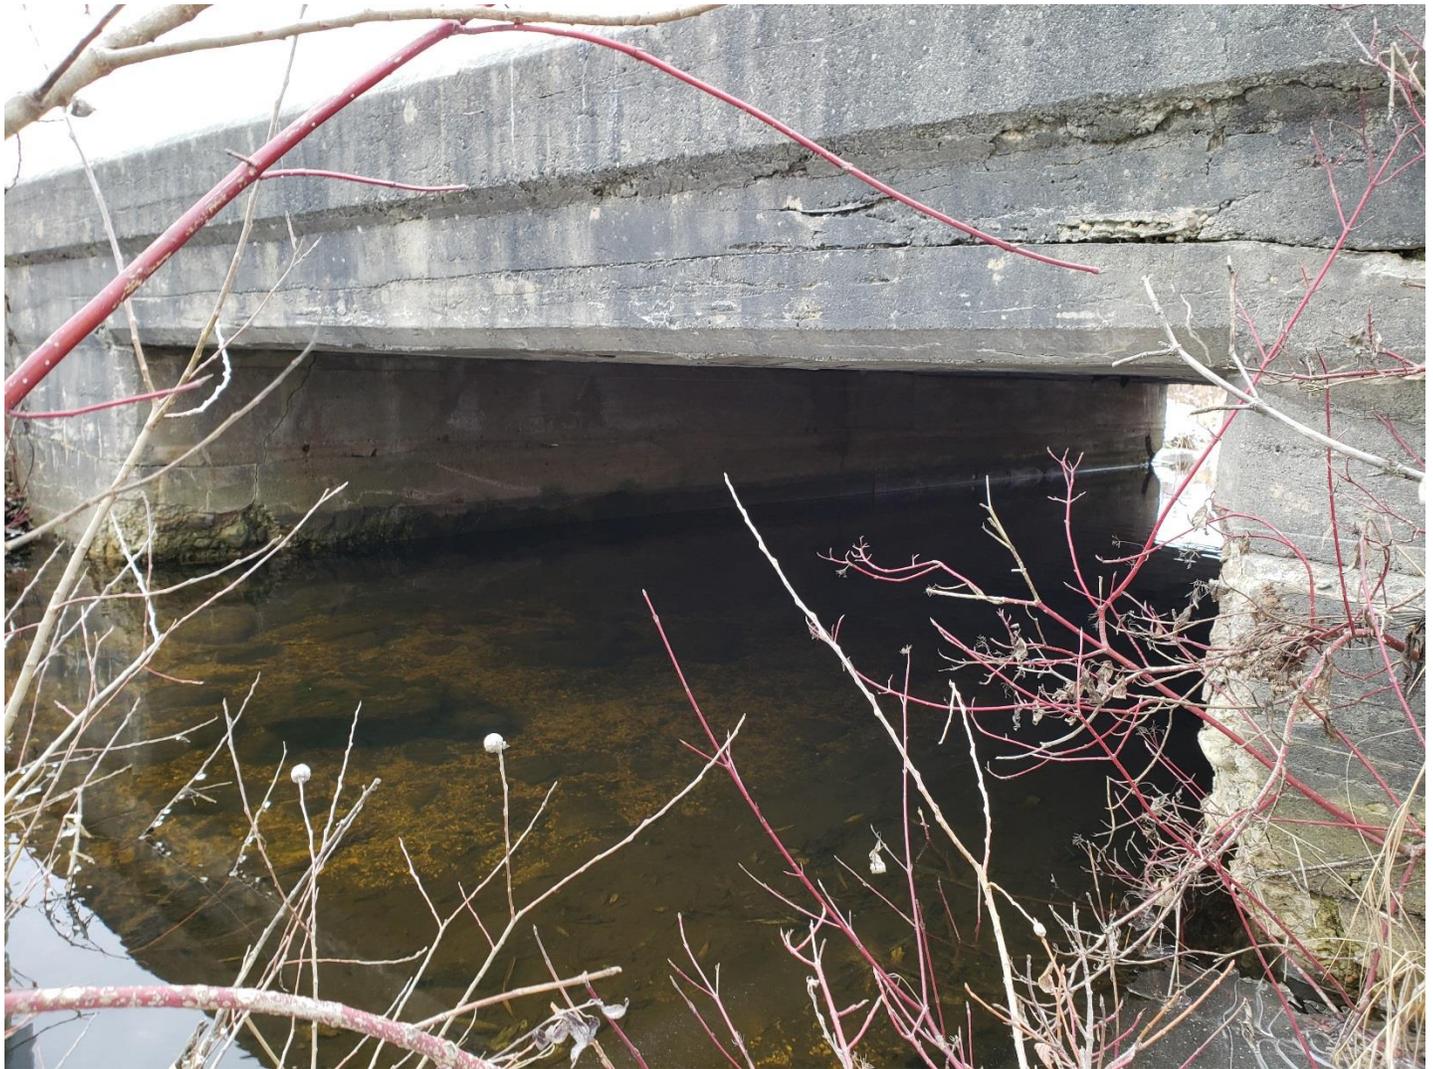
Image 7 – N-184 Elevation View

transportation network. The structure was originally constructed in 1950, having only minor repairs completed since. The structure spans approximately nine (9) metres and is a rigid frame concrete culvert, overlain by granular fill and wearing surface. A view of the structure in elevation, and from the approaching perspective are shown in *Images 7 and 8* below.

As structure N-184 is a viable candidate for rehabilitation and has the potential for future increase in importance of this asset within the Municipality of West Grey, the Municipality may consider maintaining it and continuing to repair it as necessary in order for it to remain open and in a safe operating condition. In the future, when rehabilitation is no longer a viable option, and if the importance of the structure has not increased, the structure may warrant consideration for closure by the Municipality in its future strategic planning.

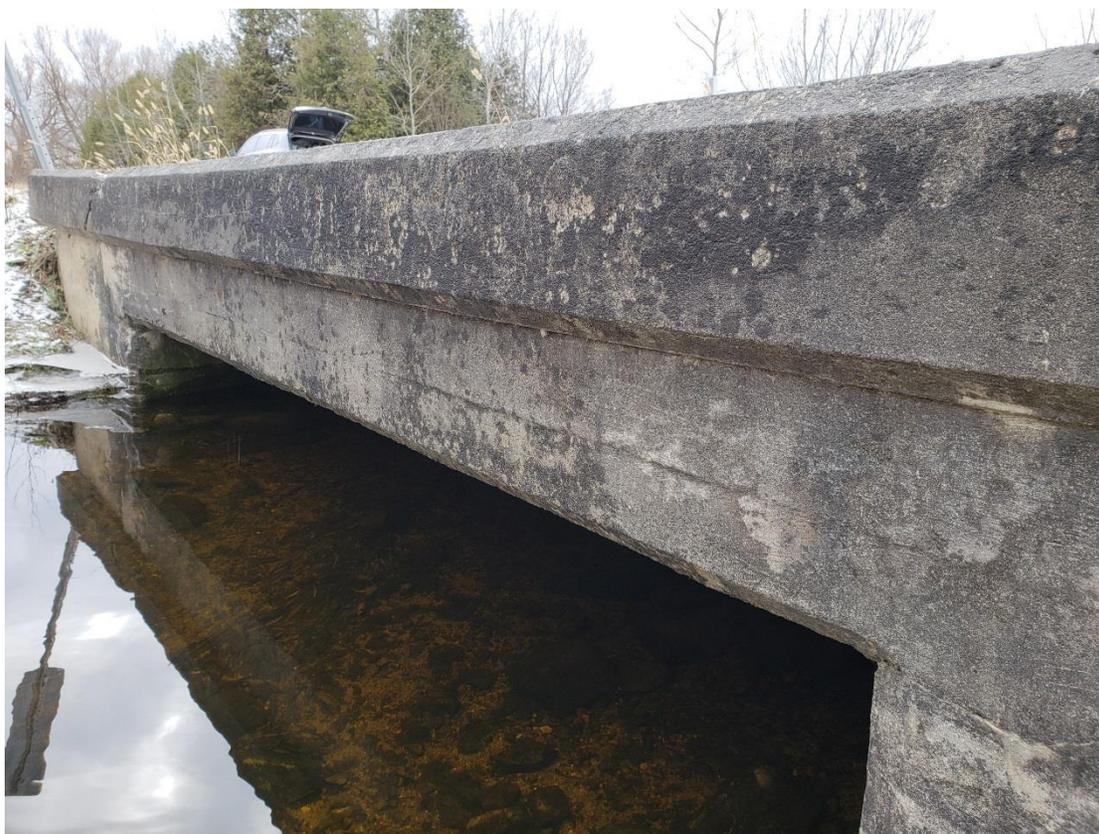
Image 9 – N-185 Elevation View

Structure N-185 serves a relatively low number of road users with respect to other structures in the Municipality, as it is located on Sideroad 25, which has a moderate-to-low level of service and is discontinuous throughout its length. The structure is in poor condition, and is approaching the end of its lifecycle, with necessary rehabilitation or replacement required in the immediate future. The current estimated replacement value of this structure is \$500,000. The structure has close proximity to Grey Road 9, and may have potential for serving an increased number of road users in the future.

As structure N-185 is a viable candidate for rehabilitation and has the potential for future increase in importance of this asset within the Municipality of West Grey, the Municipality may consider maintaining it and continuing to repair it as necessary in order for it to remain open and in a safe operating condition. In the future, when rehabilitation is no longer a viable option, and if the importance of the structure has not increased, the structure may warrant consideration for closure by the Municipality in its future strategic planning.

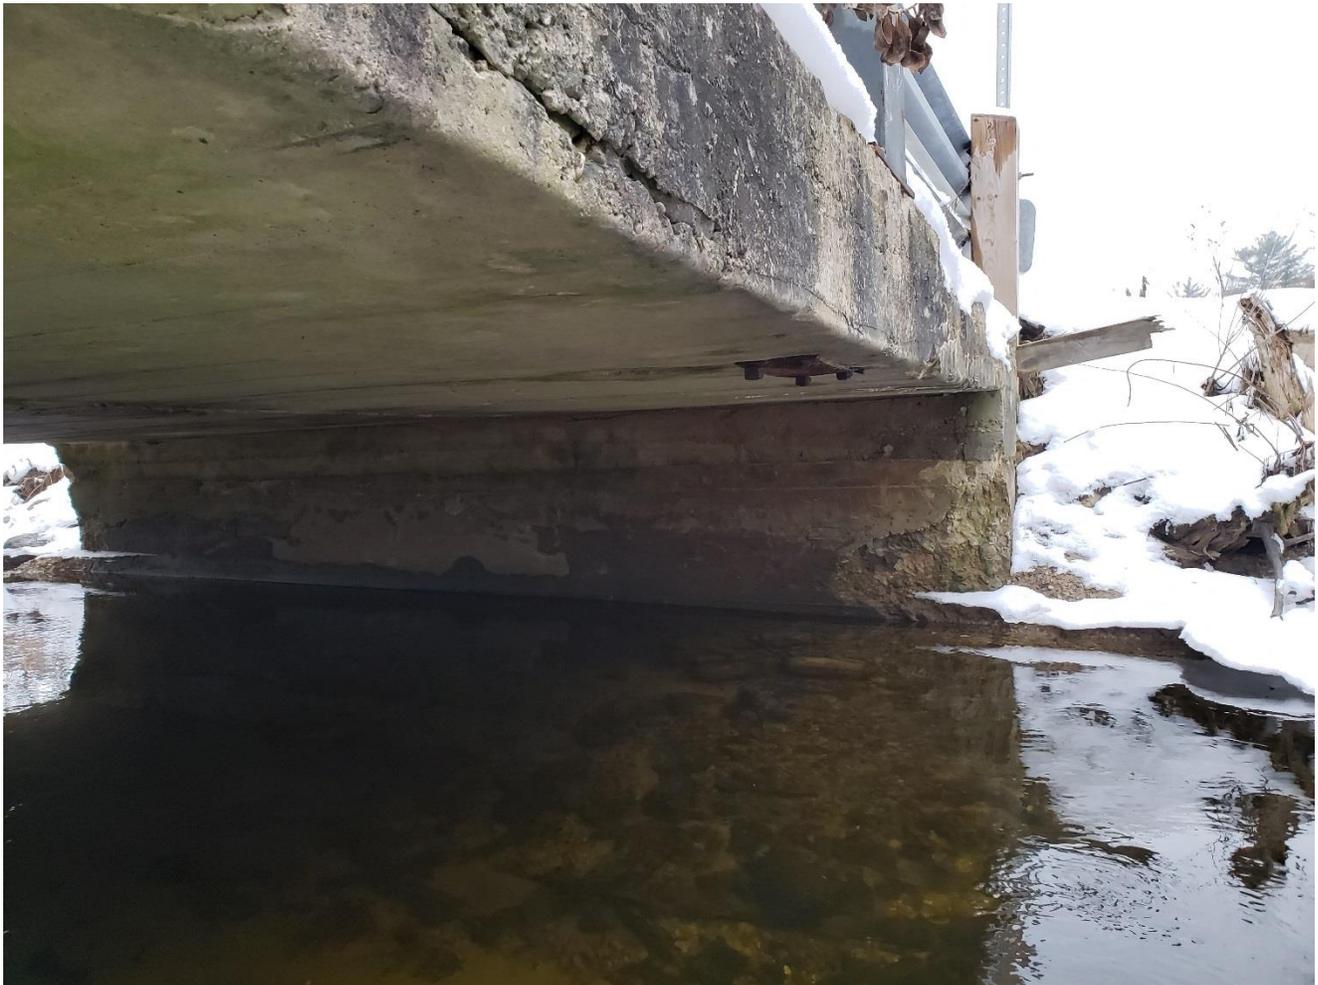
Image 11 – N-188 Elevation View

Structure N-188 serves a very low number of road users with respect to other structures in the Municipality, as it is located on Sideroad 25, between Concessions 12 and 14. Recent inspections indicate that the structure is in very poor overall condition, and the southeast wingwall has an observed failure which resulted in the temporary closure of the structure from 2016 to 2018, when it was reopened following an interim repair. An indepth evaluation of the structures safe load limit capacity is recommended if the structure is to remain open and in a safe operating condition. The structure has an approximate replacement value of \$400,000.

In the case of this structure, replacement (near future) or permanent closure are the two feasible options. Due the moderate cost of replacement and low number of road users and overall importance within the municipal transportation network, structure N-188 warrants consideration for closure by the Municipality in its future strategic planning.

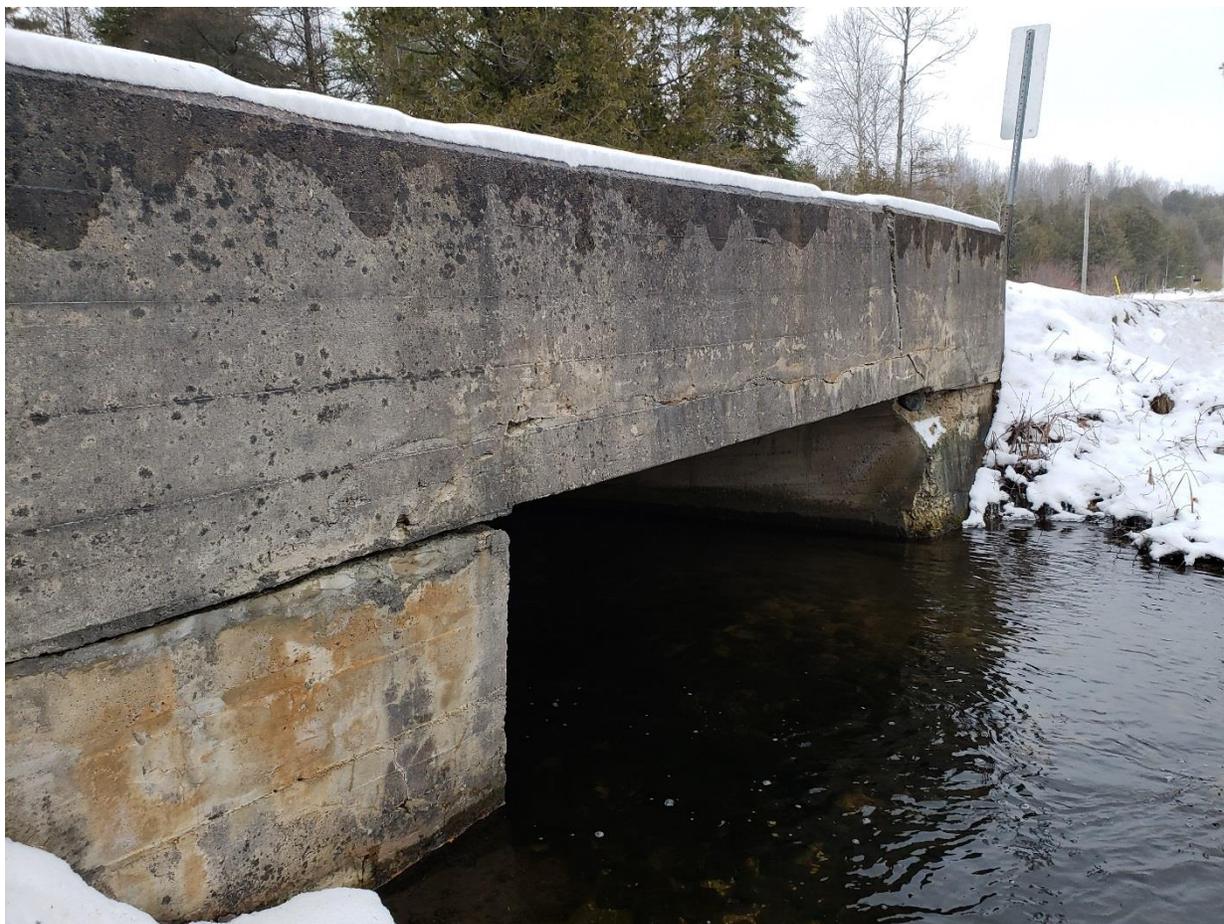
Image 12 N-189, Durham Pedestrian Bridge Elevation View

Structure N-189 serves a very low number of road users with respect to other structures in the Municipality, as it is located on Sideroad 25, between Concessions 12 and 14. Recent inspections indicate that the structure is in poor overall condition, and indicate that significant repairs will be required in the near future if the structure is to remain open and in a safe operating condition. Due to the cost of rehabilitation, replacement is likely the more economic option for this structure. The structure has an approximate replacement value of \$400,000. The structure has close proximity to structure N-188, which is in slightly worse condition and serves slightly less road users, and is recommended for closure. There are several property entrances and field entrances located between Structure N-188 and N-189, which would become stranded or require relocation were both structure to be closed.

In the case of this structure, replacement (near future) or permanent closure are the two feasible options. Due the moderate cost of replacement and close proximity to structure 188, which has been recommended for closure, structure N-189 warrants consideration for replacement by the Municipality in its future strategic planning.
