Municipality of West Grey

Lantz Bridge Conc. 2 WGR

May 18, 2021

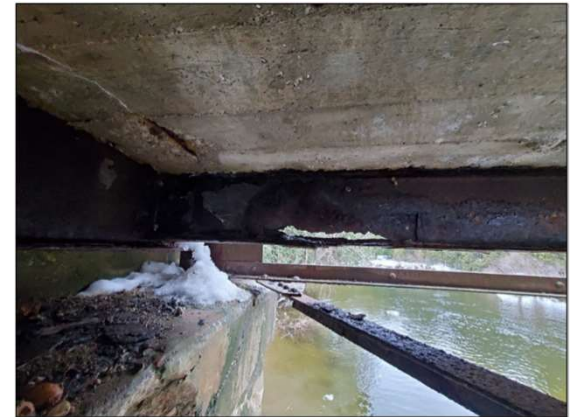
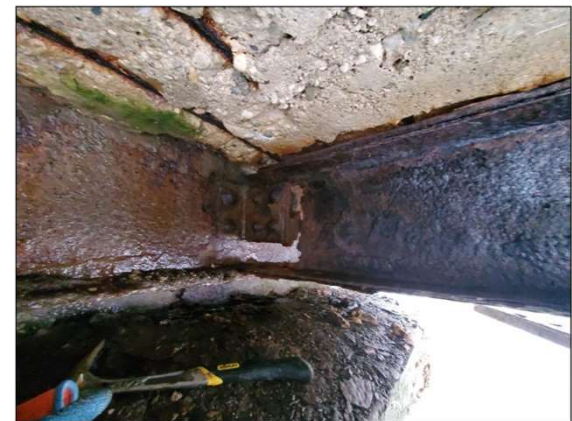
- January 15, 2021, the condition of the structure was reviewed by BMROSS.
- Suspect 4 of the 6 stringers at the south end currently provide 10% or less of original resistance. The other 2 provide 50% of original resistance. At the north end, suspect 2 out of 6 currently provide no resistance and the remaining 4 provide about 50%.
- Based on our review, it was recommended the structure be closed.

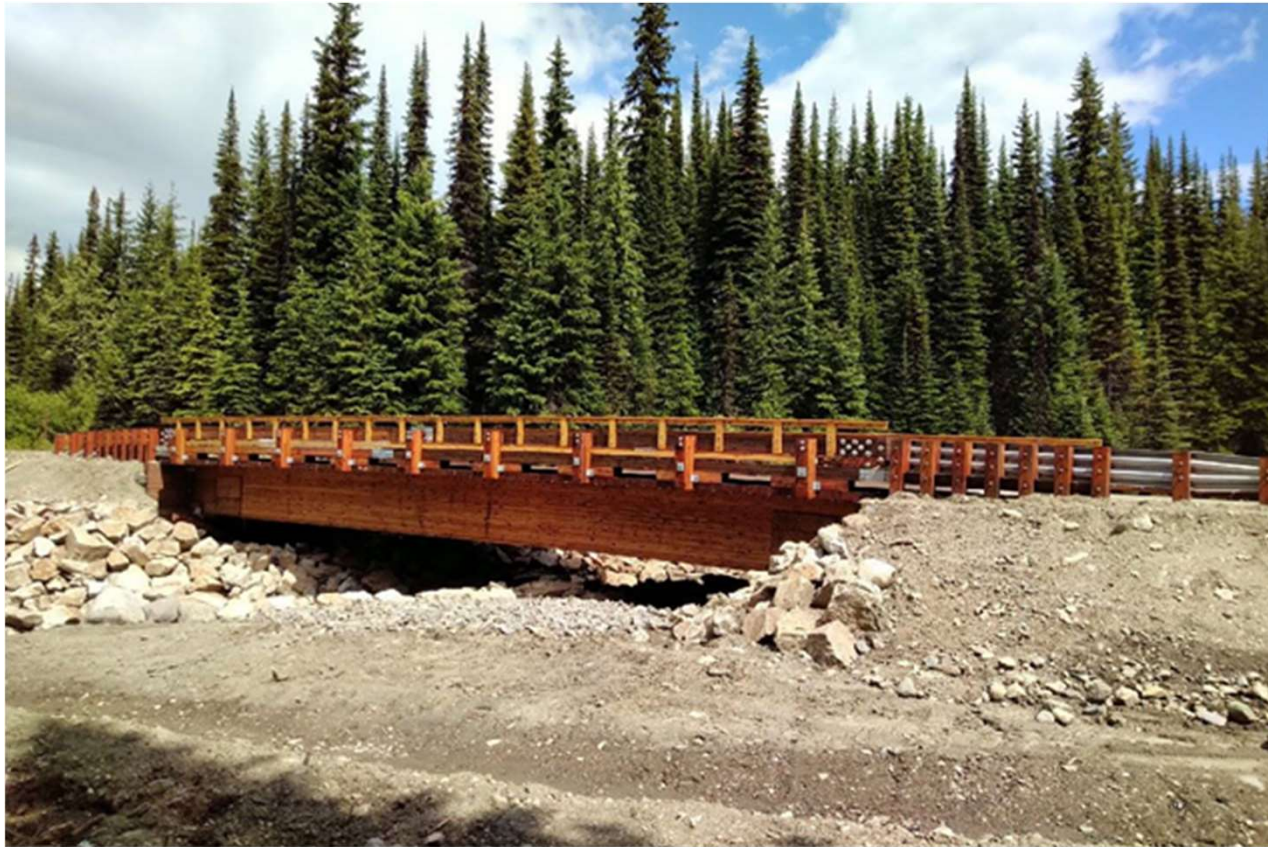
Photo

22m clear span wood superstructure bridge

- 3A - Wood Superstructure
 - Short construction period, 12 weeks
 - Deck components can be delivered sooner
 - Originally proposed when grant application submitted.
- 3B - Steel Girders and Concrete Deck
 - Longest construction period, 16 weeks
 - Longer lead time for delivery anticipated than for wood
- 3C – Concrete Box Girders and Concrete Deck
 - Second longest construction period, 15 weeks
 - Longer lead time for delivery anticipated than for wood
- Based on information gathered the wood superstructure options appears to have a few advantages
